MODEL 962

Model 962 test report

24 Sept 98

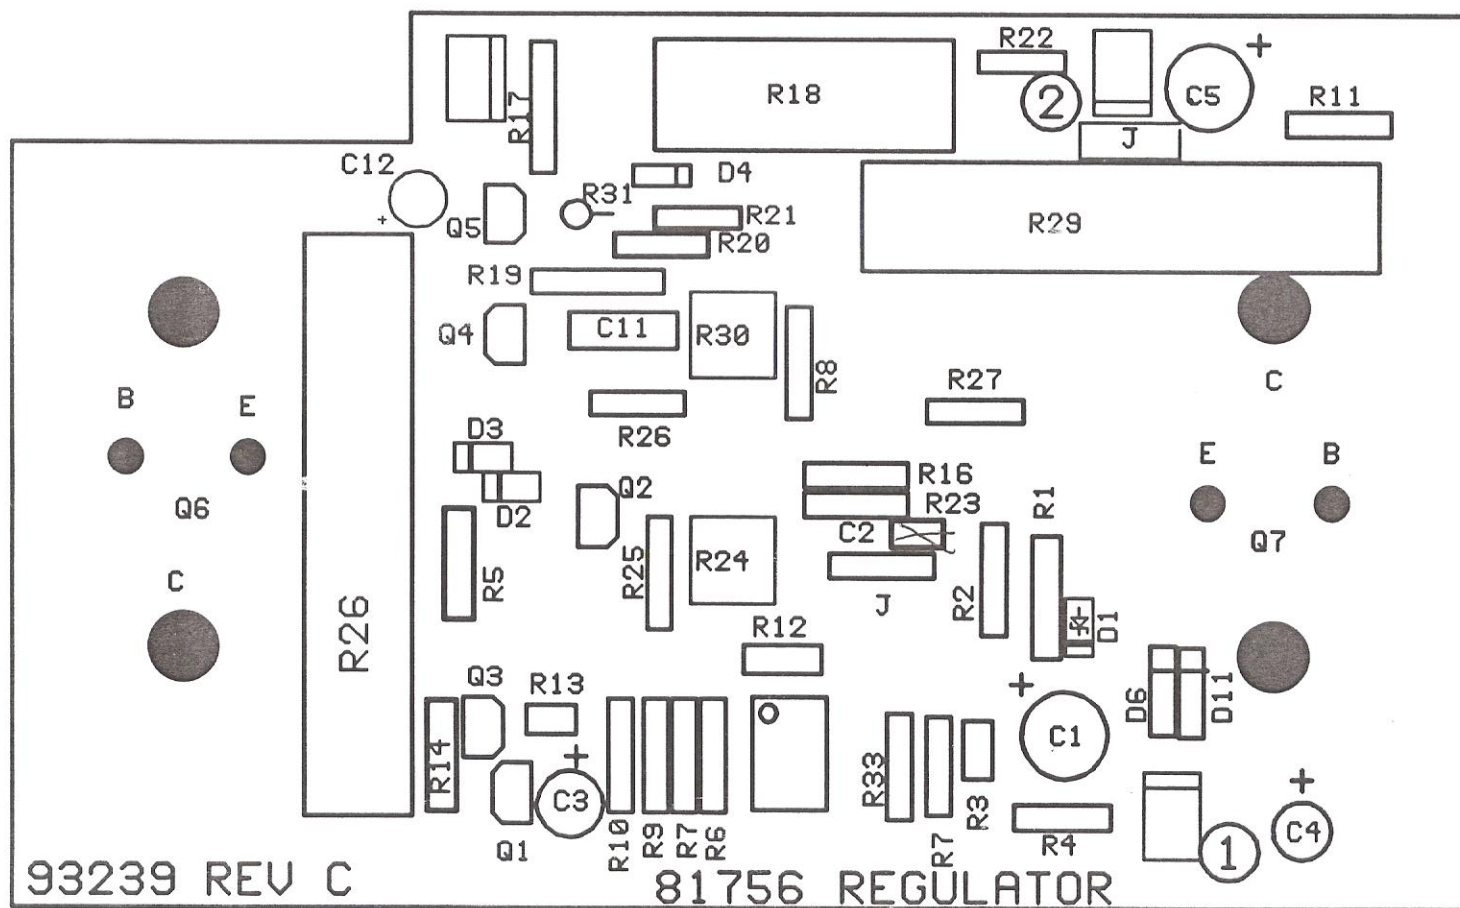
SCHEMATIC DIAGRAM OF MODEL 962 POWER SUPPLY/SPEAKER

Voltage overshoot on turn-on causes 564 over voltage protection to "buzz"

Caused by c12 - r560 charge timepulls gnd and base of Q5 to B- till charged

Change C12 from 33uF to 10 uF.....(R21-31 and C12 feedback gnd ripple to Q5 to reduce ripple on output).....this ripple was found on first run only with red zeners (change zeners also reduced ripple).

Add 1000 uF to AUX 12 Vdc jacks on rear chassisThis caused over current trip on some units....

Change R10 from 1K to 4.7K To delay trip

MOVE C2 to IC #4+5
added GK resistor 1KΩ
