## Restoration of an ICOM IC-201

### 2m Allmode Transceiver from the “Seventies”

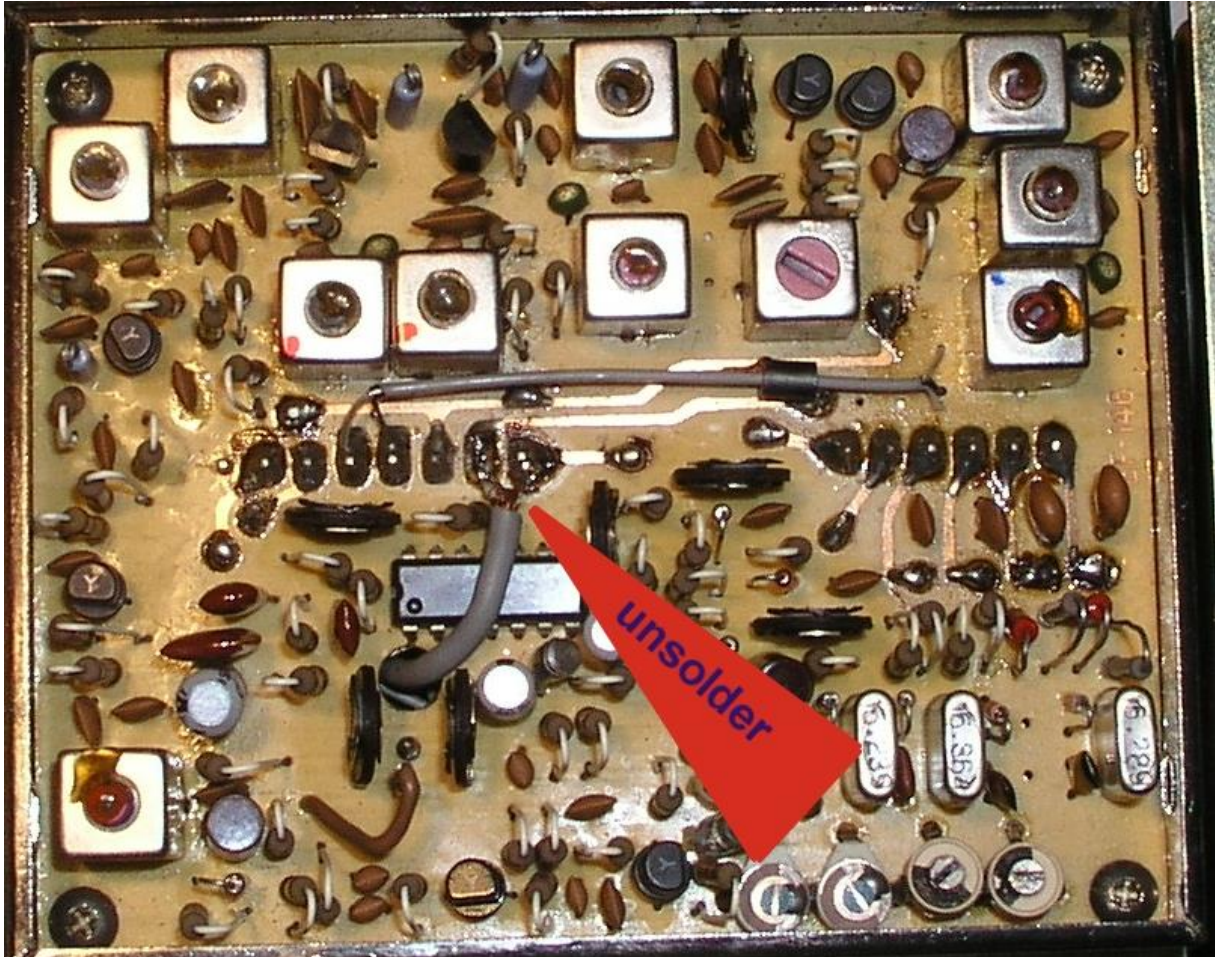
Premixer Board

Unsolder coax wire for removal

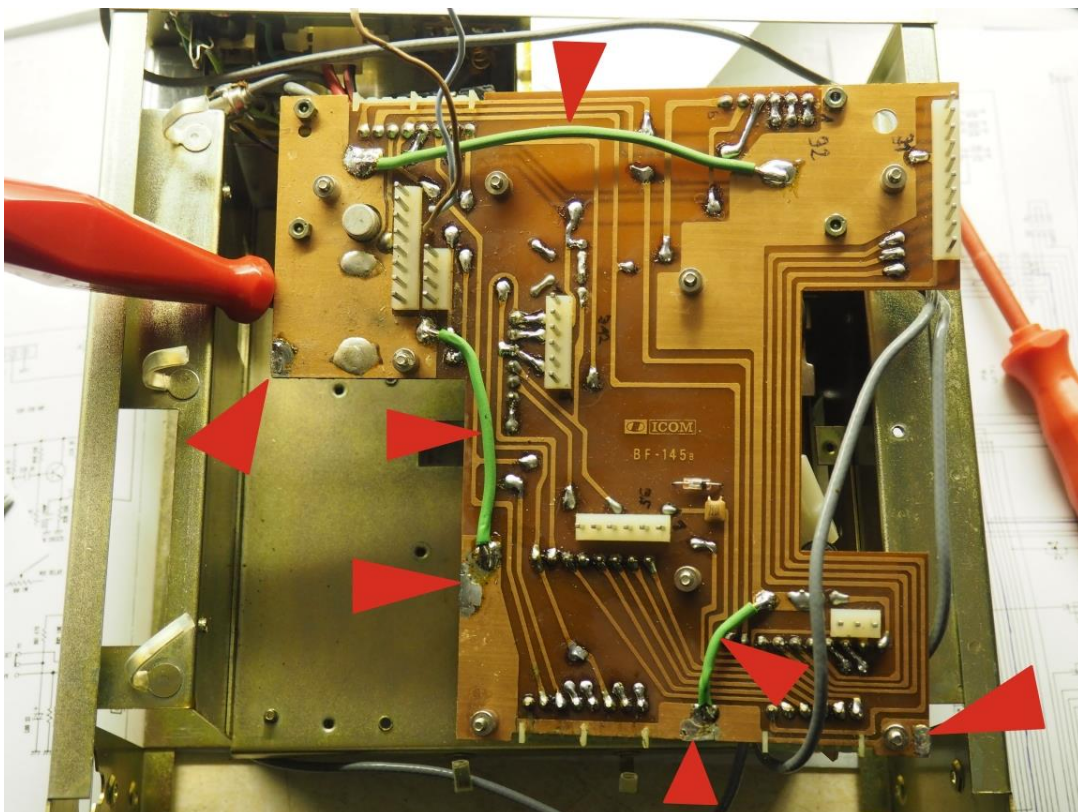
Ground connection improvements

The ground connections between some areas of the mainboard are made via the chassis and screws, which is very bad due to aging and corrosion.

In the second step improve ground connections:

- Solder three ground wires between the areas
- Connect both sides of ground layers with small copper strips
- See above picture with red arrows

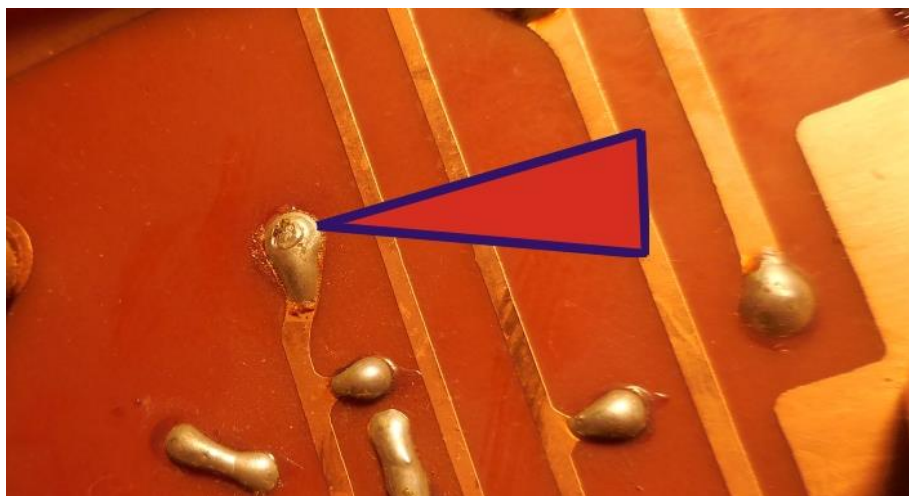
Example for bad feedthrough pin

They are made with small pins which tend to loose contact over the years.

Best is to remove ALL feedthrough pins and replace them by wires:

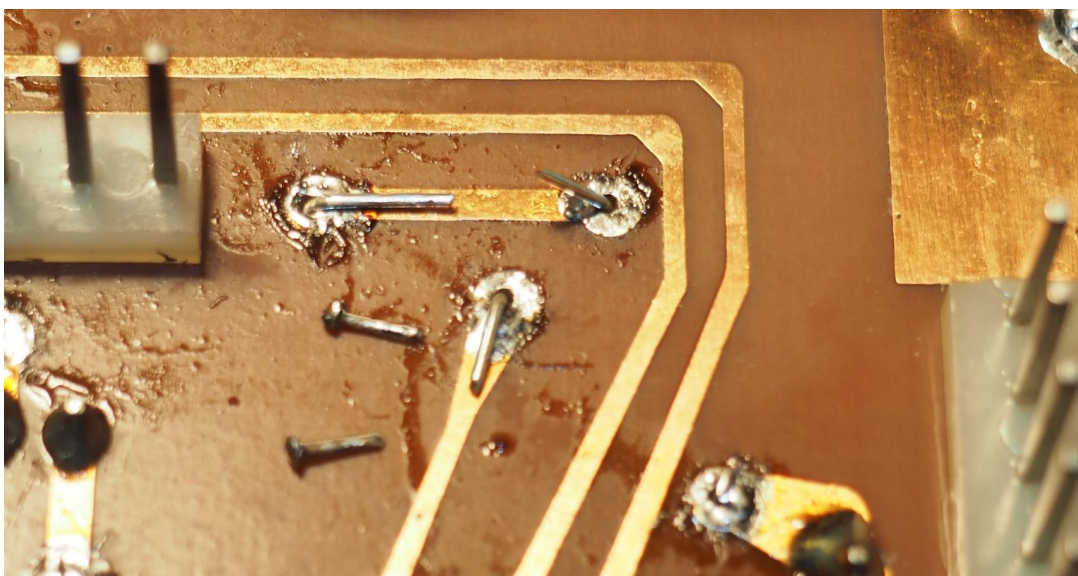
Some old pins and new wires can be seen in this picture – this work is worth to be done!

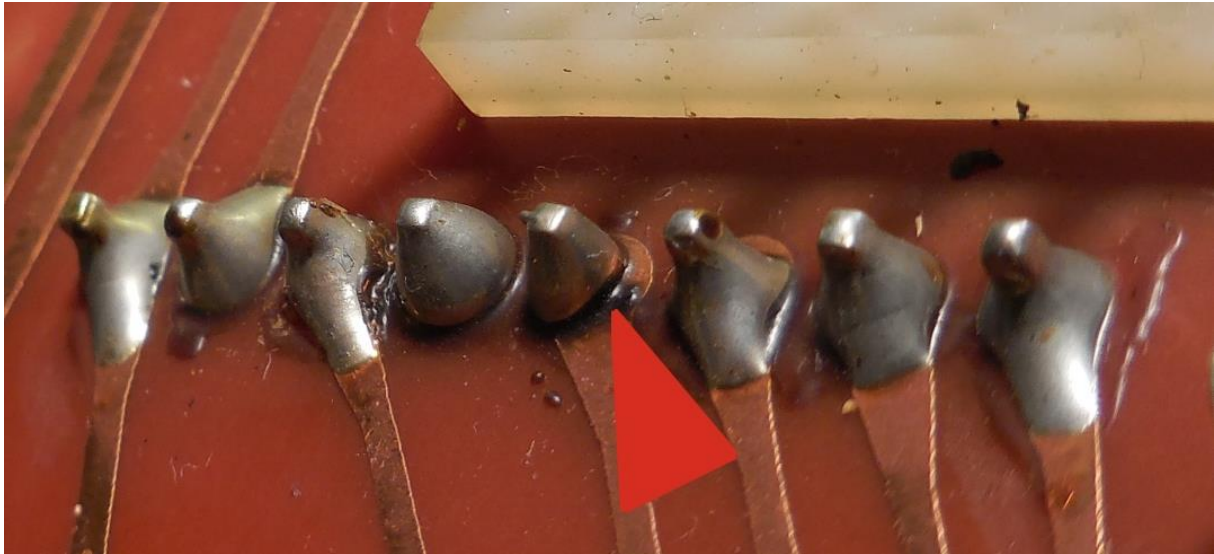
Another culprit are the pinheads on the mainboard and their connections.

All swimming on solder flux?

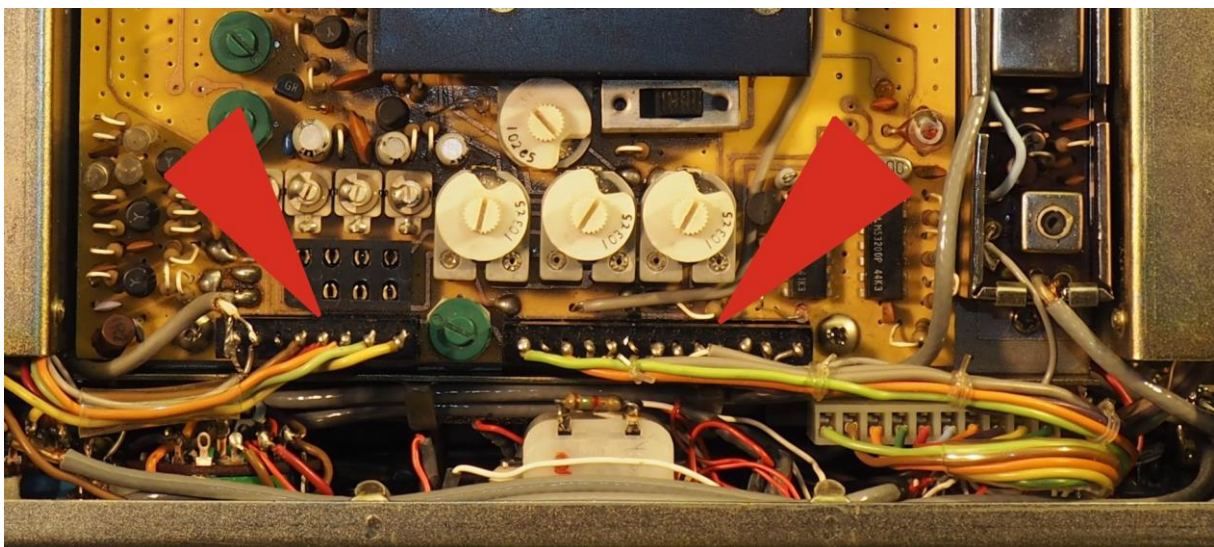
The layout of the AF-Board isn't very good related to ground wires; so additional wires are recommended. The small pinheads need also special attendance.

Critical small pinheads on the AF-board

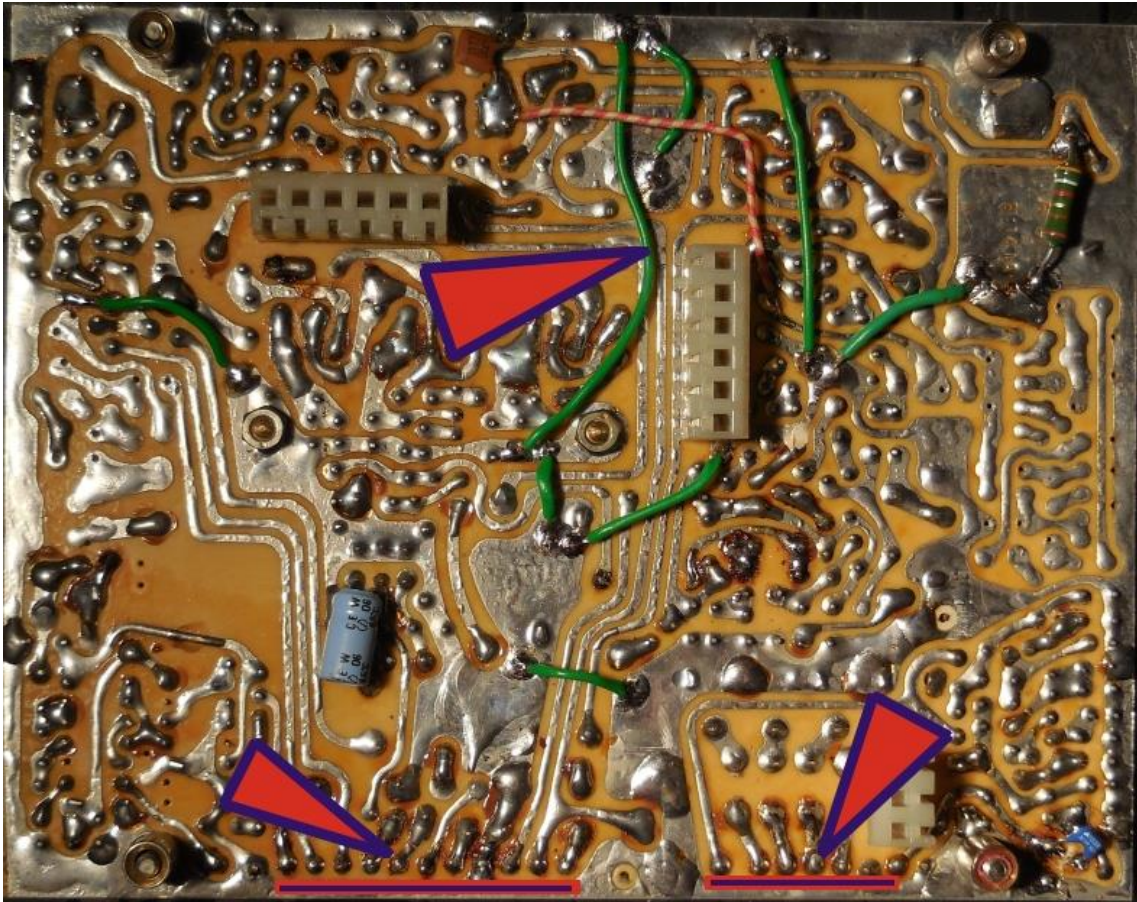
Additional ground wires (green) and resoldered pinheads on the AF-Board

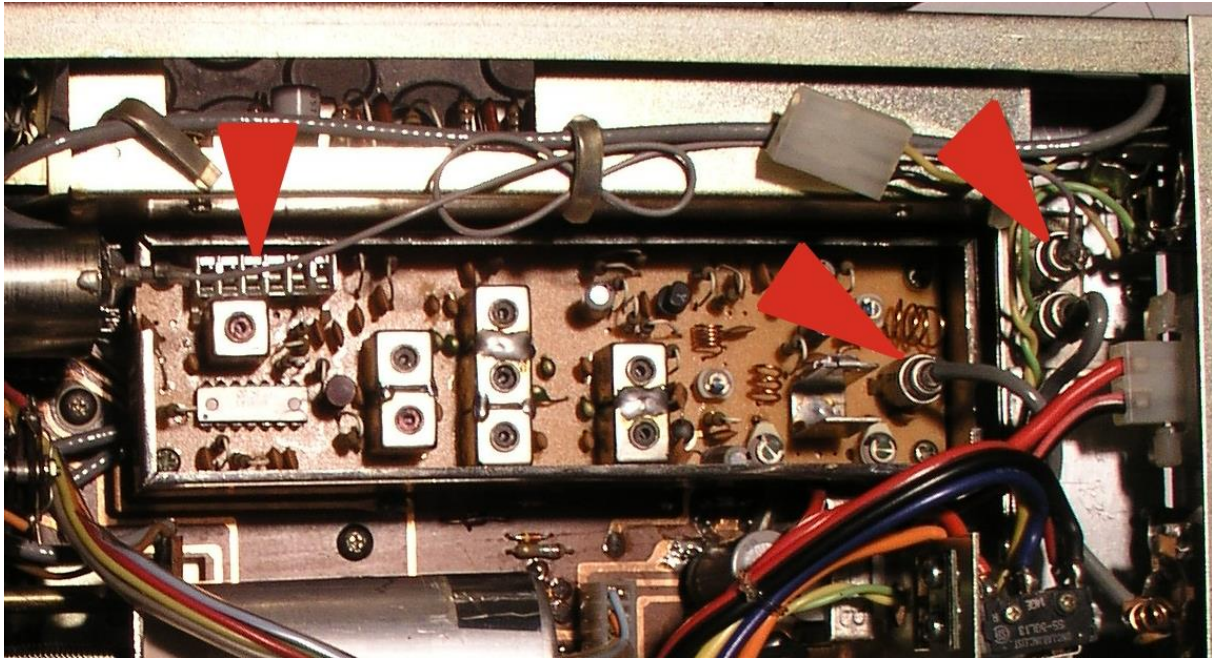
These bad plugged connections on the TX-Mix board caused low output

Boards with plugged connections can easily be removed but over the years they may degrade. Check ALL plugged connections; for coax connectors also check the center conductor! Clean/deoxit them and bend the counter contact back into the right position if necessary.

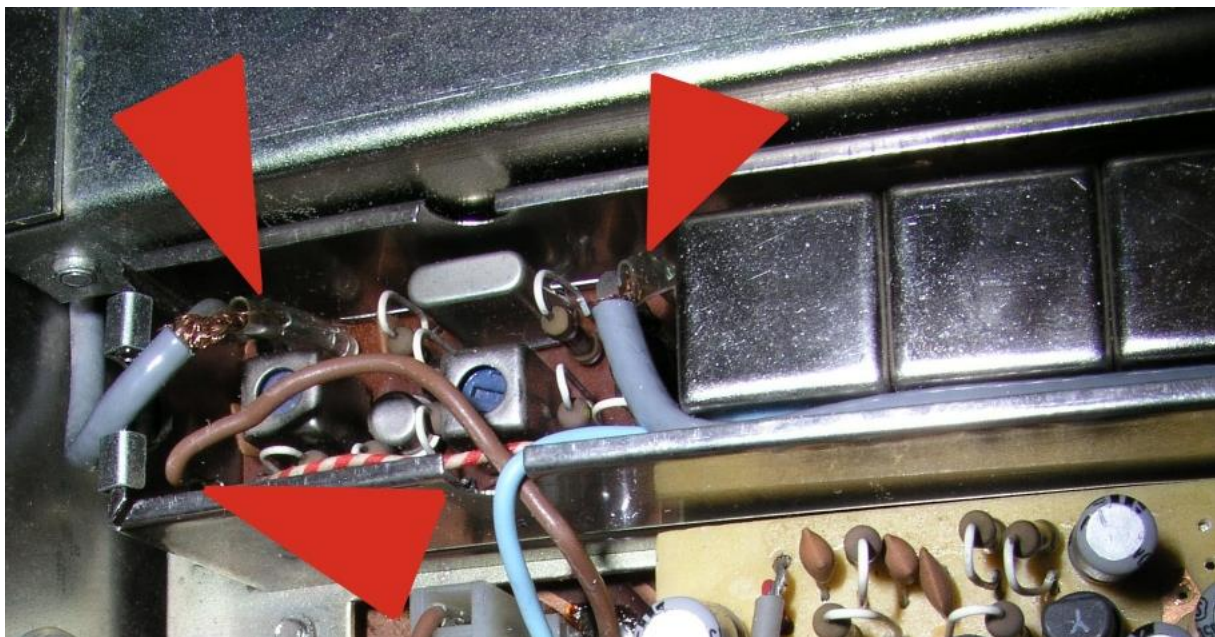
The deaf receiver was caused by bad coax connectors in the RF-Unit

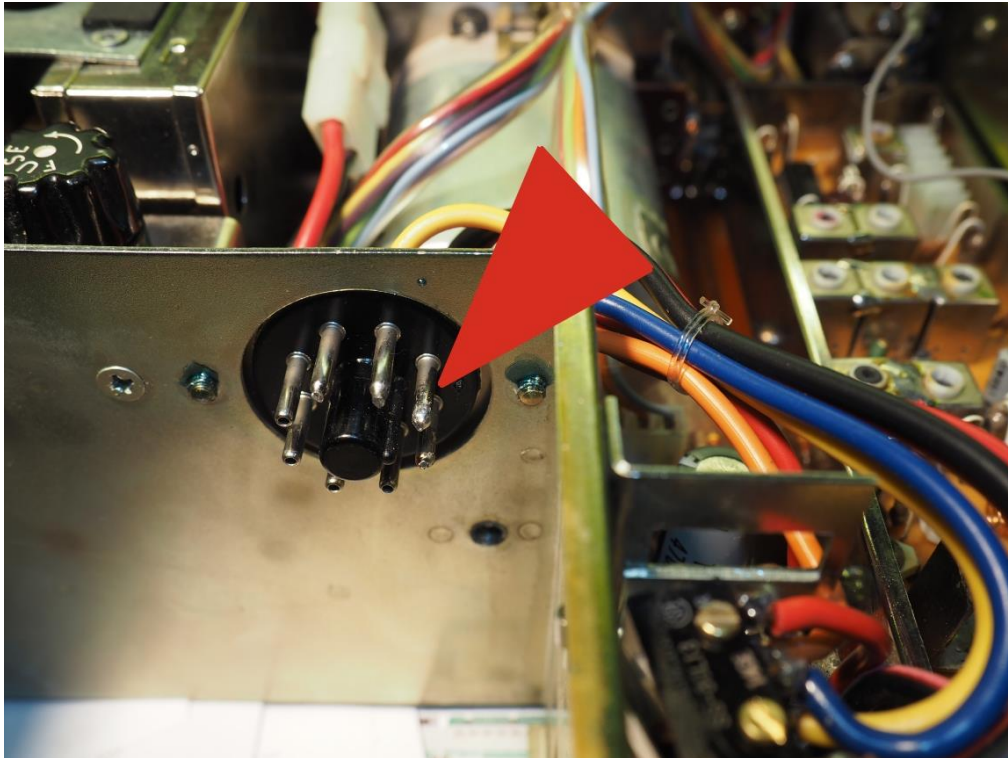
Finally, the plug of the power supply was bad:

Caused sometimes a total blackout of the transceiver
