# IC-22S on Marine Frequencies

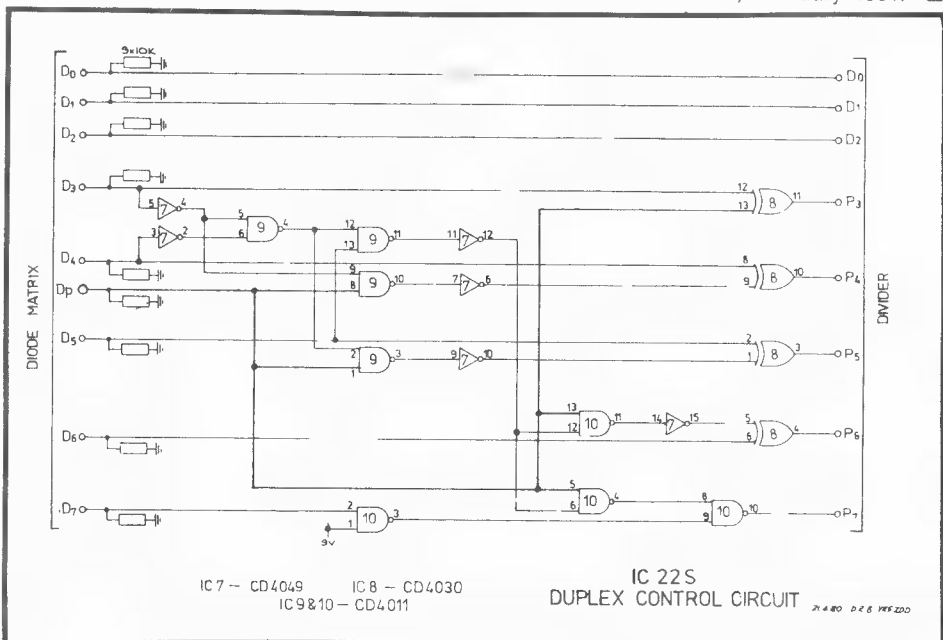
I have included a circuit diagram of the duplex control circuit obtained from tracing out the printed circuit board. Basically, at Simplex and Duplex "A" operation the frequency programmed from the diode matrix is the same as the output which is fed to the divided IC, but on Duplex "B" transmit, the logic code output is 600 kHz higher.

With this task and with use of a logic probe a faulty IC (IC7) was located and replaced, but the fault did not end here.
