## TS-890S

### Circuit update for antenna tuner failure.

## SERVICE BULLETIN ASB-0167

June 16, 2022

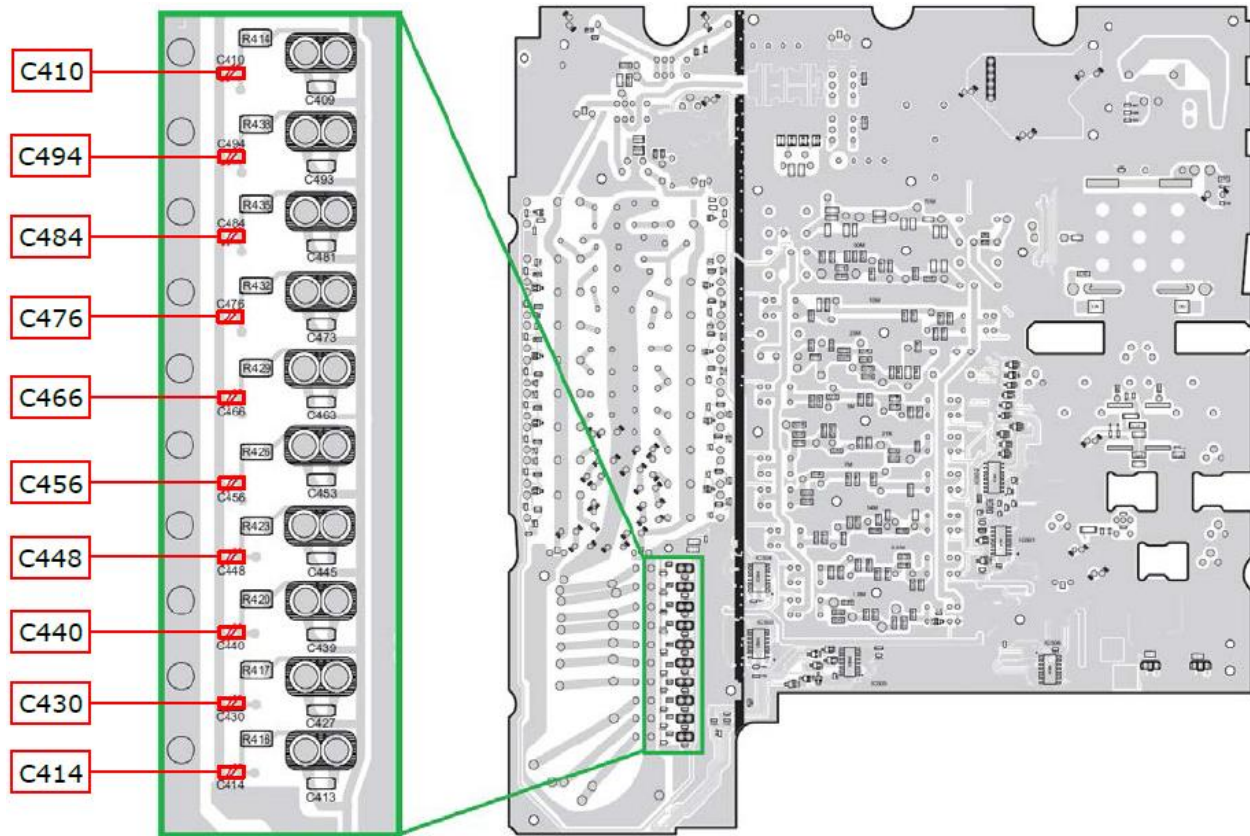
When a TS-890S Antenna Tuner circuit is repaired by replacing the relay control transistors part number DTD113ZU (mainly Q510, Q511, Q512), please also remove the chip capacitors as follows to prevent recurrence of the ATU failure.

Remove all the following 10 chip capacitors (CK73GBB1H103K) from bottom side of Final/AT unit PCB
