Replacement of power transistors SRFH1008 and MRF455

This service bulletin affects the users of transceivers with power amplifier (PA) output transistors SRFH1008 or MRF455. There are two transistors (matching pair) on each PA PCB. The following transceivers are affected:

The transistors SRFH1008 and MRF455 are obsolete. The replacement transistor is MS1253-CDN.

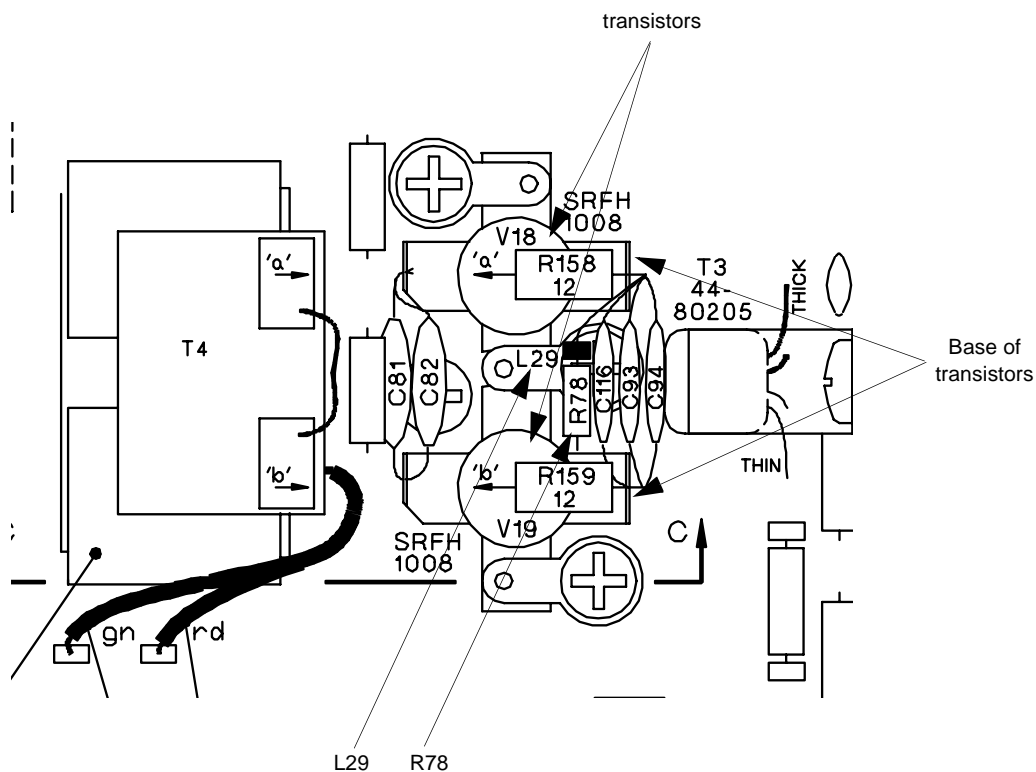
Figure 2: Power amplifier PCB for the 85xx series/9313/9480 transceivers

If R78/L29 is not present, it must be fitted.

Without the resistor/choke in place, spurious oscillations at approximately 4 MHz occur. The resistor/choke network consists of a:

- ❑ Check if there is a resistor/choke (R78/L29) across the base of both transistors on the PA PCB (Codan part number 08-03743-xxx) (see Figure 2).

- 12 Ω ¼ W 5% resistor
- ferrite bead placed on one leg of the resistor with a small amount of silastic to stop any movement

- ☐ Replace the transistors with MS1253-CDN (see Figure 2).
- ☐ Continue from [page 5, Adjusting the output bias in all transceivers](#).
