# Icom IC-M710

## Repairs / Mods

### 2023 : No Transmit Output Power.

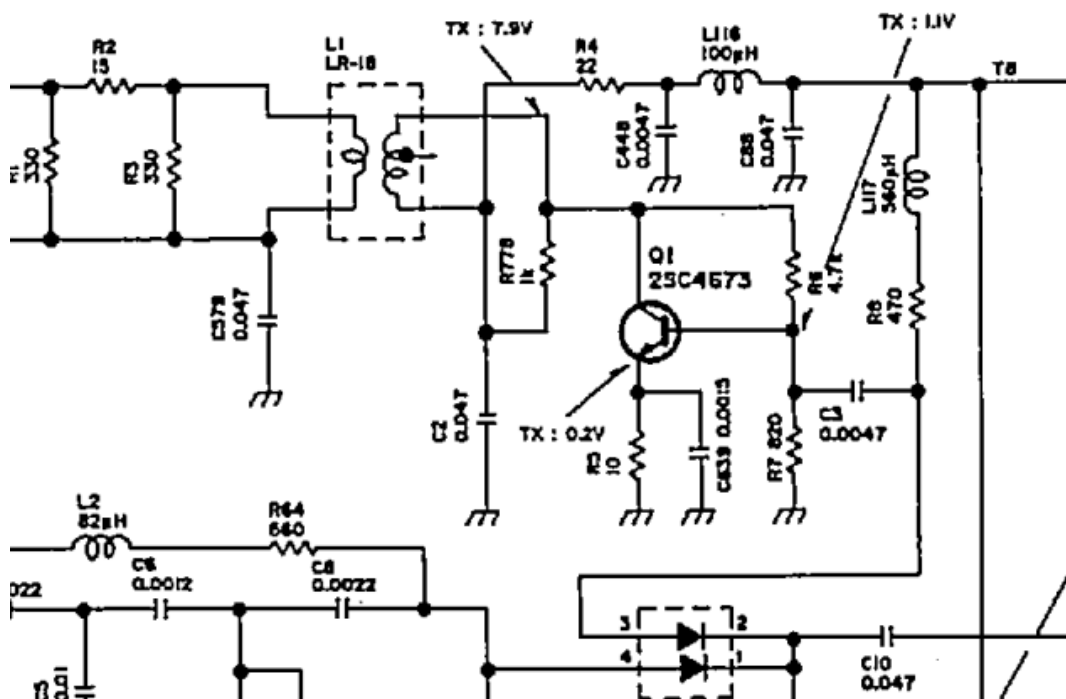
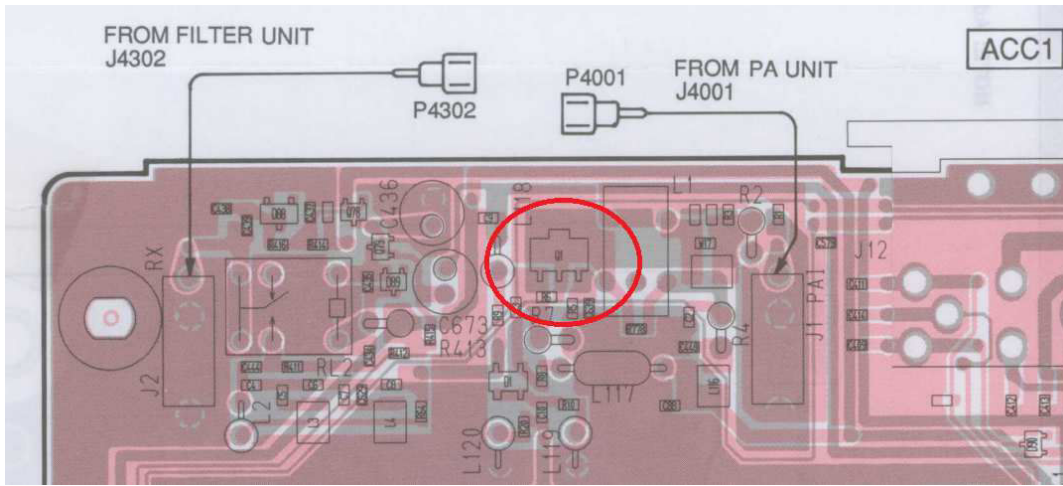
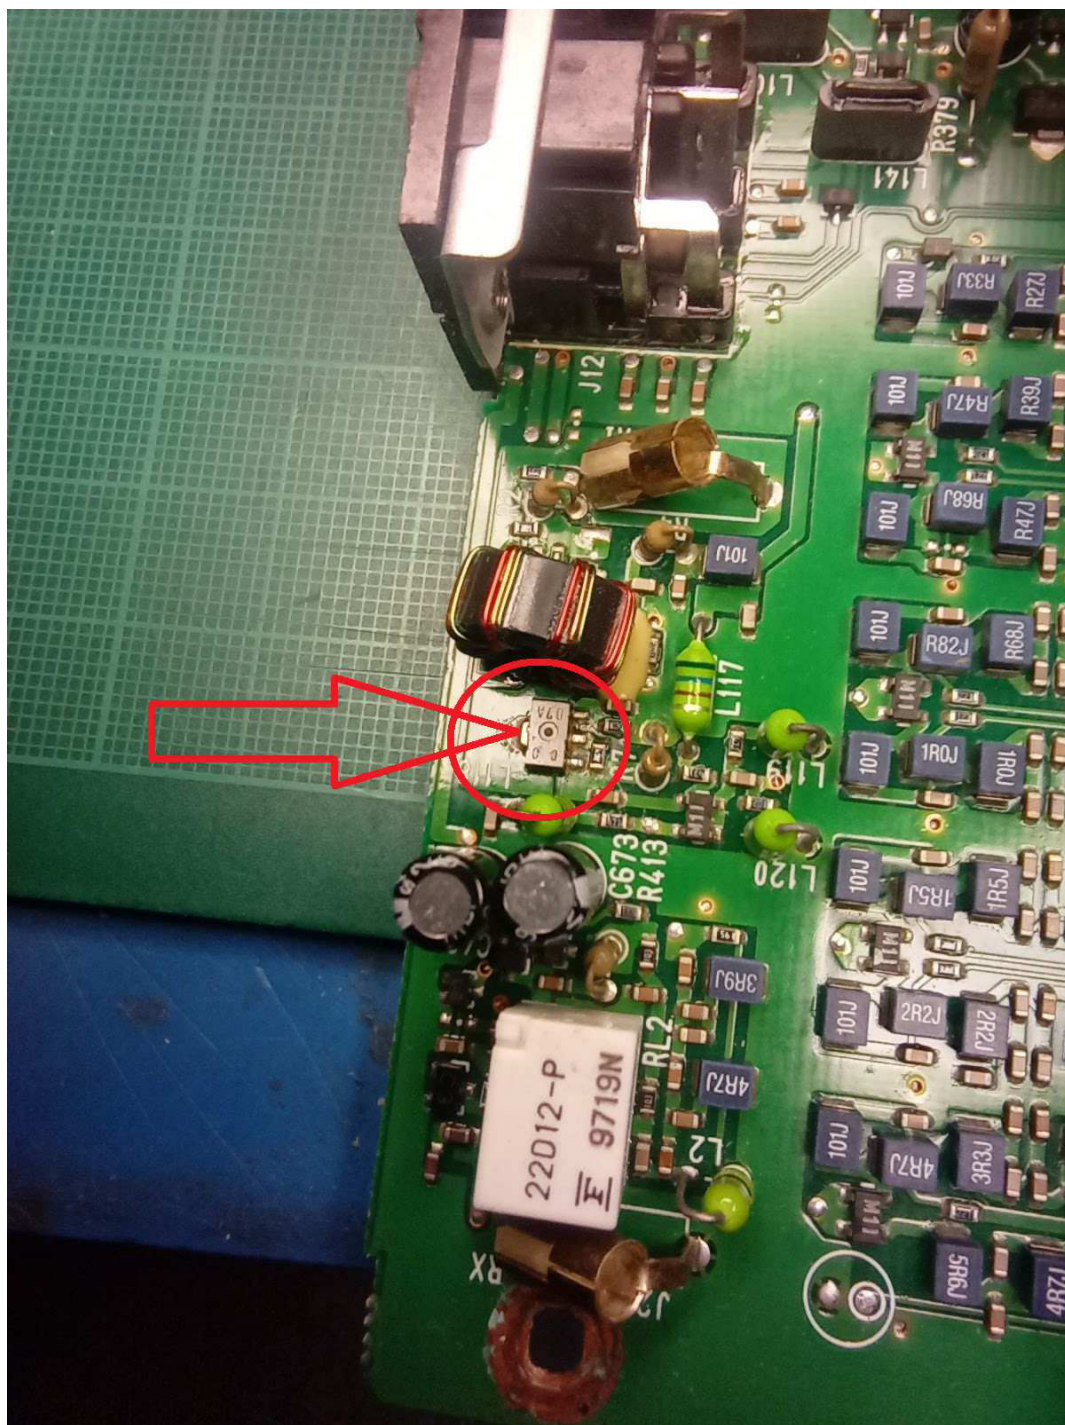
- Receive functions normally
- trace to - pre-drive TX buffer amp transistor - Q1 Main PCB
  - No Drive to PA from Main Board
  - TX signal present at base of Q1 but no signal at collector
  - Q1 2SC4673 sourced from eBay <https://www.ebay.co.uk/itm/322993473692>  
[<https://www.ebay.co.uk/itm/322993473692>]
  - 07/02/23 : Replaced Q1 and full transmit power restored.
