## SERVICE BULLETIN

EQUIPMENT TYPE KWM-1

BULLETIN NO. 1

9-12-58

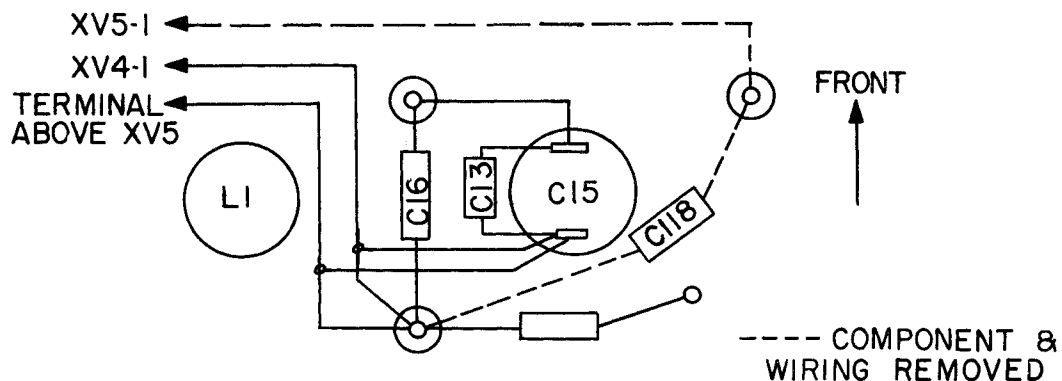
Figure 1. Wiring Location of L1 Shield Can

It has been noted that multiple beats are present in Calibrate position of the Emission Switch. The following modification will increase the strength of the correct calibration signal. Units using a type 6AU6 tube for V1 require this modification.

lead are connected to insulated terminal mounted on trimmer capacitor. Discard coax and capacitor. See figure 1.

7. Install a five inch length of coax cable (425 0926 00) from terminal directly over XV5 pin 9 (installed in step 5) to insulated terminal to which C16 and coax cable to XV4 pin 1 is connected. See figure 1. Ground coax shield to C15 as shown in figure 1. Ground shield at C15 end only.

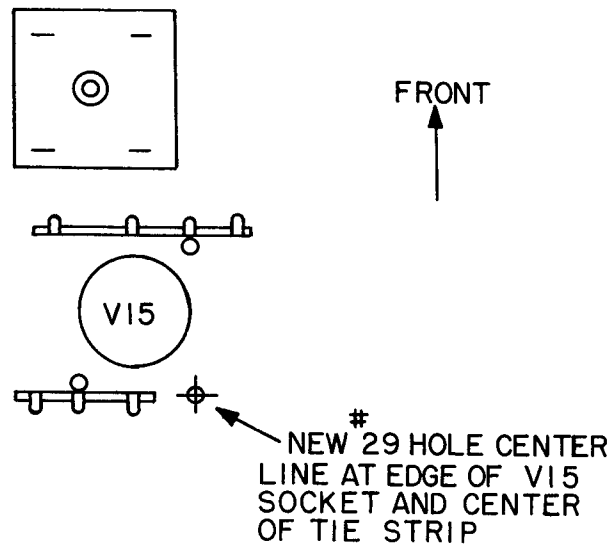
Figure 4. Location of Number 29 Hole for Installation of Insulated Terminal

In some KWM-1 transceivers a popping noise is evident when changing from receive to transmit. This noise may be greatly reduced by the following modification. Serial number effectivity 861.

2. Carefully drill a number 29 hole next to tie strip at rear of XV15 as shown in figure 4. Care should be taken not to damage cable harness.

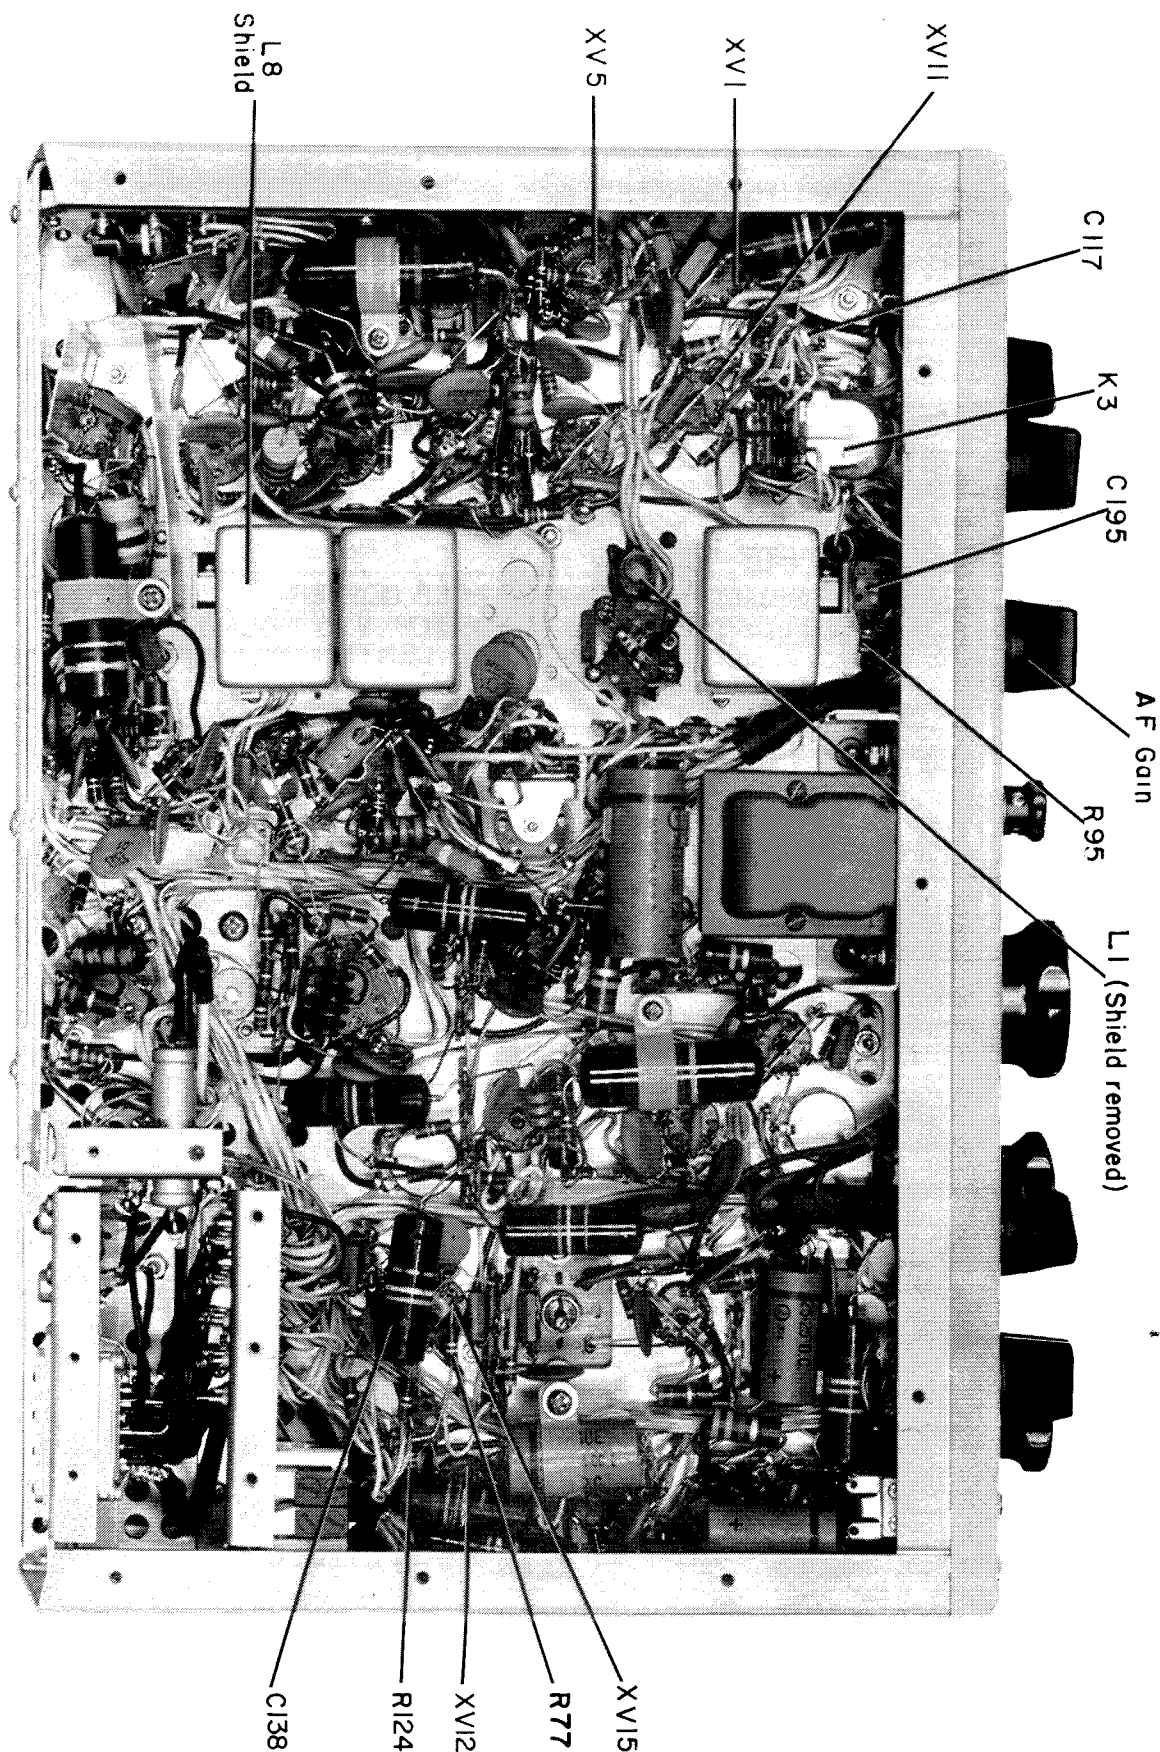
Figure 6. Location of Components, Bottom View

In earlier models of the KWM-1, some hum could be heard if the AF Gain control was run high when in CW operation. This is actually a low frequency oscillation in the sidetone circuit and may be eliminated by the following modification. Units that have this modification installed will have a four terminal tie strip mounted directly behind the RF and AF gain controls with a 470 K 1/2 watt resistor connected in series with a 220 uuf capacitor mounted on the strip. Figure 6 shows the modified circuit.

3. Remove L1 coil can. (L1 can is located beside XV4 and is second can nearest front of the unit). See figure 6.

1. Remove the 330K 1/2 watt resistor, R124, connected to terminal on terminal strip behind XV12. (See Figure 6). R124 should be removed by cutting from the strip and discarded.

1. Remove the L8 shield can. See figure 6.
2. Install five ground clips (220 1323 00) around edge of the can and replace in original location. Make sure that can mounting nuts are tight.

6. Connect .1 uf capacitor, C204, (931 0299 00) from insulated terminal installed in step 3 to same ground as C138. See figure 6.
