FL-2100B and FL-2100Z WORKING WITH SOLID-STATE TRANSCEIVERS

Ron Mills VK5XW

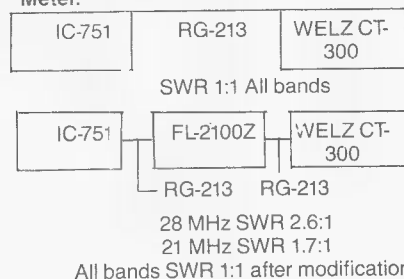
Figure 1: Test Set-up using the IC-751 SWR Meter.

The IC-751 was connected, via a short length of RG-213U coaxial cable, to the FL-2100Z, then via the same type of cable to a Welz CT-300 dummy load. The SWR read on the IC-751 was again around 1.7:1 on 21 MHz and 2.6:1 on 28 MHz.
