HF-Transceiver

Kenwood TS-830

Survival Guide

Kenwood TS-830 Survival Guide, ed. [Olaf Rettkowski](#), DL9AI, ver.1.2, 03 Dec 2002,
rev. 21 Dec 2008

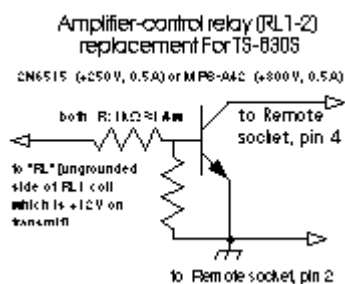
6.1 Excessive delay in relay control signal to external amplifier--which causes hot switching in the amplifier's RF relays

Cause: The RF relay in the TS-830S also switches the external amplifier relay control line. Thus, the amplifier relays can not begin to close until the RF-relay in the TS-830S has closed.

Fix: Install a NPN >200V switch transistor [MPS-A42 or=] in the TS-830S to take over the job of relay control line switching. The input [base] of the switch transistor is driven by the +12V on transmit signal ["RL"] that drives the coil of the TS-830S' RF-relay, RL1. The base-current is limited to approx. 11 mA with a 1 KOhm series resistor. Connect another 1 KOhm resistor between the emitter and the base to drain off the stored charge in the base. The emitter connects to chassis-ground. The collector connects to the wire from pin 4 on the Remote socket. Pin 2 of the remote socket should be connected to chassis-ground or to the emitter of the transistor. The NPN transistor can only switch a positive relay-control line voltage, so this circuit will not work on negative relay-control voltage amplifiers like the SB-200 and the 30L-1. The fix is to convert these amplifiers to [standard] positive V relay control line polarity. A solid-state electronic cathode bias switch [ECBS] is useful in this application. Such a circuit is shown in QST magazine, January 1994, "The Nearly Perfect Amplifier."
