**Rotary Relay Replacement**

**ICOM 720A**

**KA6BFB**

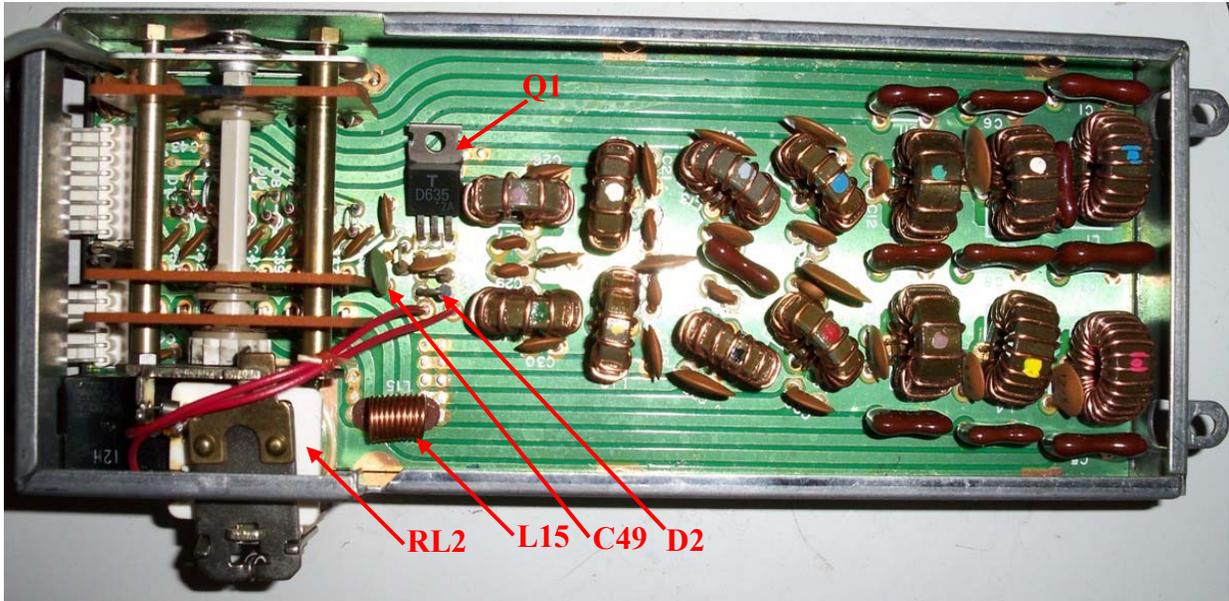
Figure 1. Filter Module prior to modification

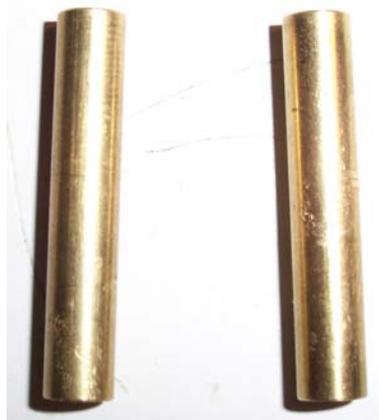
Figure 2. Brass tubing from rotary relay

- 1) Completely remove the existing rotary relay (RL2). Be careful to leave all other existing components intact. Save the 2 longer brass tubing sections for later use.

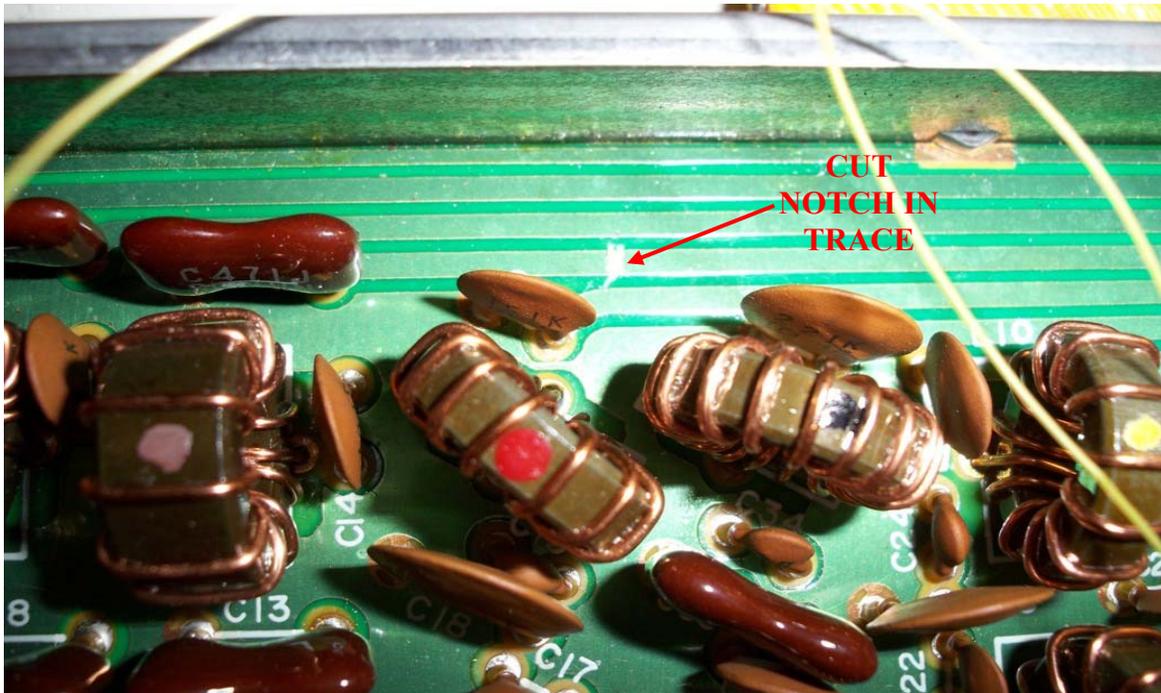
Figure 3. Notch made in PCB trace to accommodate new placement of L15.

- 2) Remove D2 and C49.
- 3) Remove Q1 and replace with a 2N2222A. Be sure to accommodate the different pin-out of the two transistors. The collector pin is the middle hole.
- 4) Remove L15 carefully. This inductor will be moved elsewhere to make room for a relay board. With an insulated piece of wire place on the bottom of the PCB, make a shorting connection to complete the former path of L15.
- 5) Make a notch in PCB trace as shown in Figure 3. Clear top of PCB on both sides of the notch to expose bare copper on PCB. L15 will be soldered here.
- 6) Install L15 as shown in Figure 4.

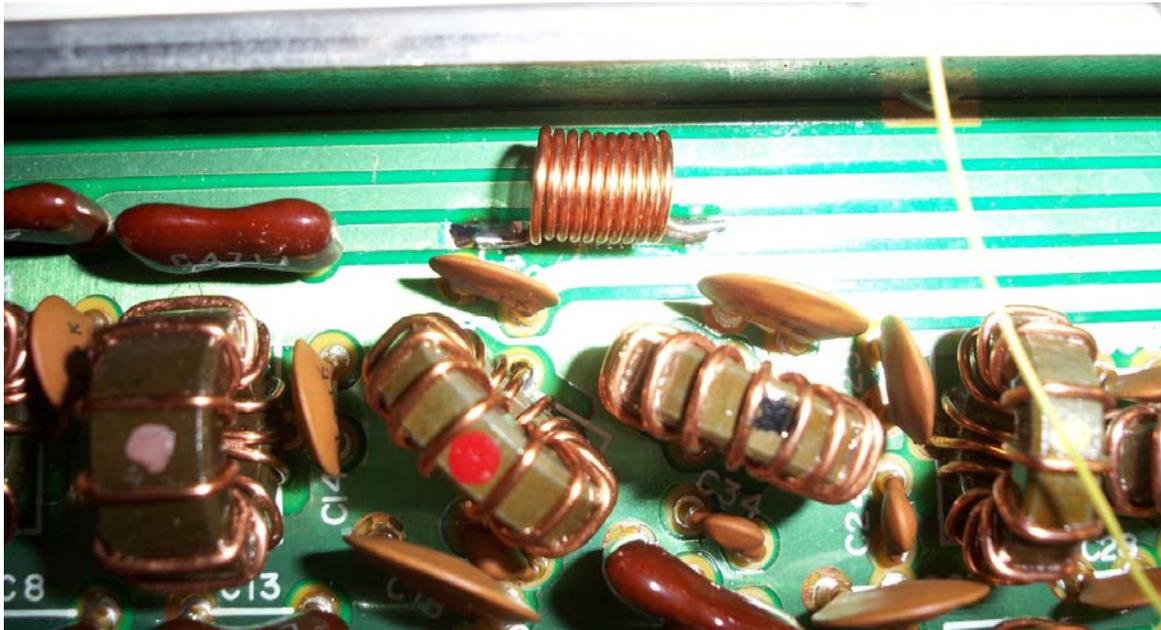
Figure 4. L15 installed in new position.

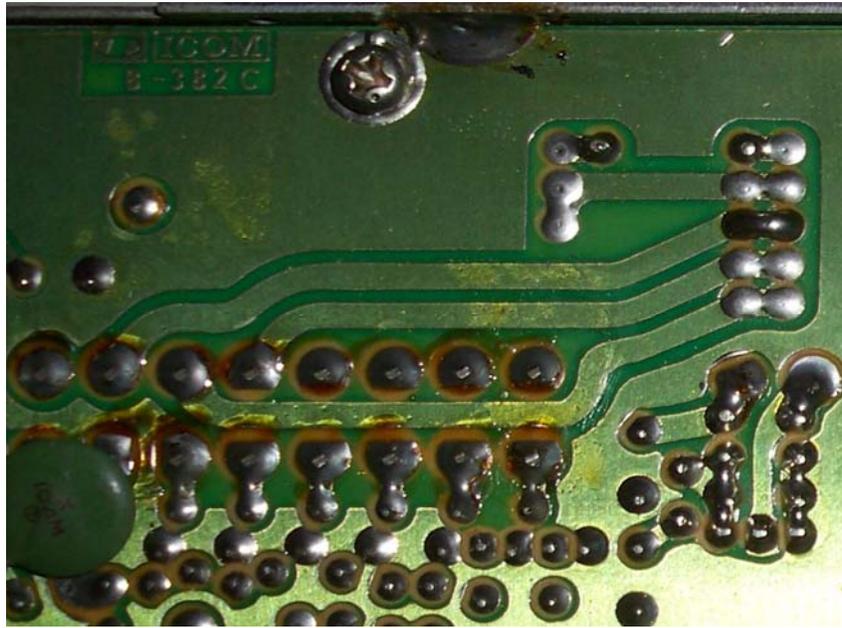
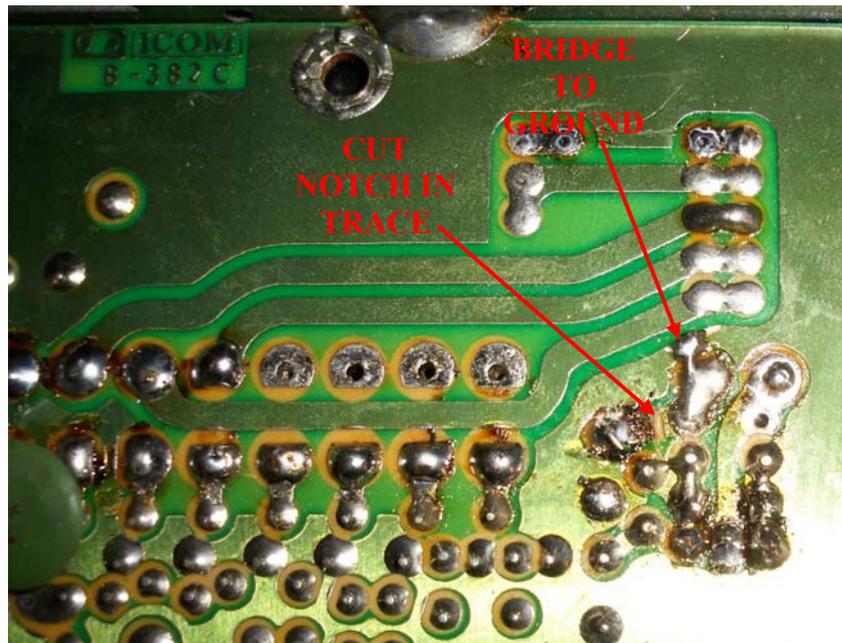
Figure 5. Original condition of PCB compared to modified version.

- 7) Perform the modification to bottom side of PCB as shown in Figure 5. A trace will be cut, and one of the resulting sides will be bridged to the ground. This will be used as the ground connection hole for the soon to be constructed control board.

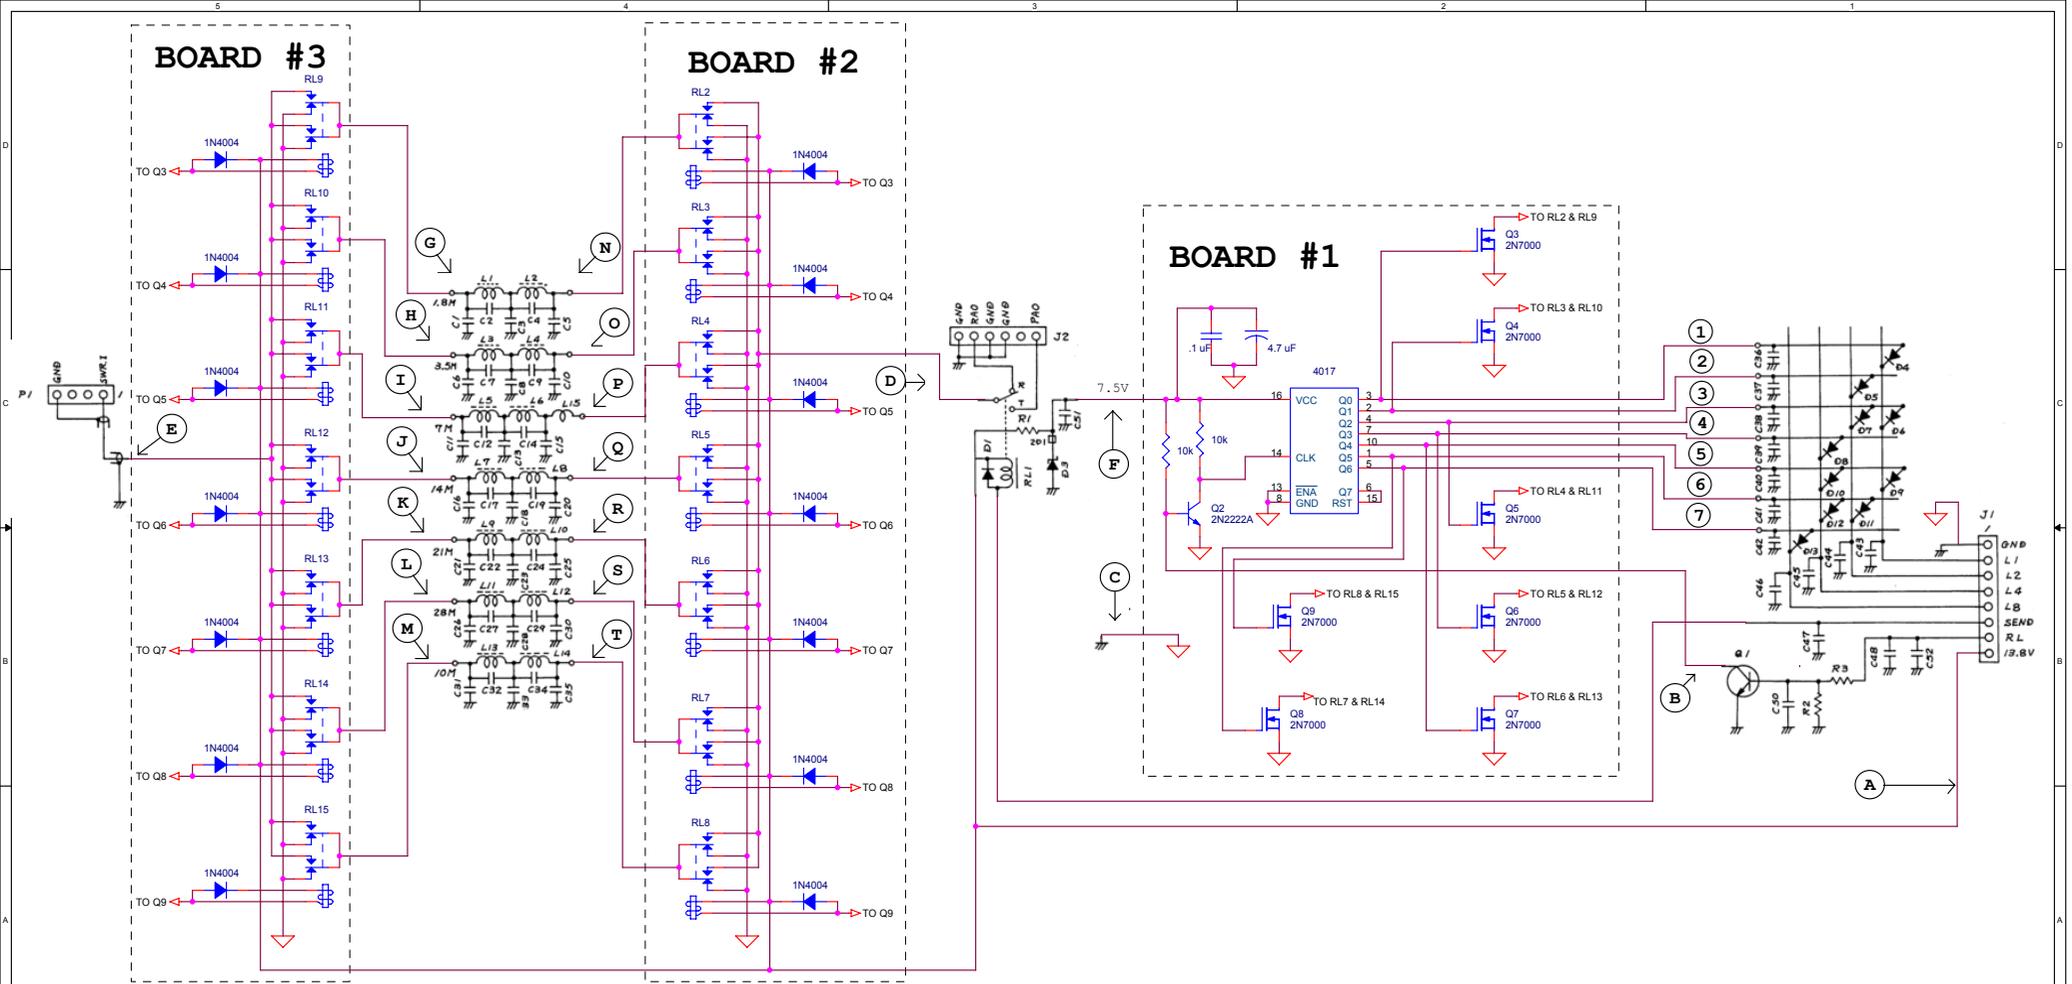
The complete schematic with the existing and additional circuitry is shown in Figure 6. The circuitry inside the dotted rectangles is the new circuitry. MOSFETs were used for the relay drivers instead of bipolar transistors. The reason for this is two-fold. First, there is a lower parts count because base resistors are not required. Second, the gates of the MOSFETs require negligible current, so the outputs of the 4017 are not loaded. This lack of loading means the voltage on the CMOS outputs are very close to the original 7.5 volts provided by the still used Zener regulated supply formed by R1 and D3.

The entire schematic of the completed project is shown in Figure 6. The circuitry inside the dotted rectangles is constructed for this project. The circuitry outside the dotted rectangles is the original Icom circuitry minus the components removed in steps 1 thru 3. Pictures of the final project are shown in Figures 7 and 8.

Figure 6. Schematic of completed filter module. Areas in dotted rectangles are added circuitry.

Any troubleshooting will require a basic understanding of how the circuit works. In the original circuit, the rotary relay had three poles. Two of the poles were used to place the selected low pass filter in the circuit. The third pole was used for feedback to the microprocessor for position information of the rotary relay. There were seven separate positions in the rotary relay, corresponding to the seven different low pass filters that were switched. The position info from the third pole of the relay routed the 7.5 volts from the zener regulator into the diode matrix formed by D4-D13.

Output from the diode matrix provide binary data on the 4 bit bus (L1,L2,L4 and L8) for position information. The 1 of 7 high output signal formerly provided by the rotary relay

is now provided by the 4017 counter outputs. The pulse that formerly caused Q1 to advance the relay one position is now used to cause the counter to advance one count. The counter is decoded internally and 10 outputs provided. In this implementation, the 8<sup>th</sup> count is used to reset the counter so that it cycles back to output #1 being high.

The single high output will remain high until a pulse advances the counter, at which time another output will go high. These outputs drive both the diode matrix and the gate of a MOSFET. A high signal on the MOSFET gate will turn it on and effectively ground one side of the connected relays. This performs the same function as the rotary relay without the noise, oxidation, and alignment issues.

If the relays sound right when clicking, but there is low sensitivity in the receive and high collector current during transmit, either a relay is failing to key or some of the filter wiring is incorrect. Fortunately the low pass filters are DC shorts from input to output. The operation of the relays can be conducted with just J1 connected and the module out of the radio. For any given band, the proper connections can be tested for continuity between the "SWR1" pin of P1 and the "RA0" pin of J2. These points are clearly visible on the schematic on Figure 6. During proper operation, there should be low resistance continuity between those two pins.

Referring the schematic on Figure 6 and using the 1.8 MHz low pass filter as an example, Pin 3 of the 4017 should be high. This should produce a high L1 on J1, with L2, L4, and L8 all low. The high level on pin 3 of the 4017 should also turn on Q3, which in turn should drive the coil of RL2 and RL9 low. This should key both RL2 and RLY 9, resulting in continuity between SWR1 and RA0. If there is not, going from left to right on the schematic, there should be continuity between SWR1 and the enameled wire on relay 9. Continuing, there should be continuity between SWR1 and points G and N. Continuing, there should be continuity between SWR1 and the enameled wire on RL9. If the continuity is not present, either the relay is not keying, or the wiring is going to an incorrect relay.

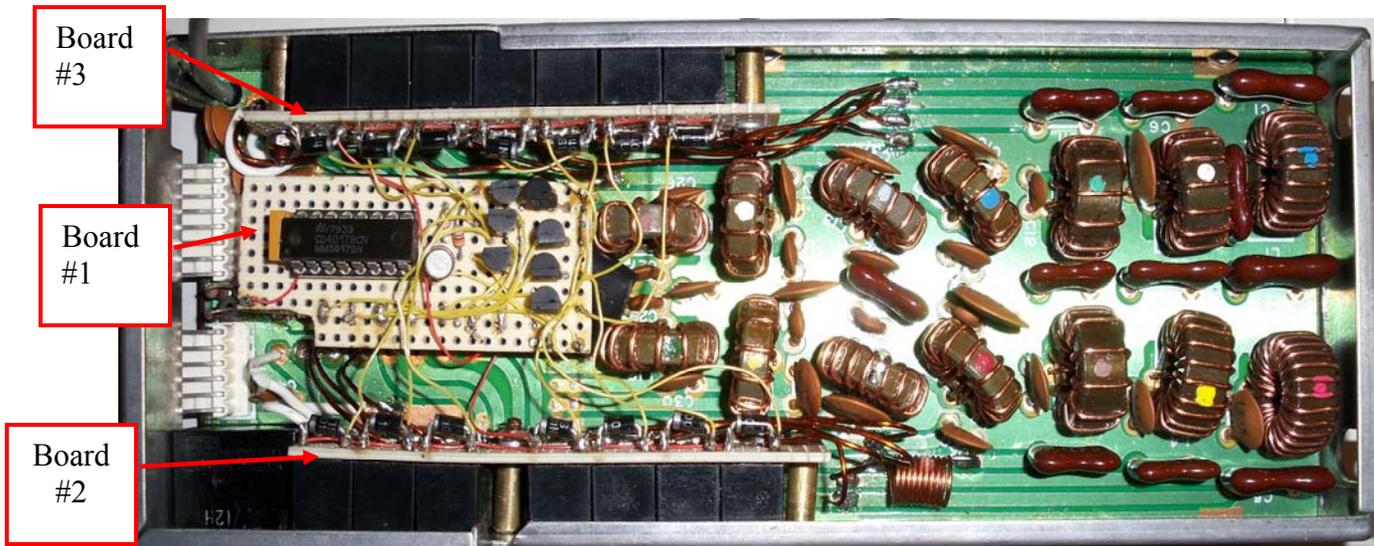
Figure 7. Completed filter project top view.

- 10) Place Board #3 inside the module as shown in Figures 7 and 8. This is a tight fit, so be careful. Attach all of the wires to the proper points on the PCB. This will require some planning before installation. In my case, the wires to Points E and M were toward the end of the module with the loose gray cable. Points L and K were soldered immediately in front of the board to the PCB below. Points G, H, I and J were soldered as shown in 12.

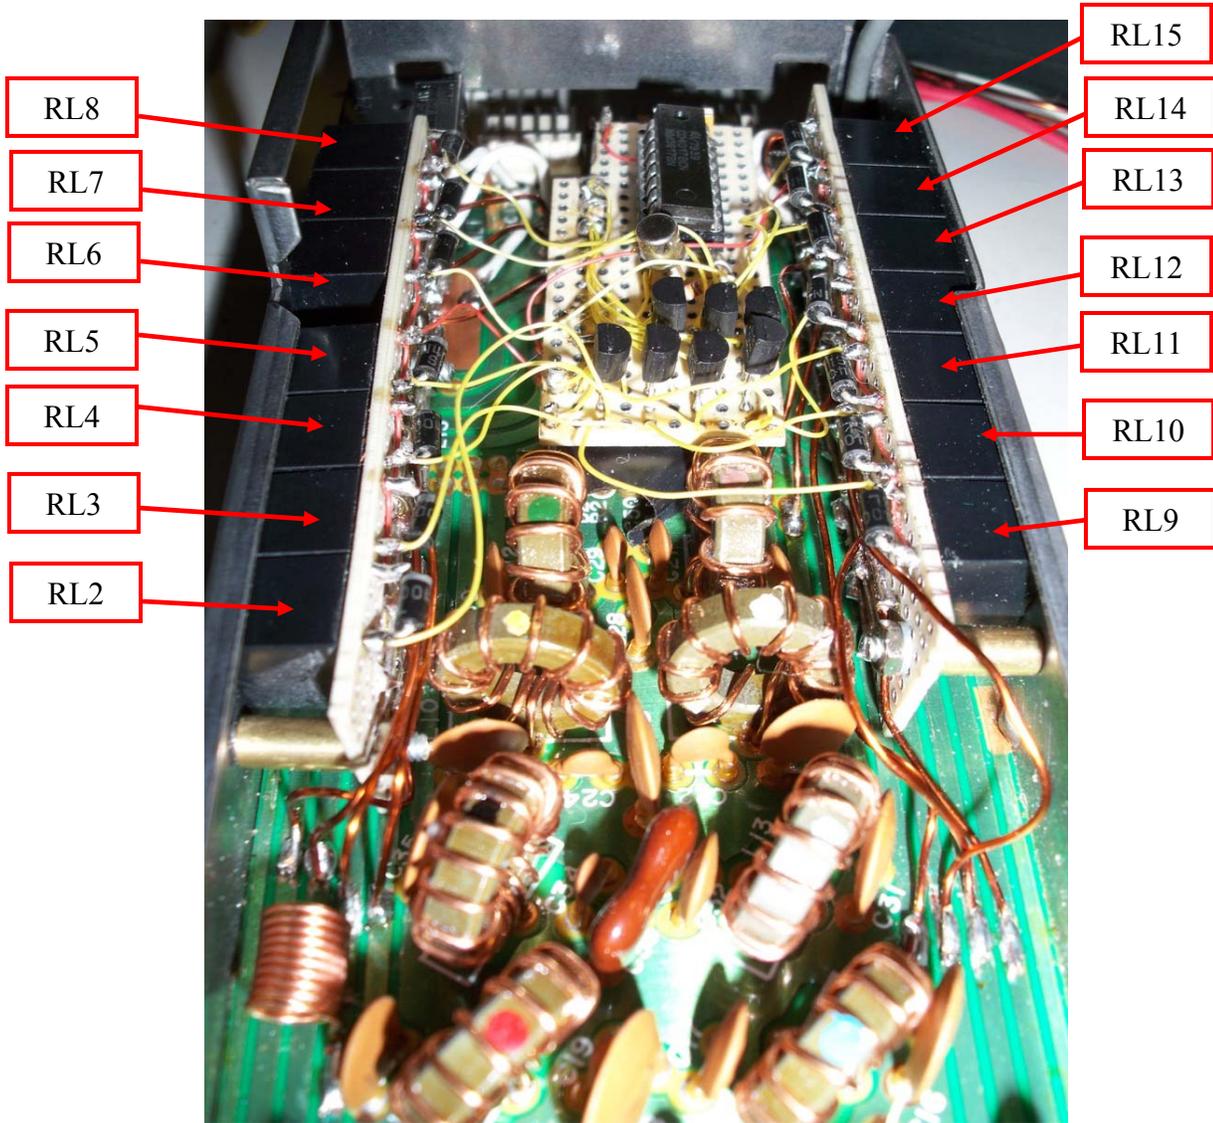
Figure 8. Completed filter project side view.

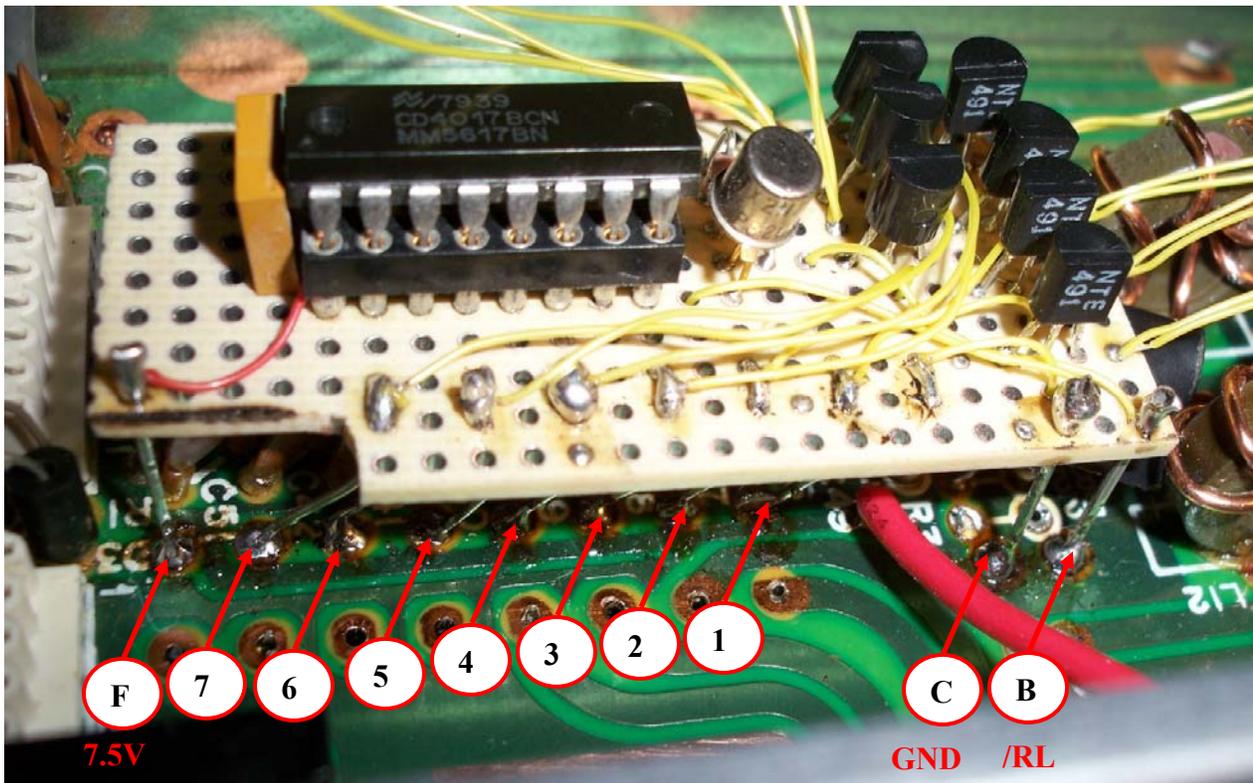
Figure 9. Board #1 (Control Board).

- 8) Construct and install Board #1. This board is constructed on perf-board with 100 mil spacing. An IC socket is highly recommended. Refer to Figure 9 for reference. The 3 stiff metal pins holding up the board at points B,C and F are from wire wrap pins. An insulator is placed between the bottom of the board and the top of the existing circuitry below it. The other wires connecting to the PCB are 22AWG solid wire. Include sufficient length wires from the drain of each transistor to reach each relay. The test points in Figures 9 and 10 correspond to the test points in the schematic.

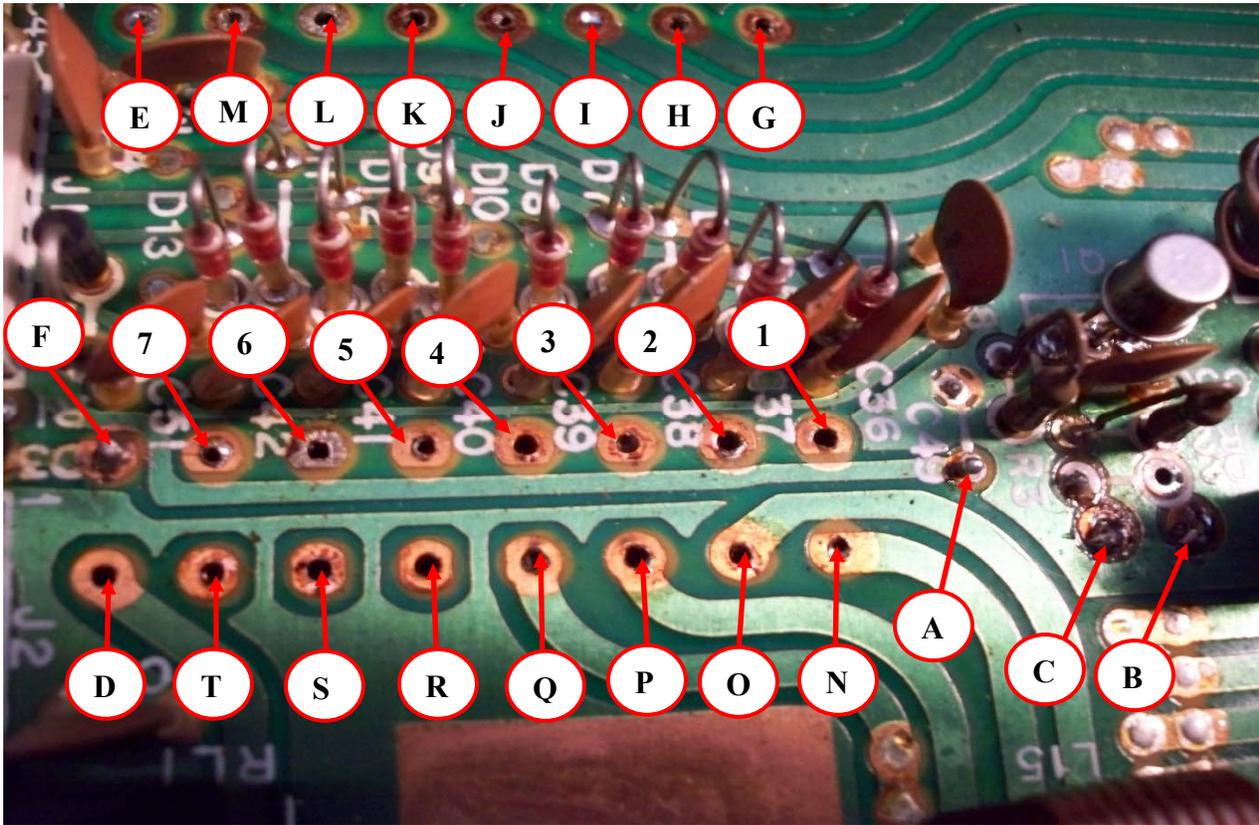
Figure 10. Test Point positions. These correspond to schematic in Figure 6.

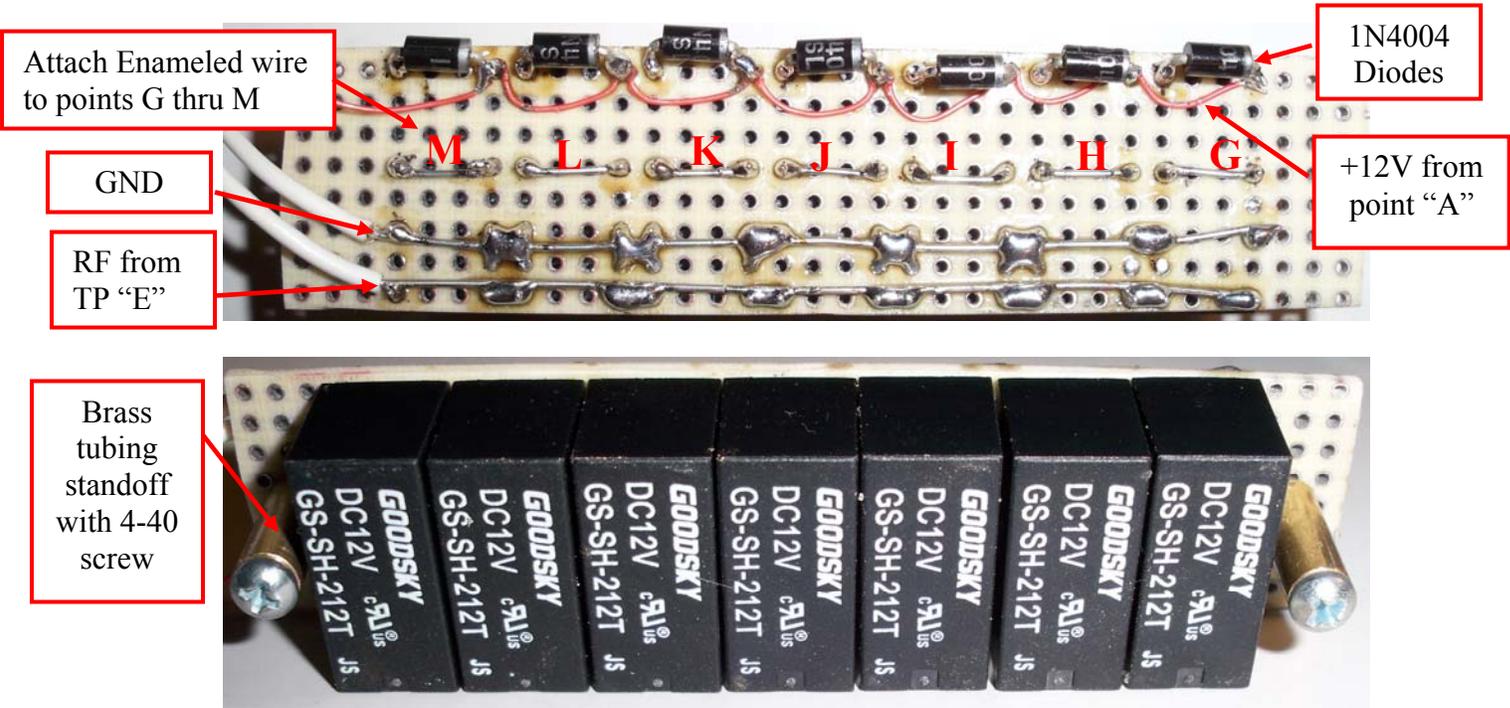
Figure 11. Front and back view of Board #3.

- 9) Construct Board #3. Refer to Figure 11 for details. Leave adequate room on the sides of the board for the mounting screws. Cut the brass tubing from the original relay to the width of the new relays. These are used as standoffs to retain the boards as shown in Figures 7 and 8. #4 screws fit perfectly inside of the tubing. Drill holes through the sides of the module as required to retain the board. Solder sections of enameled wire adequate to reach the proper destination on the circuit board. These enamel wires are not shown on Figure 11.

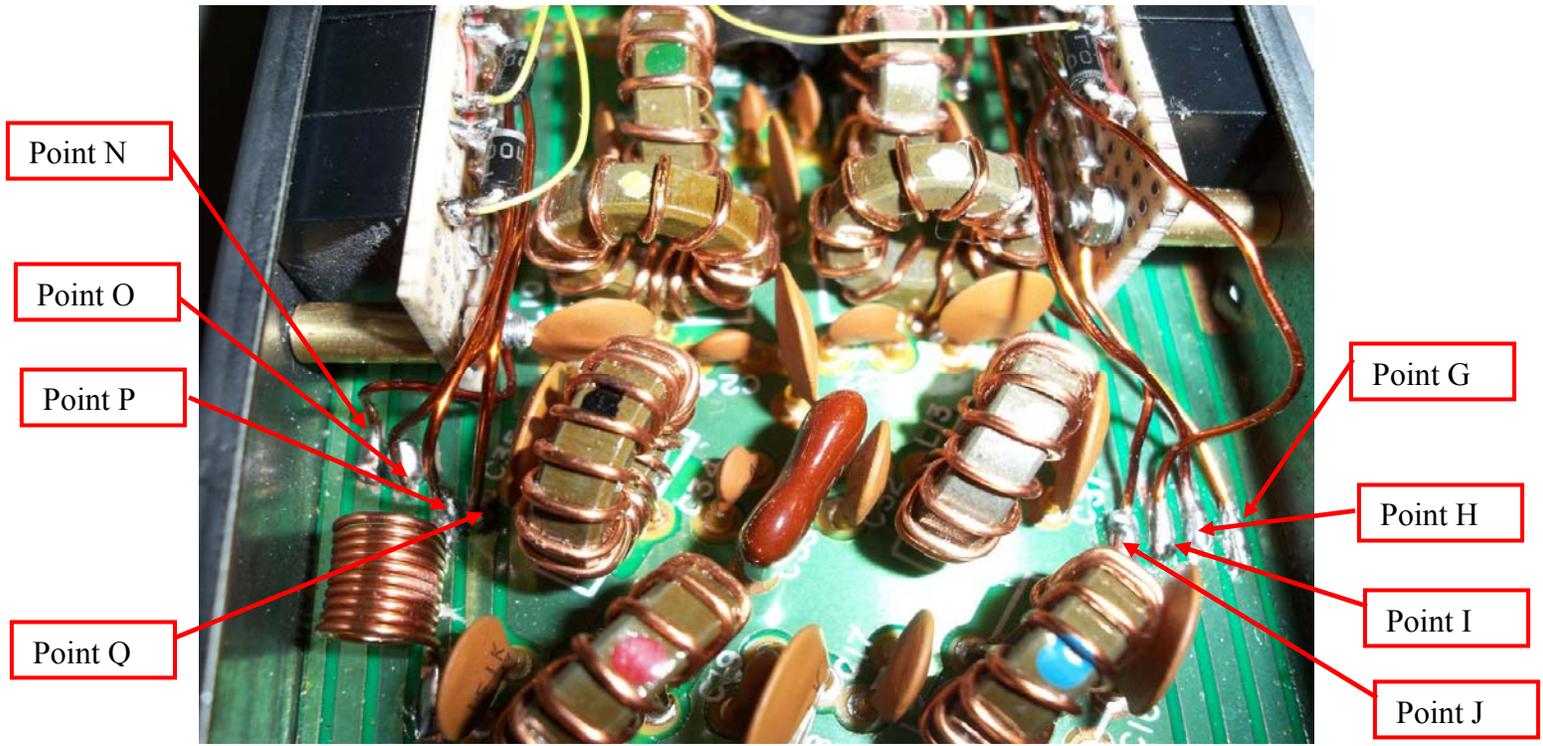
Figure 12. Close-up showing wiring of the ends of the relay boards

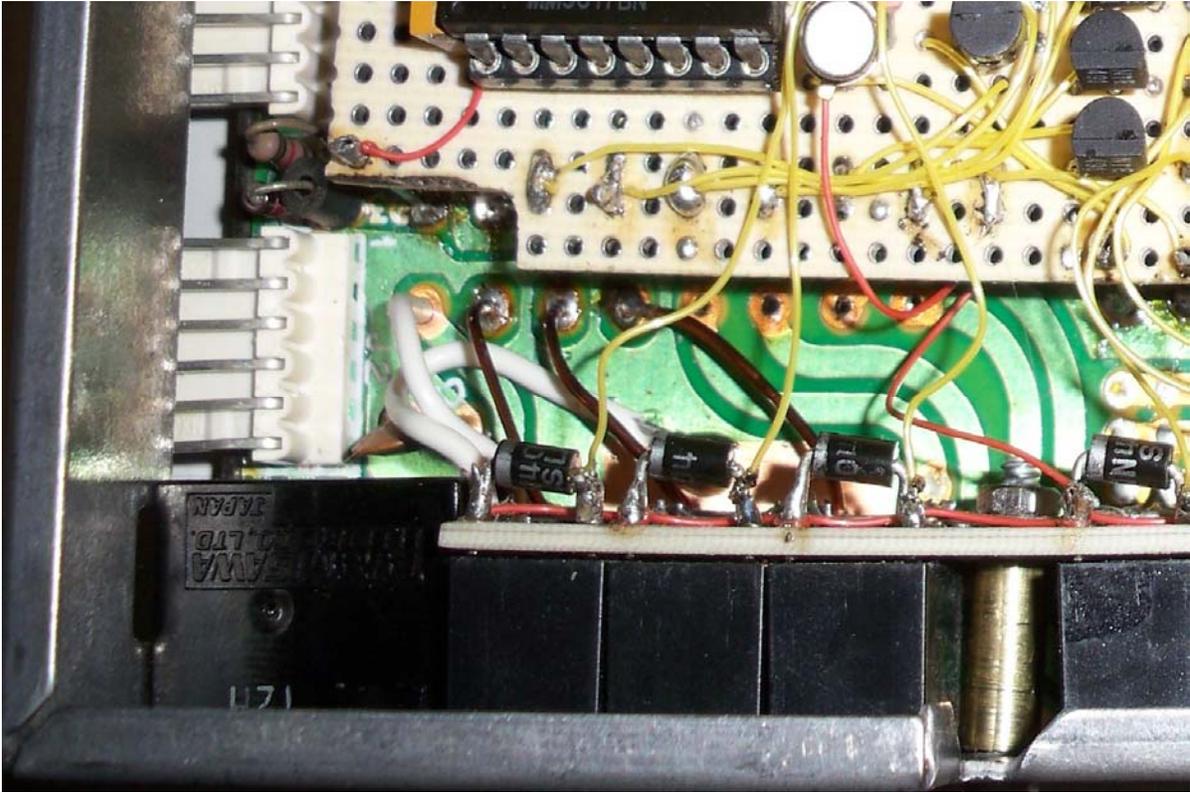
Figure 13. Close-up of wiring for points D,T S, and R of Board #2

- 11) Construct and install Board #2 in an analogous fashion to that of board #3. Note the different mounting requirements for the standoffs. This will result in a gap in the middle of Board #2 between relays and no screw at the end of one board. This is necessary because of the large hole in the module to accommodate the former rotary relay. The added extra complexity of this mounting is rewarded by the extra space available on this side of the module. Figure 13 shows a close-up of the wiring of points D, T, S, and R

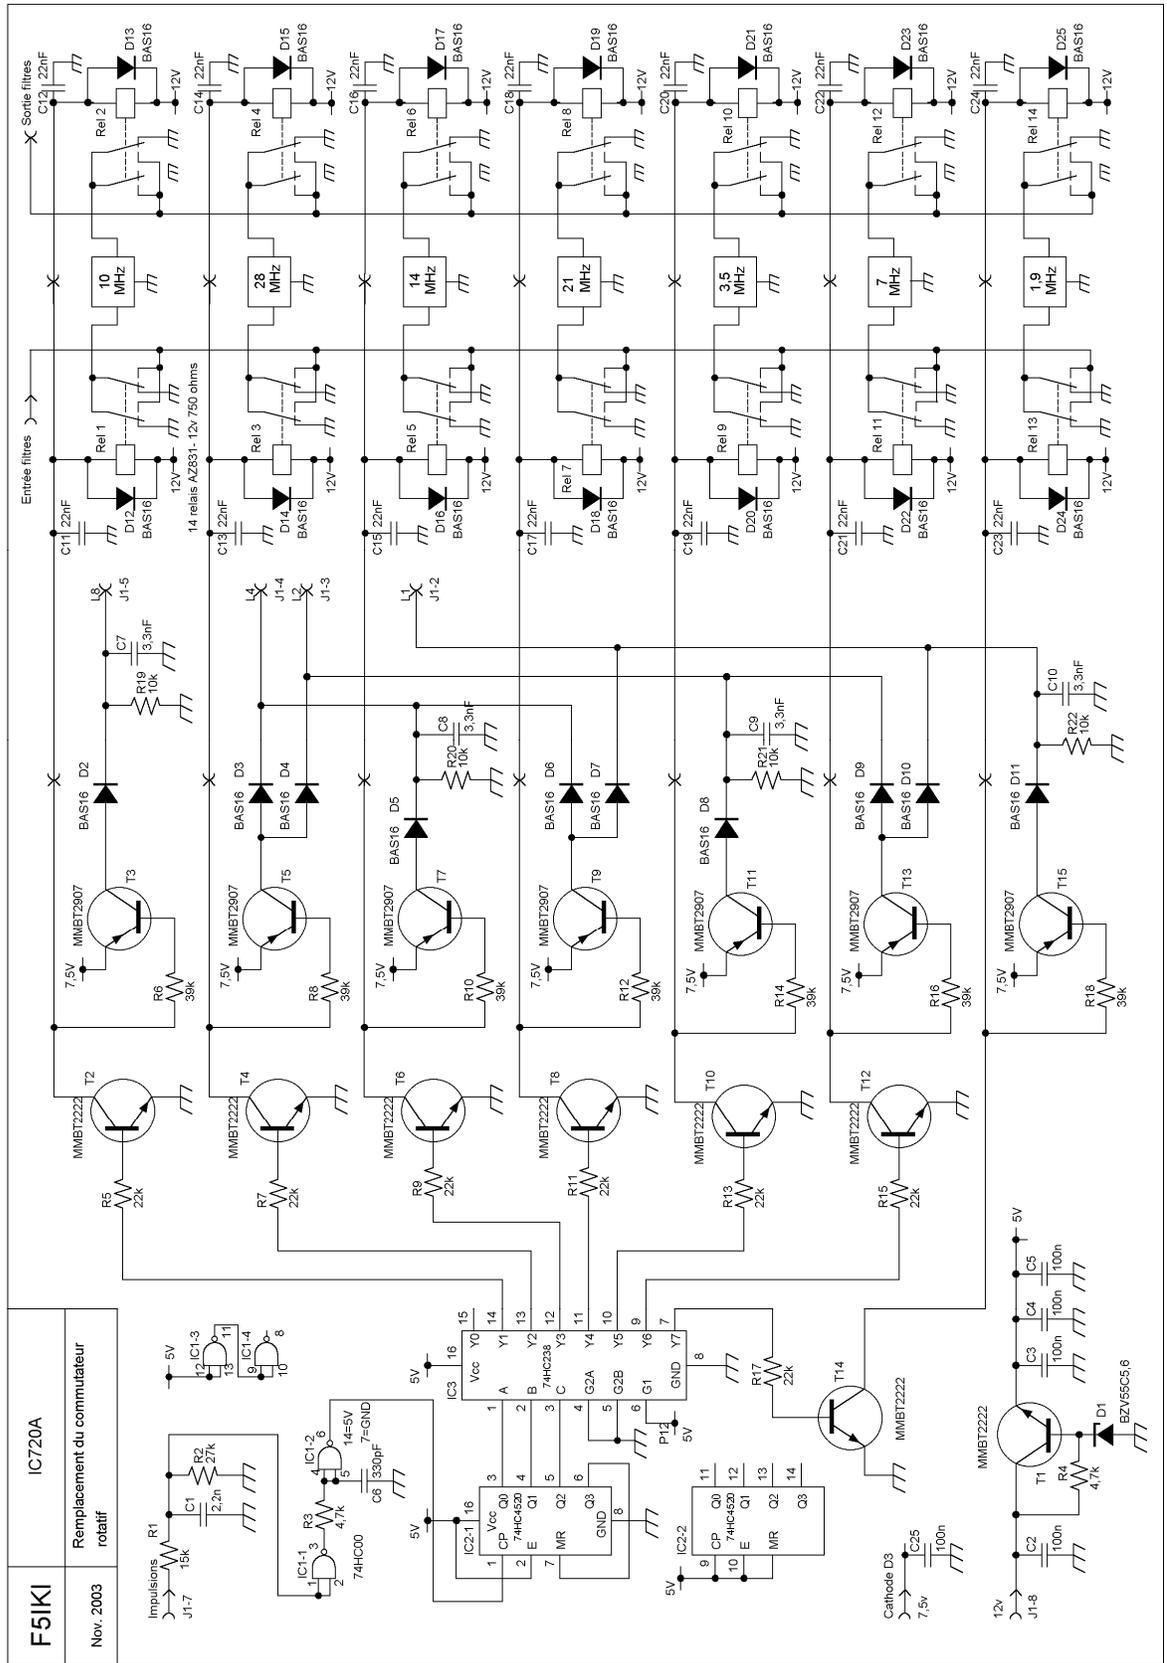
Figure 14. Schematic of original concept by F5IKI.

The original circuit by F5IKI in Figure 14 contains three ICs and many discrete components. Chips with 5 volt rails were used with a 5 volt regulator, and then PNP transistors used to level convert outputs where needed to the 7.5V level used in the original circuit. The use of a 4000 series CMOS chip by IW9HGS which can use a rail voltage of 7.5 volts, and a 4017 which contains a counter and decoded in one chip reduced the chip count. This circuit is shown in Figure 15.

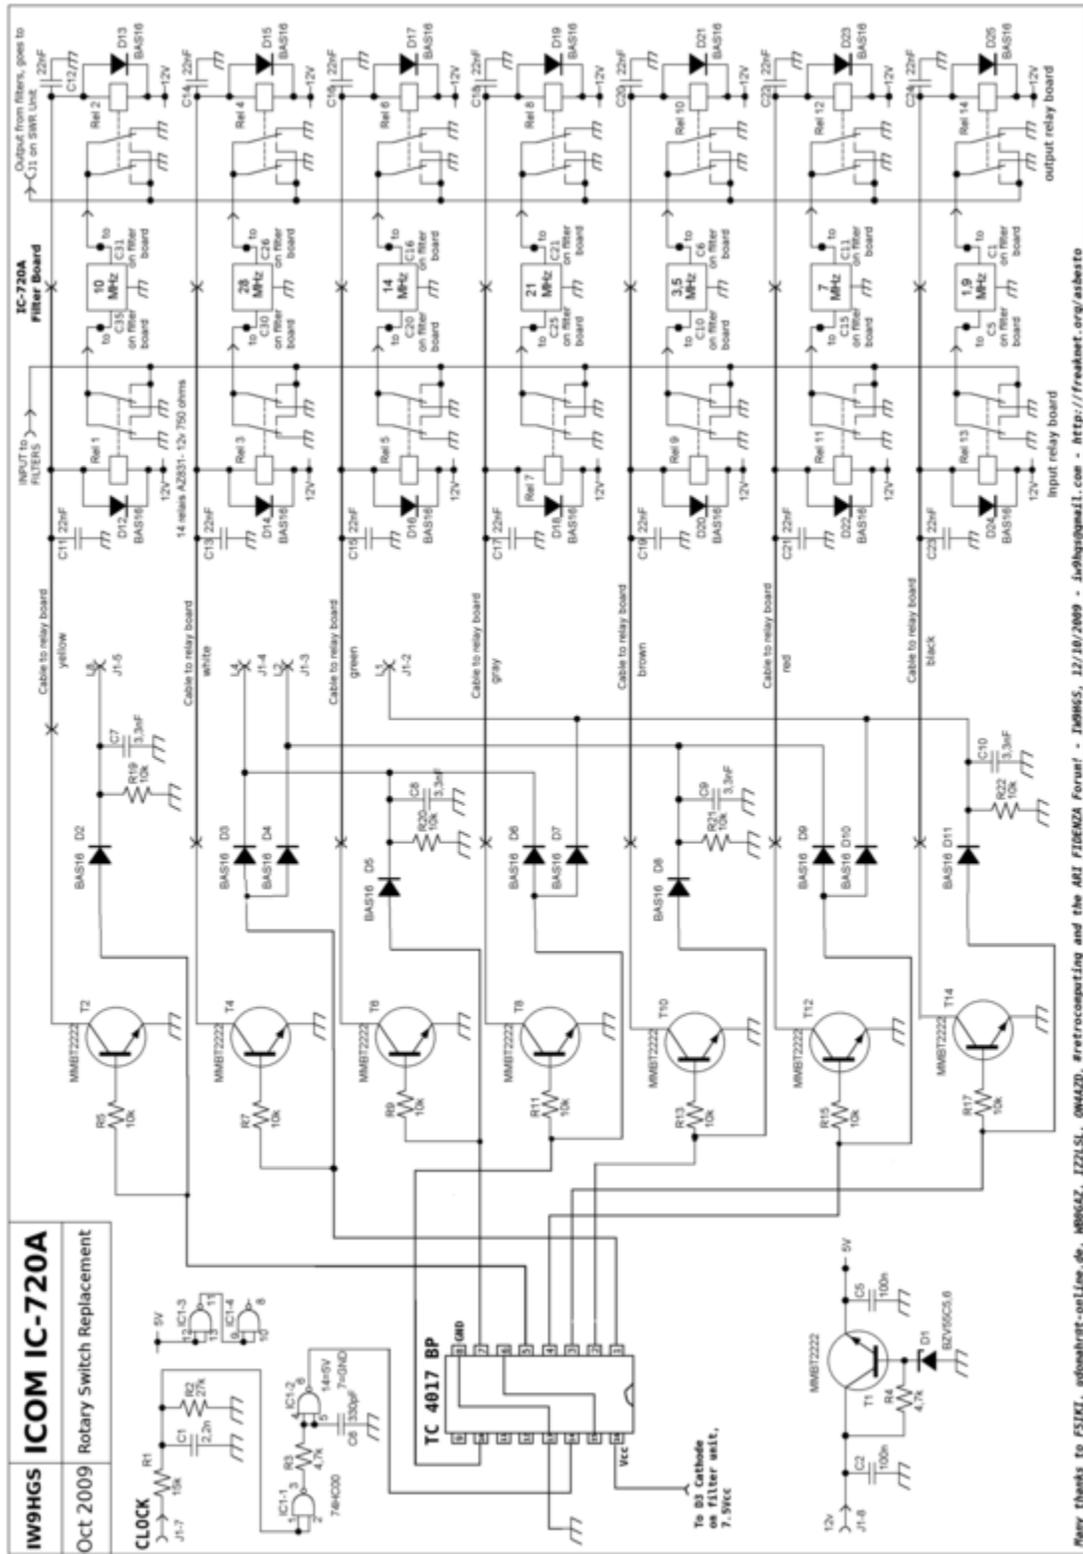
Figure 15. Schematic showing modifications to F51KIs design by IW9HGS.
