## The Bendix RA-1B aircraft radio receiver

Ulrich Fierz HB9AIK

# Signal

**Issue 56: August 2020**

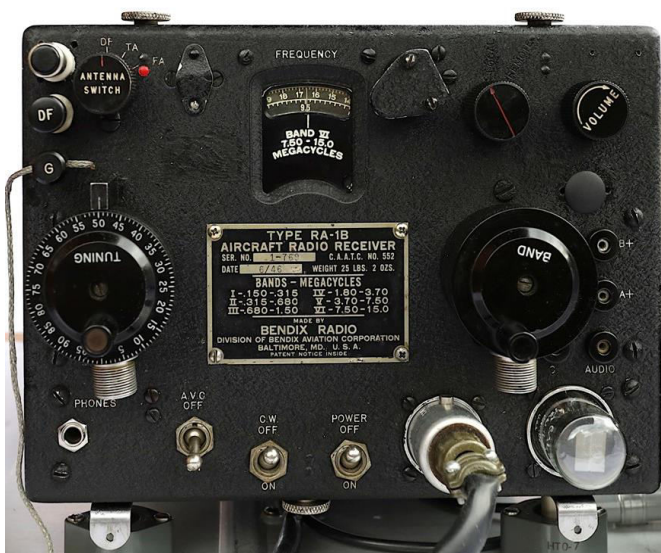
**Figure 3. RA-1B front panel (refurbished radio)**

The old EM87 sticking out was always somewhat vulnerable and too 'modern'. Initial thoughts leaned towards a 1629 indicator which was used in the ARC-5 command sets but, in the end, a shorter component was selected: the 6AL7GT. This is an indicator for AM/FM receivers with three rectangular sectors, used here with just one input. While not as attractive as the round magic eyes, it is compact and of the correct diameter to fit in the space of the remote connector (**Figure 3**, lower right-hand corner).

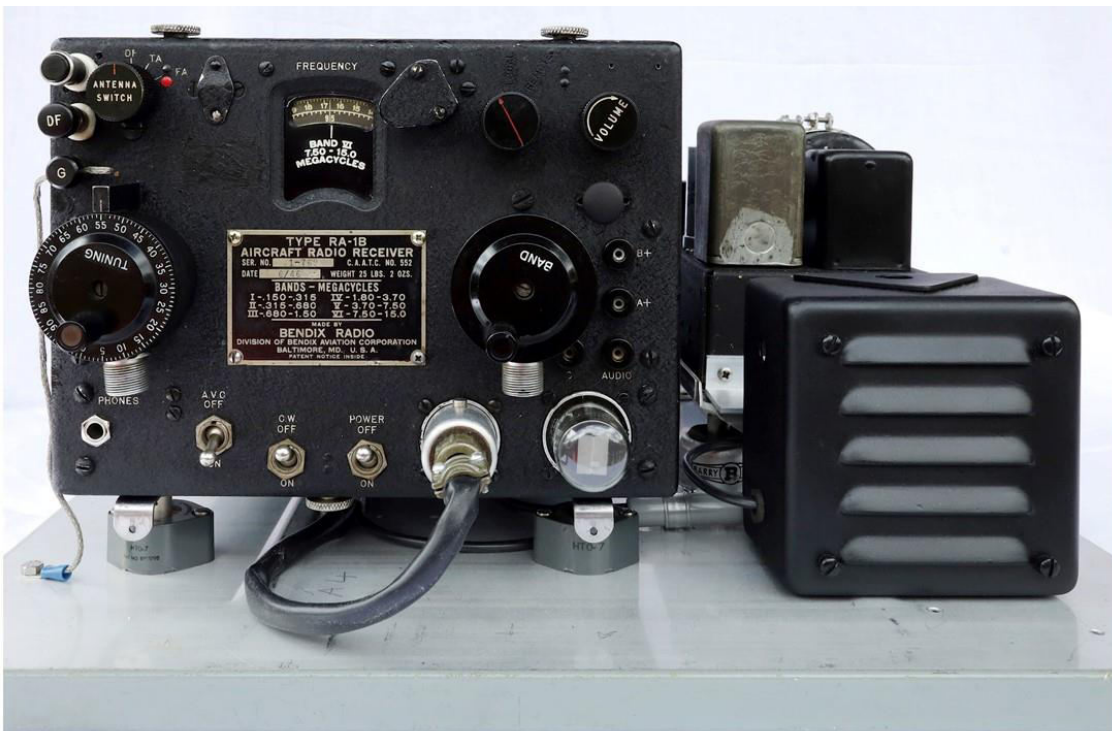
Figure 11. Layout of the RA-1B on an aluminium plinth for demonstration

In order to be able to display and demonstrate the receiver, an aluminium plinth was constructed to allow proper grounding of the components – similar to an aircraft installation (**Figure 11**).

The receiver was put on shock mounts that fit into the mounting rails of the receiver and the dynamotor was put on a suitable aircraft mount. All cables were made up using selected gauge PTFE-insulated wires for the required functions which were pulled into a silicone sleeve. As experience showed later, it would have been better also to include a shield braid to further reduce EMI.

The speaker is an old LS-166 that was repainted black and bolted to the plinth without the rear cover.

The +28 VDC power input is filtered by a high-current 2 mH choke and a large 14,000  $\mu$ F computer-grade capacitor. A series resistor consisting of three 2.7  $\Omega$  resistors in parallel reduces the input voltage to approximately 26.5 V and, at the same time, limits the inrush current into the large capacitor. **Figure 10** shows the layout of the plinth. The choke and input resistor are behind the receiver.
