F110S, F111S, and F121S

Correcting “E” Pattern on PCB for Encryption

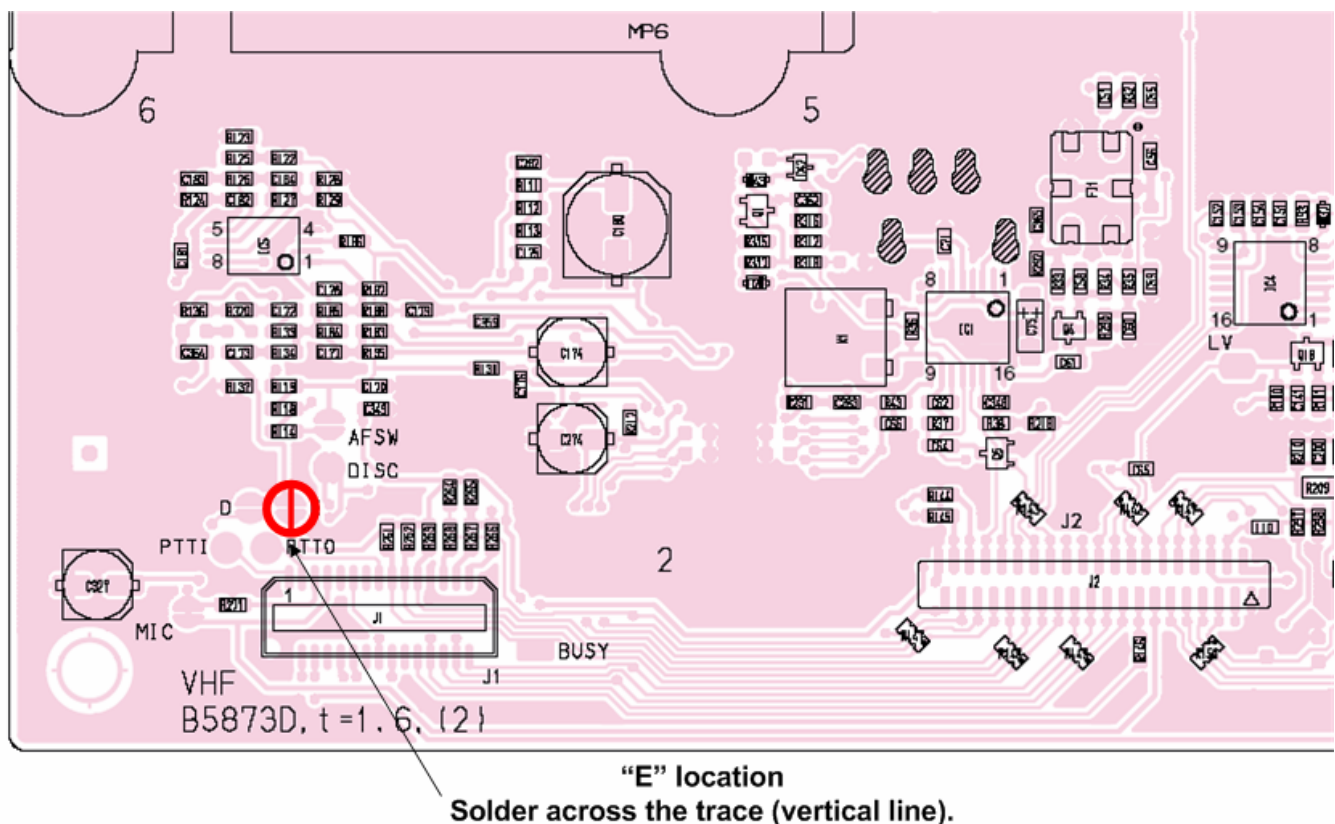
Trace Location

The following view is the top of the main PCB. Solder the trace as show.

Some serial numbers of the applicable radios have an incorrect trace pattern in the main PCB. If a UT-110 is installed, this trace pattern causes the scrambler signal to remain un-decoded. To correct this, the trace at the “E” location on the main PCB needs to be soldered.
