Vintage Radio

The Pye TRP-1 Portable HF Transceiver

Despite government opposition, radio communications spread rapidly in Australia following the end of WW2. Released in 1949, the Pye TRP1 was one of the new breed of HF portable transceivers designed to meet the growing demand for suitable equipment.

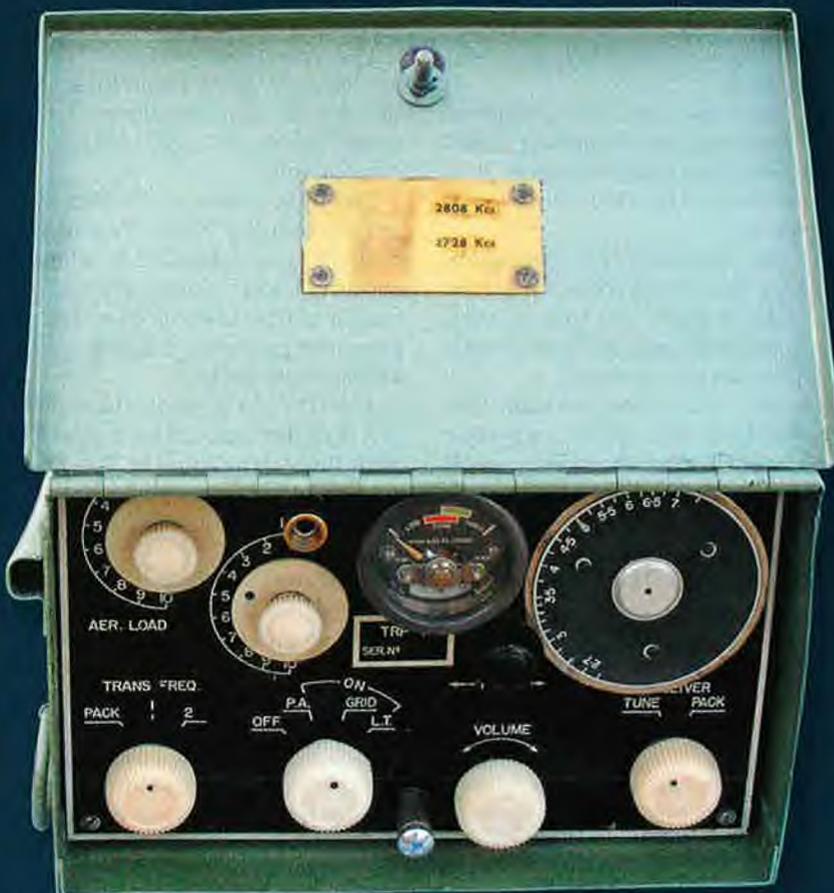
This view shows the fully restored transceiver. The original brown cabinet was resprayed a hammertone green colour and looks new again.

Next, I covered the rubber grommets and the labels on the cabinet with masking tape and gave the worst areas a coat of spray primer. The first production run of these sets was painted a green hammertone colour but this one, part of a later run, was painted a salmon colour. However, I repainted this unit hammertone green like the

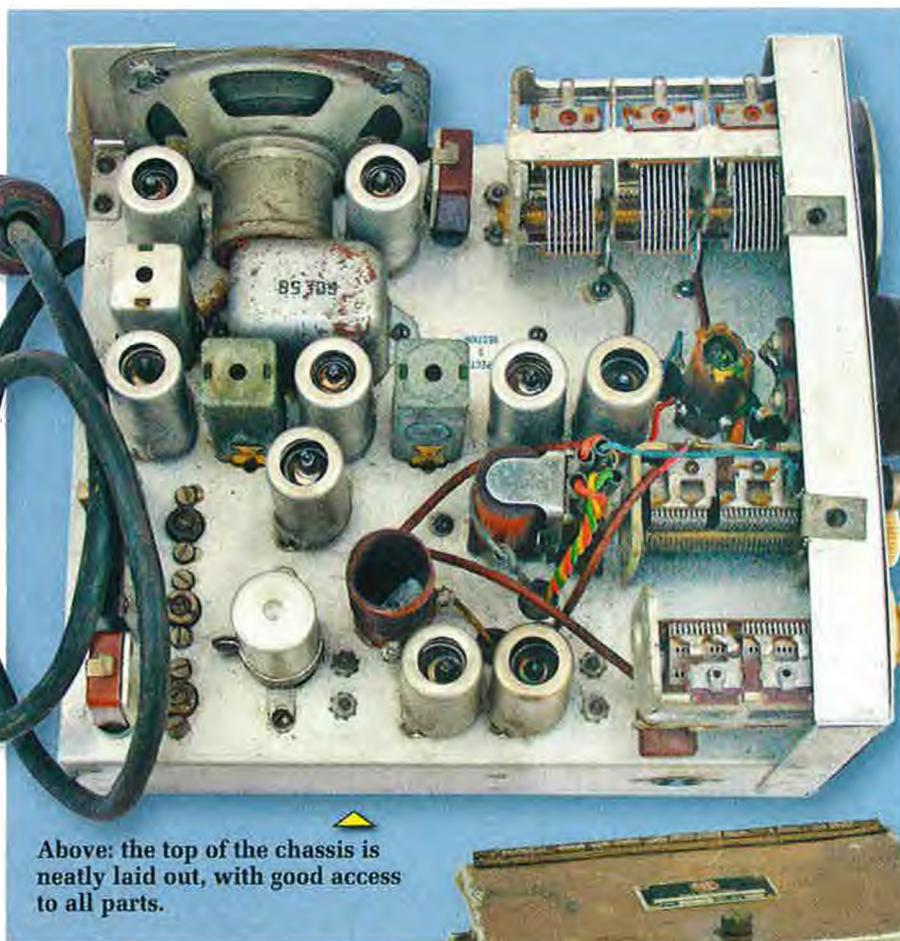
Above: the top of the chassis is neatly laid out, with good access to all parts.

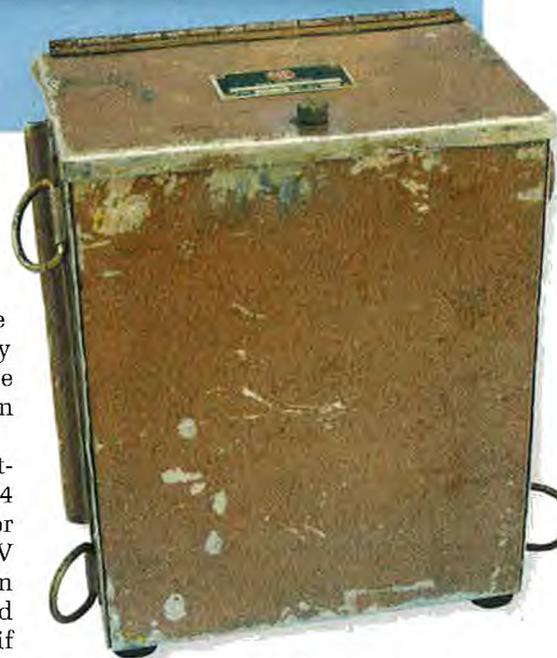
The cabinet had been knocked about during its life and had quite a few dents and flaking paint. The dents were knocked out and the cabinet resprayed green to match an earlier production run (see facing page).

As can be seen from the photographs, the cabinet of the unit featured here had been knocked around quite a bit. In fact, the paint was flaking off and the cabinet had a few dents in it but this is understandable considering the type of work the set did.

I knocked out the dents in the case using a small hammer and a heavy flat piece of metal which was placed behind the surface being worked on. That done, the case was cleaned with a turpentine-soaked rag to get rid of any grease and then sanded to remove any loose paint.

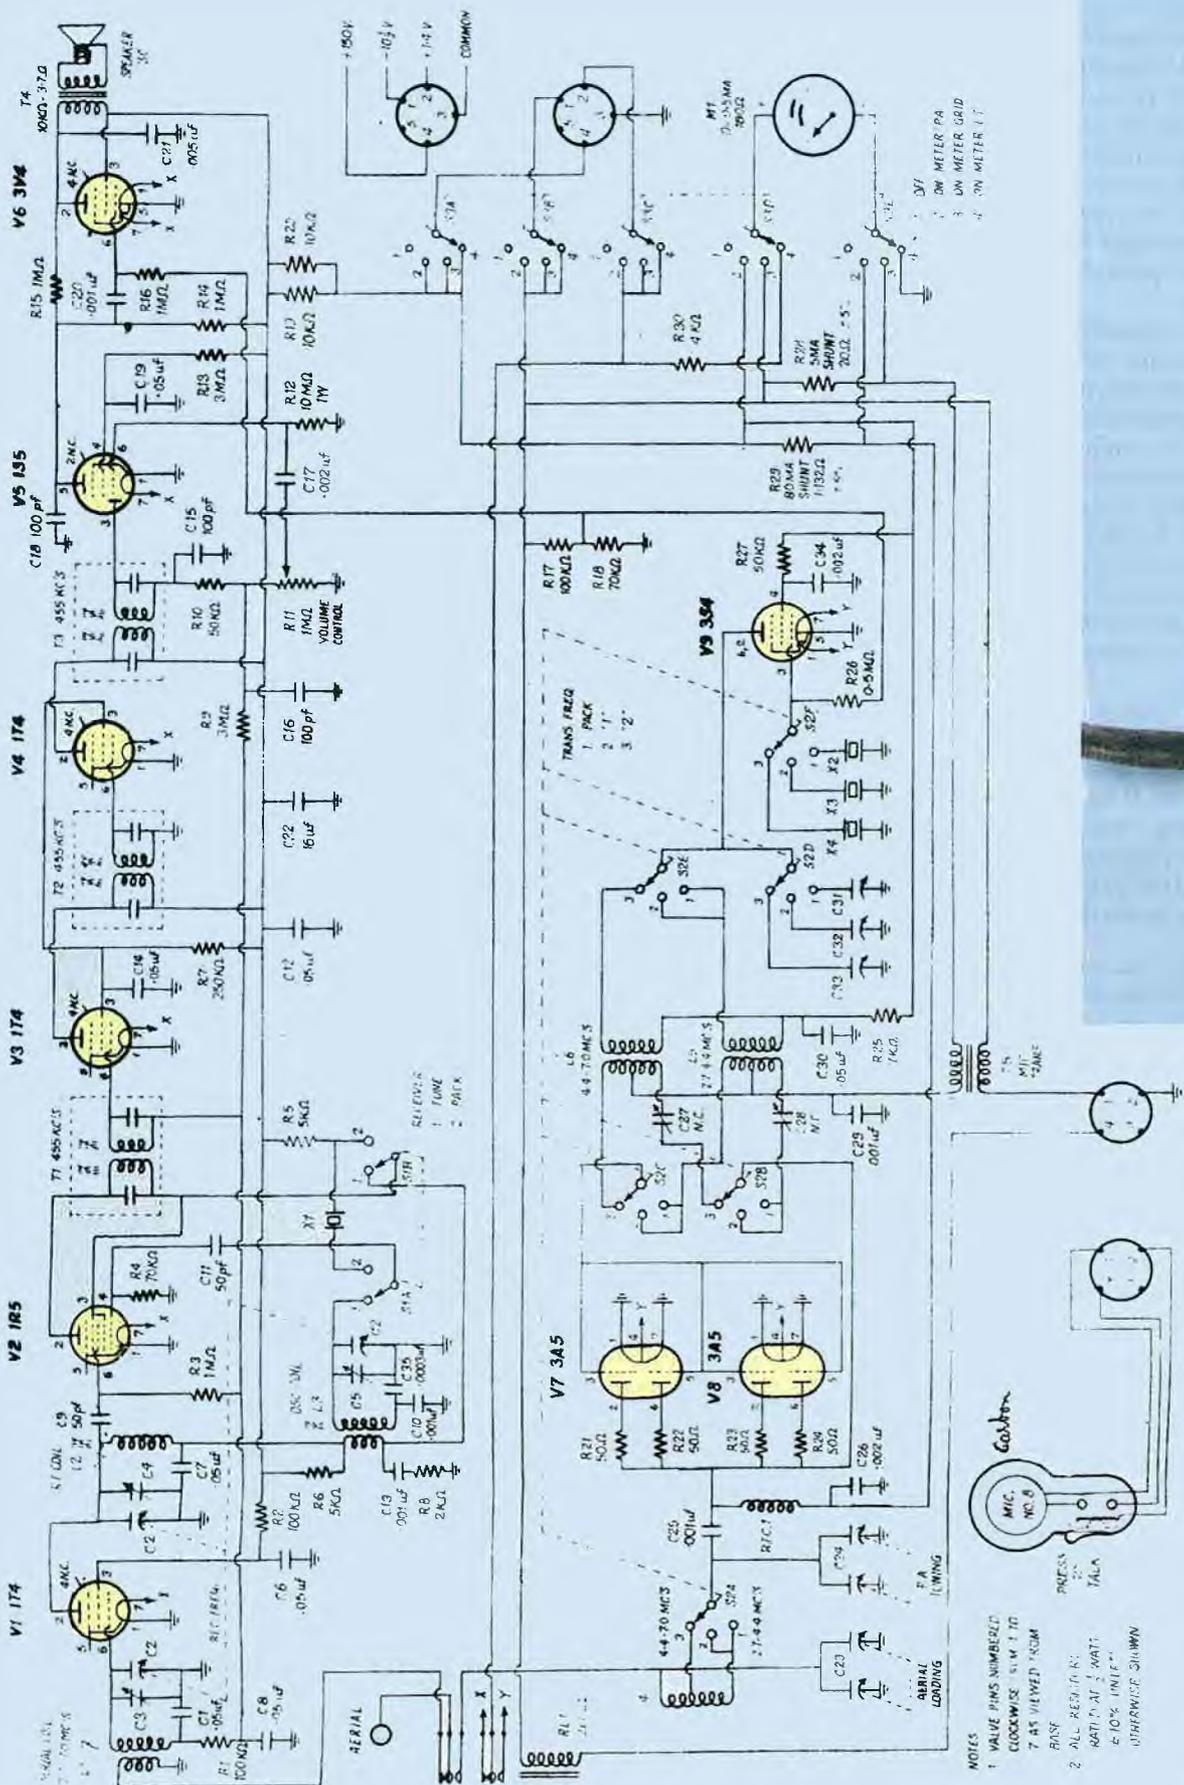
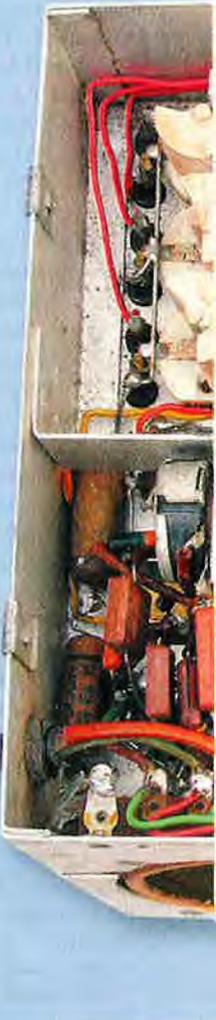
Fig.1 shows the circuit details. The receiver is a conventional superhet with a 1T4 RF stage, a 1R5 converter, a 2-stage IF amplifier using 1T4 valves, a 1S5 detector/AGC/audio amplifier and a 3V4 audio output stage. A bias of -4V is used for the 3V4 and this is obtained directly from a tapping on the -10.5V bias battery.

to them. The converter can either be manually tuned across the 2.7-7MHz band or accurately tuned to a spot frequency using a crystal oscillator. The high tension (HT) for the receiver is supplied by a 150V battery via two parallel 10kΩ resistors. These drop the voltage to around 75V when the receiver is operating.

Now let's take a look at the transmitter section. As shown, it uses a 3S4 as a crystal oscillator and driver for the output stage. This stage has -4V of bias applied to protect the valve in the event that crystals are not fitted to all three possible positions (ie, if a vacant position is selected by the frequency switch). The oscillator plate circuit is tuned by C31, C32 or C33 to suit the particular crystal selected by switch S2.

The RF output stage consists of two double-triode 3A5 valves, with all sections in parallel. Each plate is fitted with a 50Ω "parasitic stopper" resistor to prevent spurious signals from being transmitted.

circuit. In this case, neutralisation is achieved by feeding back energy in anti-phase via the tapped secondaries of driver coils L5 and L6. The resulting anti-phase signal is applied via neutralising capacitors C27 & C28 to

Fig.1: the receiver section is a conventional 6-valve superhet based on V1-V6. The transmitter circuit is also conventional and uses a 3A5 as a crystal oscillator and two 3A5s in parallel for the RF output stage.

null out the grid-to-plate capacitance in the valves (this circuit is similar to that used in the early triode-tuned radio frequency (TRF) receivers).

The modulator is the essence of simplicity. It consists of a carbon microphone, a -10.5V supply to power the microphone and provide bias for the RF output stage, plus a microphone transformer (T5).

In operation, speech signals are picked by the microphone and fed to transformer T5. This then modulates the transmitter by applying the audio signal directly to the grids of the 3A5 valves which operate with the full -10.5V of bias.

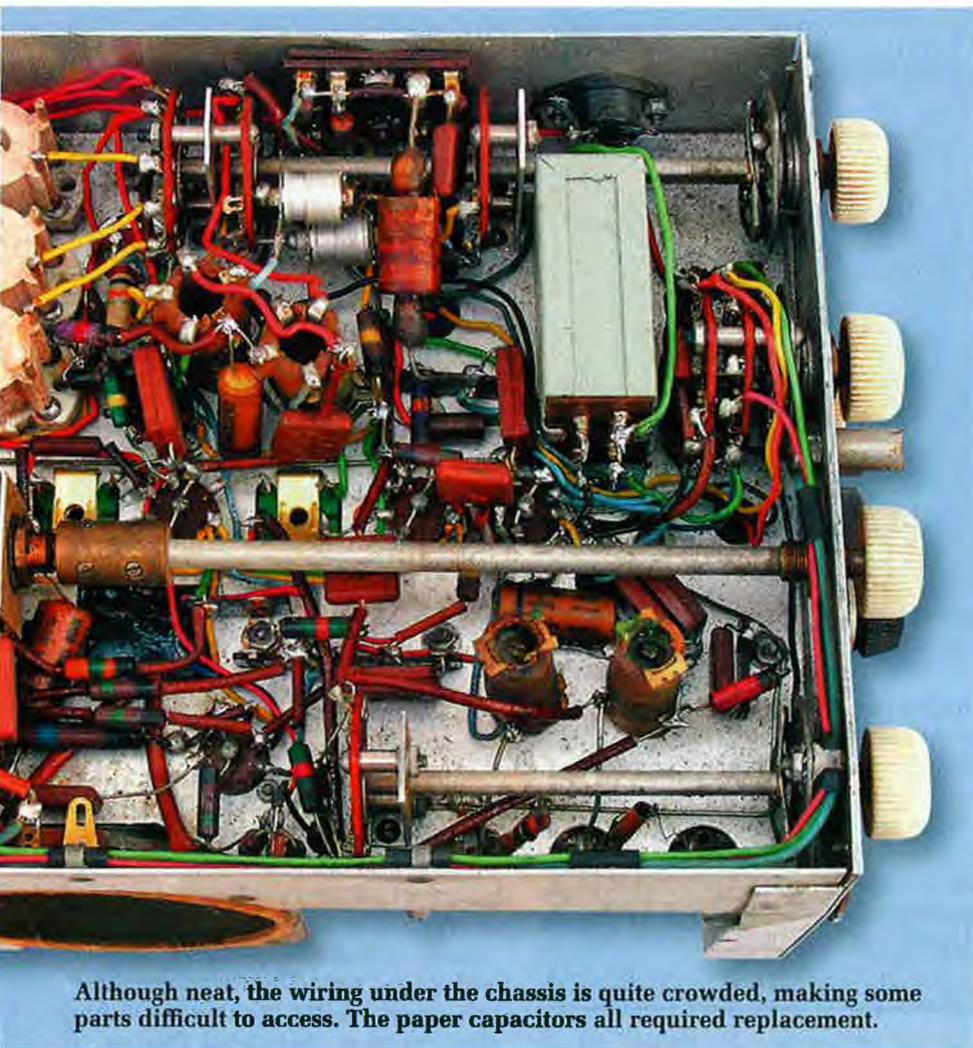
Although neat, the wiring under the chassis is quite crowded, making some parts difficult to access. The paper capacitors all required replacement.

Now that the set and its cabinet had been cleaned up, it was time to overhaul the electronic circuitry. Unfortunately, the parts are difficult to access in some areas, particularly around the transmitter section, but I was eventually able to replace all the paper capacitors. They were all quite leaky, even though it was obvious that they had been replaced about 40 years ago.

Some of the sub-miniature metalised paper capacitors were smaller than my polyester capacitors, so fitting new ones wasn't all that easy. One or two resistors had drifted in value and were also replaced. At this stage, with no shorts or other circuit faults evident, I applied power to the receiver. It came on immediately with a rush of noise from the speaker. I connected it to an antenna and although I couldn't hear many stations (at least not during daylight hours), it appeared to be working just like it had nearly 60 years ago.

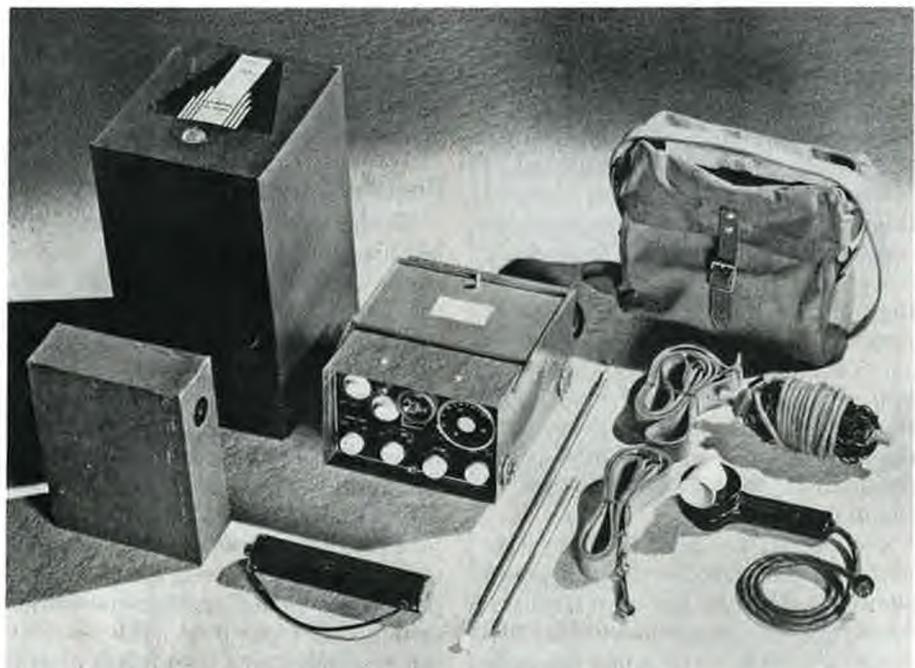
Taken from the handbook, this photo shows the TRP-1 transceiver (centre) complete with all its accessories, including batteries, antennas and the microphone. The large "camp" battery at top left was optional

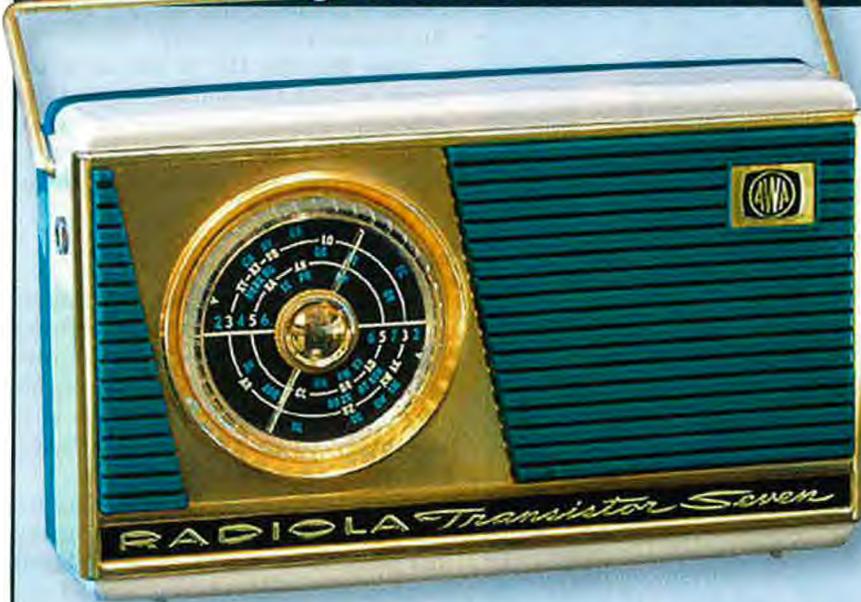
Photo Gallery: AWA 7-Transistor Radiola

MANUFACTURED BY AWA in the 1960s, the Radiola Transistor Seven came in quite a few model numbers, each based on a small upgrade. These model numbers included the B19, B19Y, B19Z B24, B24Z & the B52. The transistor line-up was as follows: 2N1639 converter; 2N1638 first IF amplifier; 2N406 overload; 2N1638 second IF amplifier; 2N408 audio driver; and 2 x 2N408 push-pull audio output stage. The diode detector was a 1N87A. The audio output was just 150mW before noticeable distortion and although this doesn't sound much, it was still very acceptable. Photo supplied by the Historical Radio Society of Australia Inc (HRSa), PO Box 2283, Mt Waverley, Vic 3149. www.hrsa.net.au

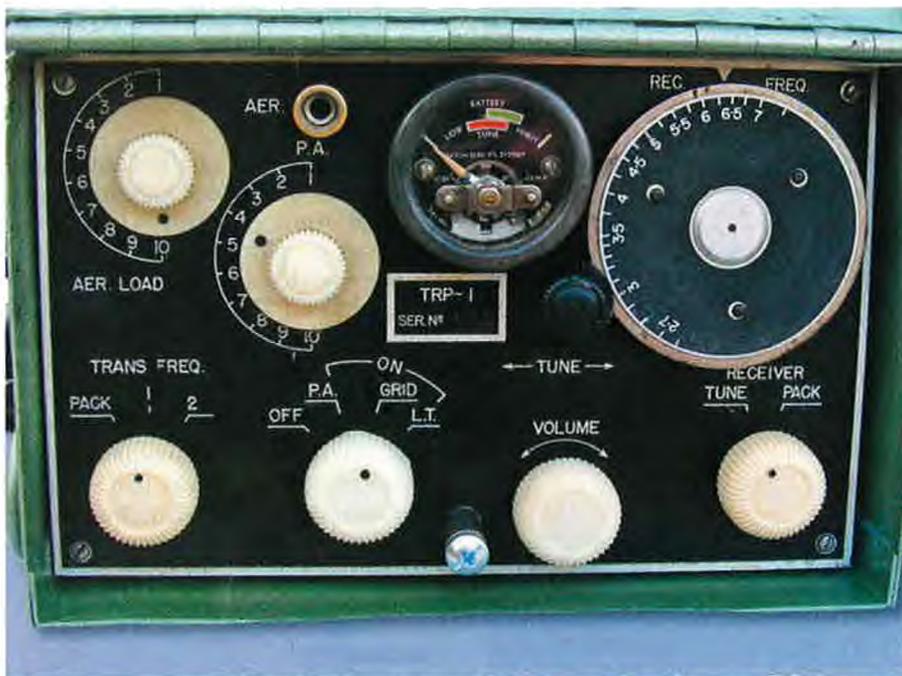
This close-up view shows the front panel controls on the fully-restored unit. It tunes the frequency range from 2.7-7MHz and has a transmitter power output of between 1.5W and 2.3W.

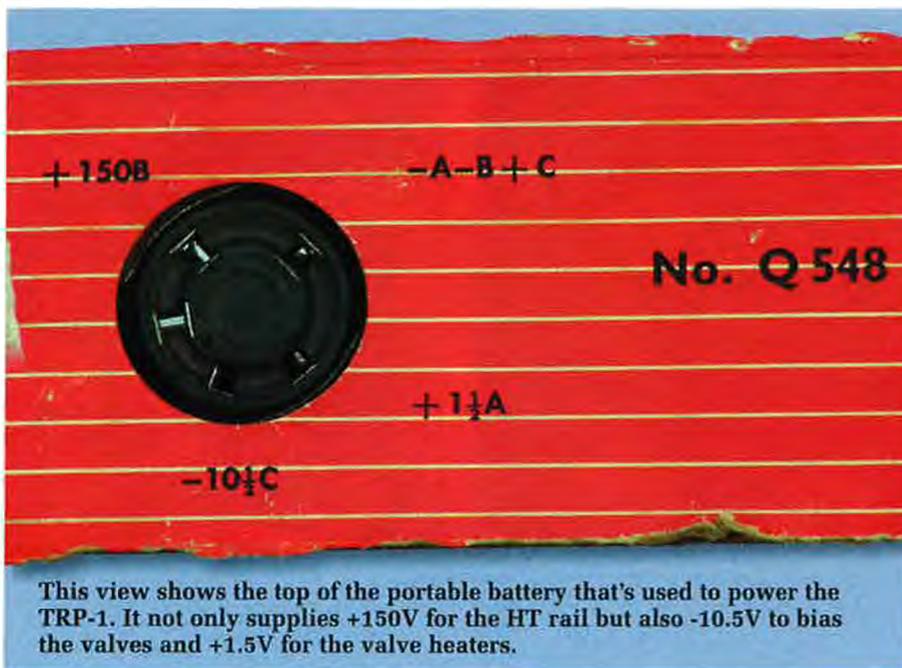
This view shows the top of the portable battery that's used to power the TRP-1. It not only supplies +150V for the HT rail but also -10.5V to bias the valves and +1.5V for the valve heaters.

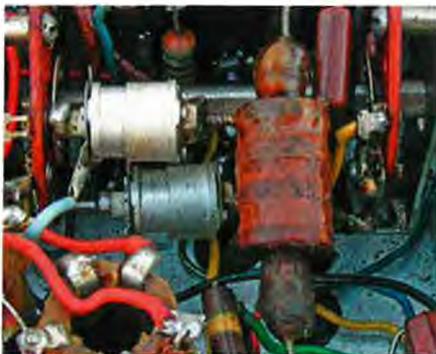
Some parts in the TRP-1 are difficult to access, particularly around the transmitter output stage.
