## Refurbishing a Collins R-390-A//URR Series Receiver

### Plus, the Evolution of a Cold War Warrior 1950-1955

#### BY MIKE CHARTERIS,\* VK4QS/VK4XQM

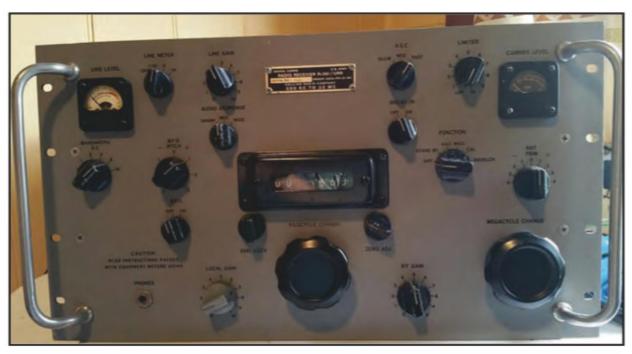
Photo A. Front panel of the author's Collins R-390//URR. (Photos courtesy of the author, except as noted)

The R-390//URR and R-391//URR were only manufactured by Collins and Motorola between 1950 and 1953 (*Photos A* and *B*). With 33 valves (tubes, for those of us in the U.S.) and no cost spared, they have been described as the ultimate valve communications receivers. They utilized a series of gears, cogs, and cams with inductive tuning and a very stable permeability-tuned oscillator, complemented by two R.F. stages, six I.F. stages, three audio filter settings, and six selectivity bandwidths.

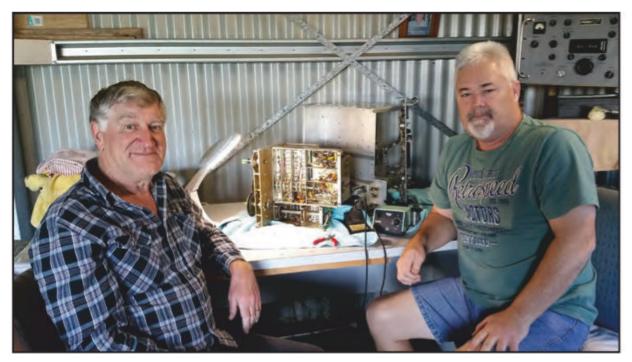
Photo C. Bert Pitt (L) and Mike Charteris, VK4QS, (R) working on the R-390-A//URR RF deck.

Once again, when it came to removing the RF Deck, it was really straightforward with the unscrewing of a few green cheese head captured screws, undoing a couple of MBC connectors and a little bit of jiggling, and out it came. This had been fundamental in the design to enable field repairs, if necessary, to return the unit to service. As I said before, you can't help but be amazed at the engineering simplicity by which this very complicated receiver can be dismantled in virtually no time at all. To my surprise, there was plenty of room in which to work and lots of fresh air space to keep everything relatively cool. The same procedure was carried out as when all the resistors were checked for their values. True to age and form, most (if not all) were way out of their 10% value ranges and were replaced with 5% ers.

We moved onto replacing as many capacitors as possible with the same procedure of cutting to the lead, looping on the new lead and soldering. All of the disc ceramics proved ok and were left alone. Some rather tight spots were encountered (*Photo G*) but eventually were overcome with persistence.

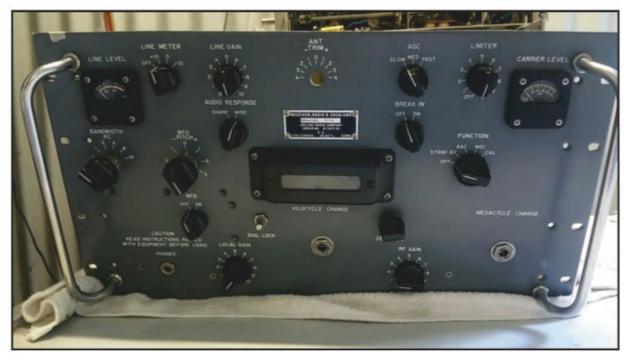
Photo D. R-390-A Front Panel Disconnected.

Thus, the Phillips-head screwdriver was engaged into the first face panel screw as I embarked on what became a oneday-a-week, two-year journey. As it happens once the face panel screws are removed, all of the pots and switches of the R-390-A stay attached to the front panel to be lowered down in front of you (*Photos D* and *E*).

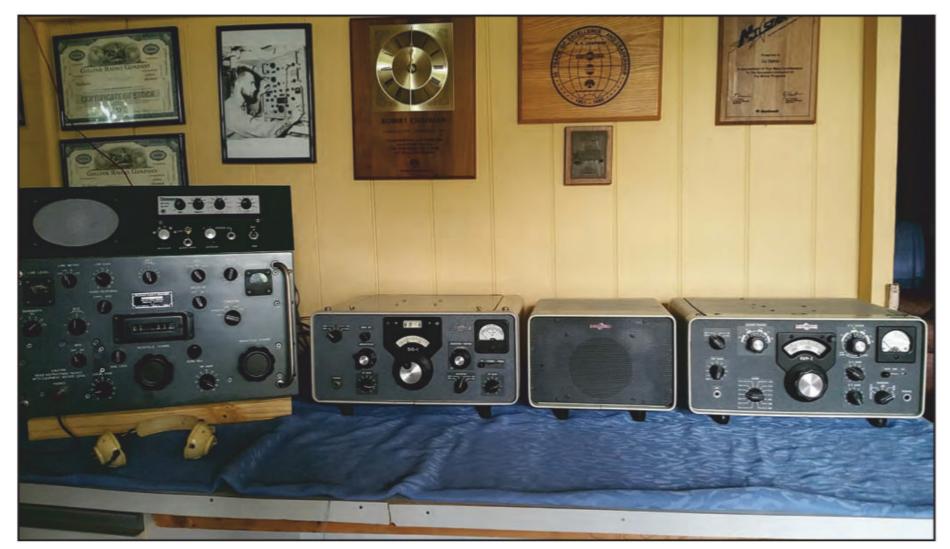
Photo H. The refurbished R-390-A is now back home in the author's vintage Collins station.

A new set of valves and all these new resistors and capacitors actually saw my Collins R-390-A//URR reborn. I hooked it up to my URM-25 signal generator and injected 3  $\mu$ V into the antenna socket. The response was loud and clear, so the level was lowered further to just 1  $\mu$ V and, again, the signal came through pretty audibly. So, just to show off, I dropped it to a 1/3<sup>rd</sup> of a  $\mu$ V and blow me down if this receiver did not pick it up and show it as an audio signal. I was amazed and gratified that all my work had been rewarded with such amazing results.
