# Repairing mechanical filters from an R-390A

Graham Baxter G8OAD

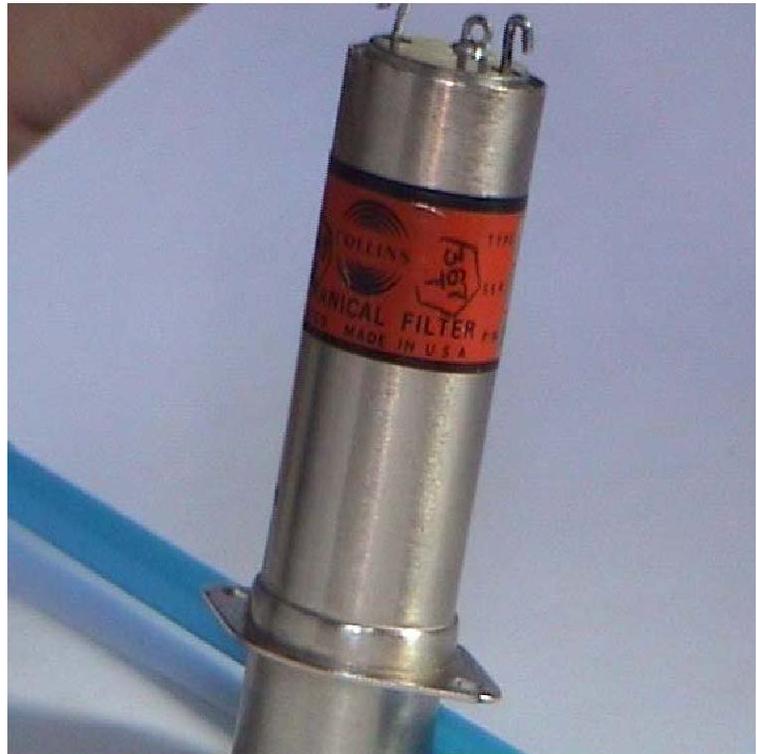
The body of the filter was originally supported within the outer barrel by a combination of stiff paper washers and foam doughnuts. Over time the foam breaks down and turns into a tarry substance which contaminates the filter. The paper becomes very brittle and crumbles.

The result of this is that the mechanical assembly is no longer supported within the case. This can either be bad, or very bad.

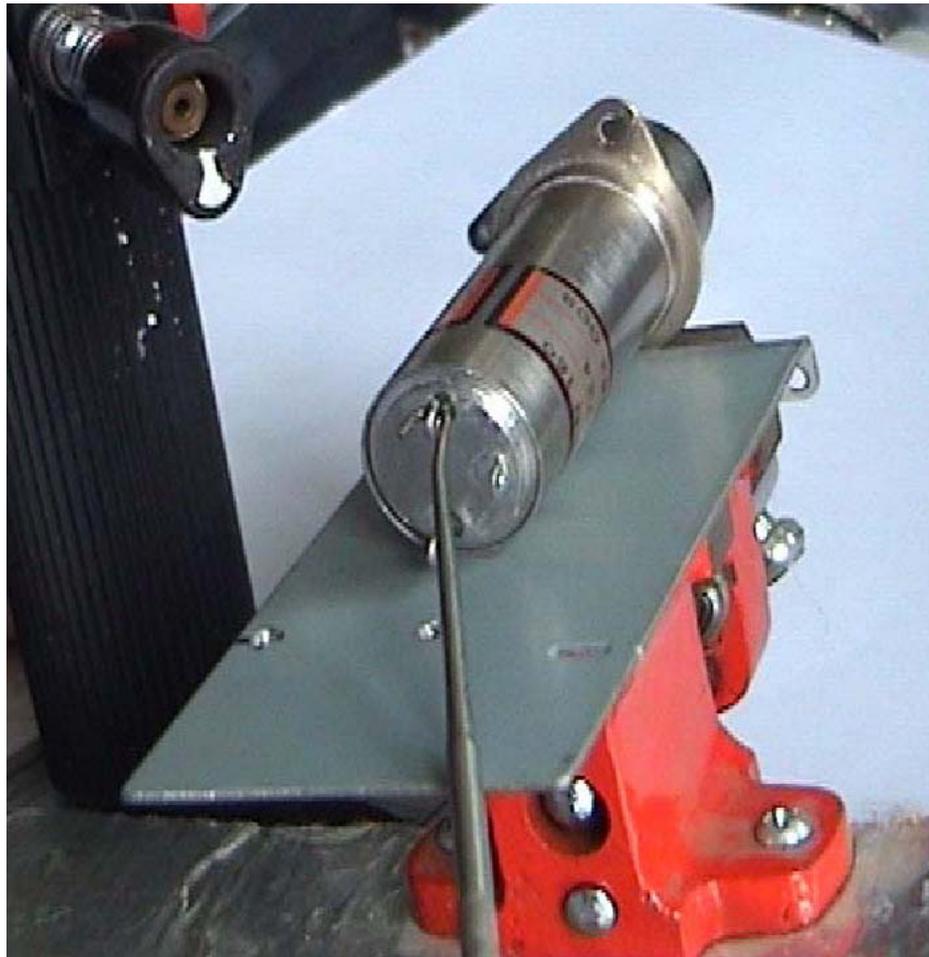
Try to arrange a metal sheet immediately beneath the filter so when the end cap comes out it has somewhere to land without pulling on the fine wires. I used a spring hook to gently pull the terminal hooks whilst playing the flame in circles around the cap.

It is quite possible to do this without burning the label. Once you see the solder start to run, carefully put down the butane torch (something else I didn't do first time round) and then gently pull the cap. It should slide out with little resistance. Let it rest on the tray to cool.

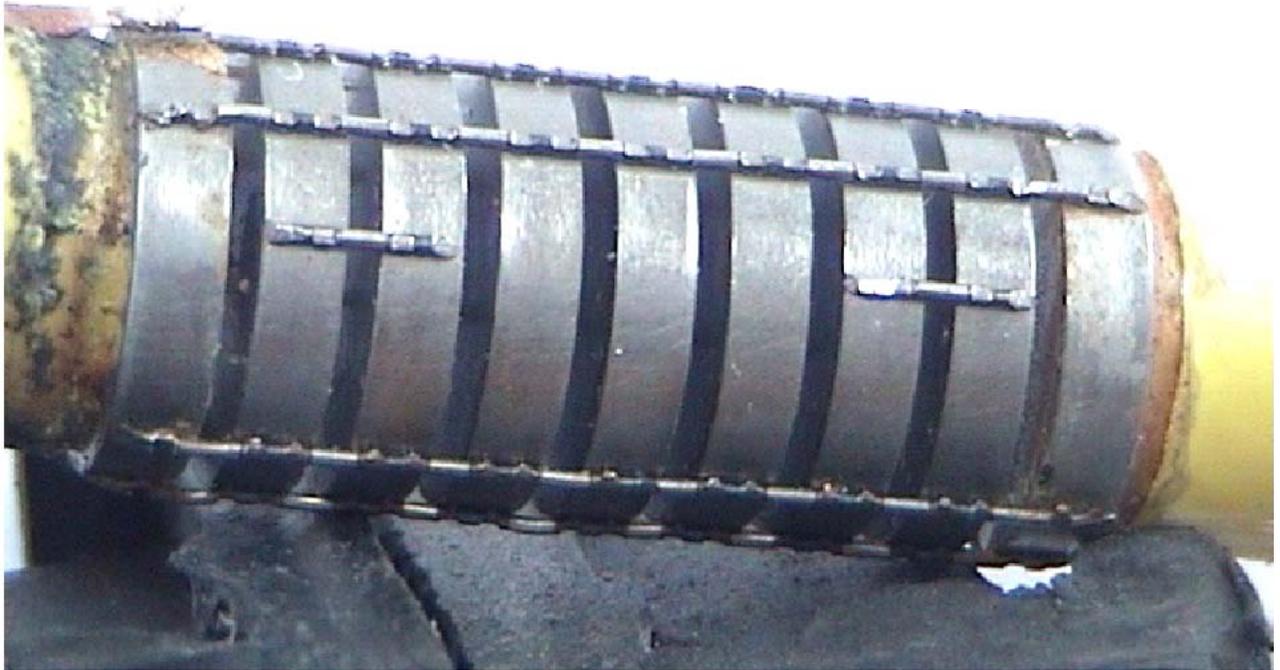
By now the filter will have cooled. You will probably see a dismal black powdery sticky goo. This used to be foam rubber. It is amazing that a substance can be both powdery and sticky. Keep it off your clothes. I scooped most of it out with a spring hook. Carefully withdraw the mechanical assembly.

You will see that the filter comprises a set of disks with a coil at each end. This assembly will almost certainly need to be cleaned. In my case the debris from the foam had gone between the disks. Fortunately it seems to clean off quite well in alcohol.

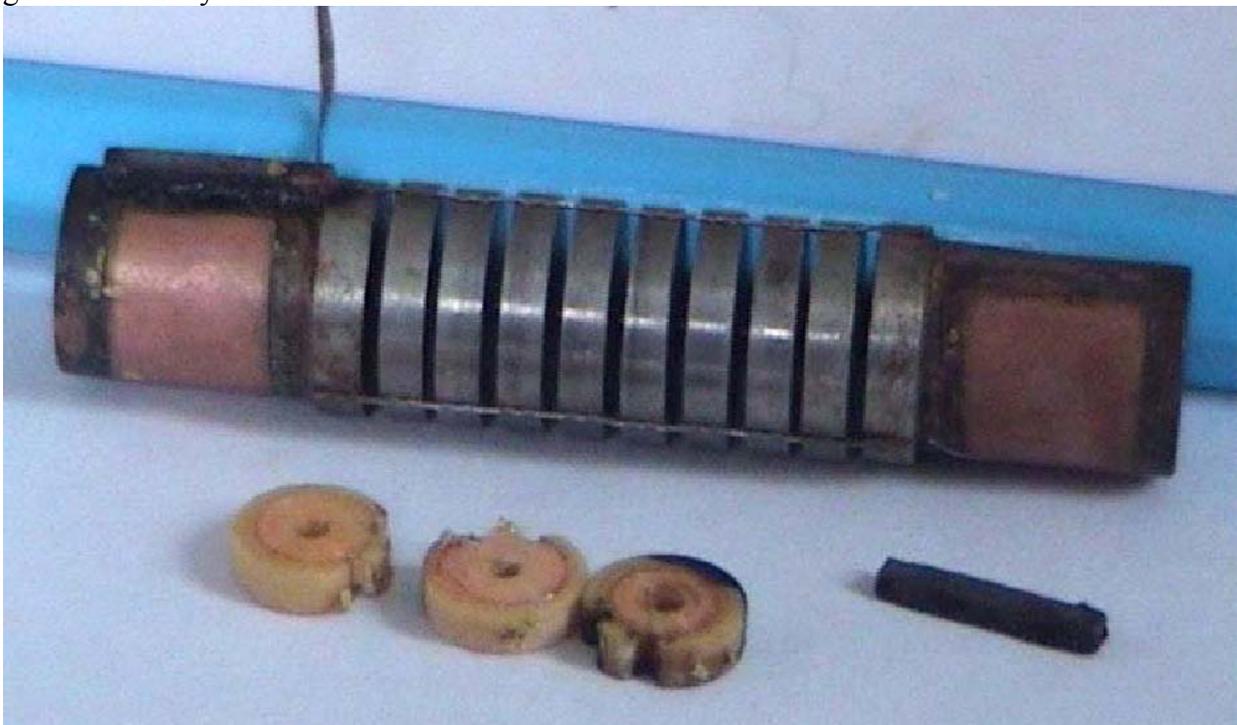
At each end of the filter, there is an actuator coil which sits inside a copper cup. In the centre of the coil there is a very fine magnetostrictive needle. On the outside of the copper cup there is a bias magnet which is both glued and taped in position. I removed the tape and the magnets in order to get the assembly clean.

In the foreground of this picture are the three cheek pieces which form part of the coil. More about them later.

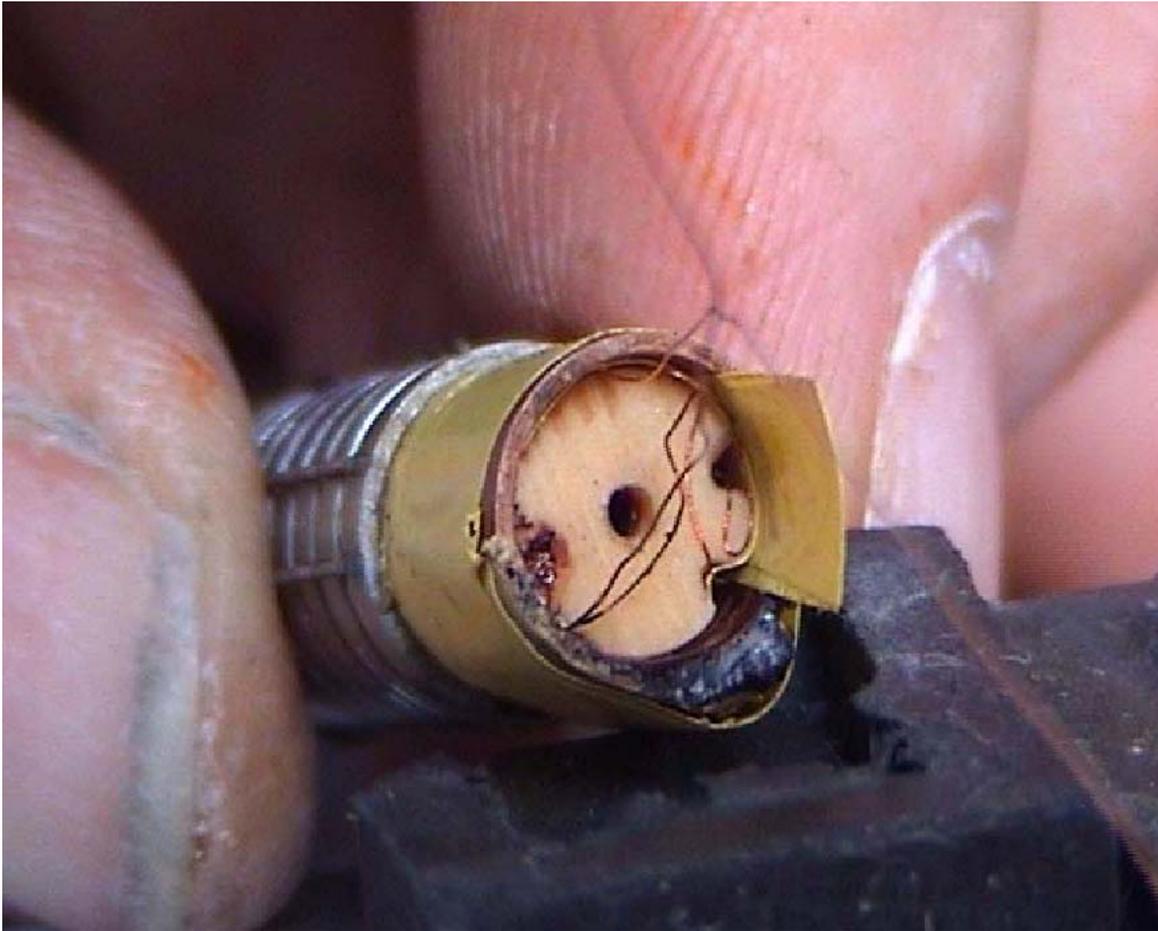
Here is a picture of the coil in position. You will also see the bias magnet held to the outside of the copper cup with yellow tape. Note also the helpful tape for withdrawing the coil.

You can just make out the actuator wire in the centre of the coil. Here is a picture of the cup and the actuator wire with the coil removed.

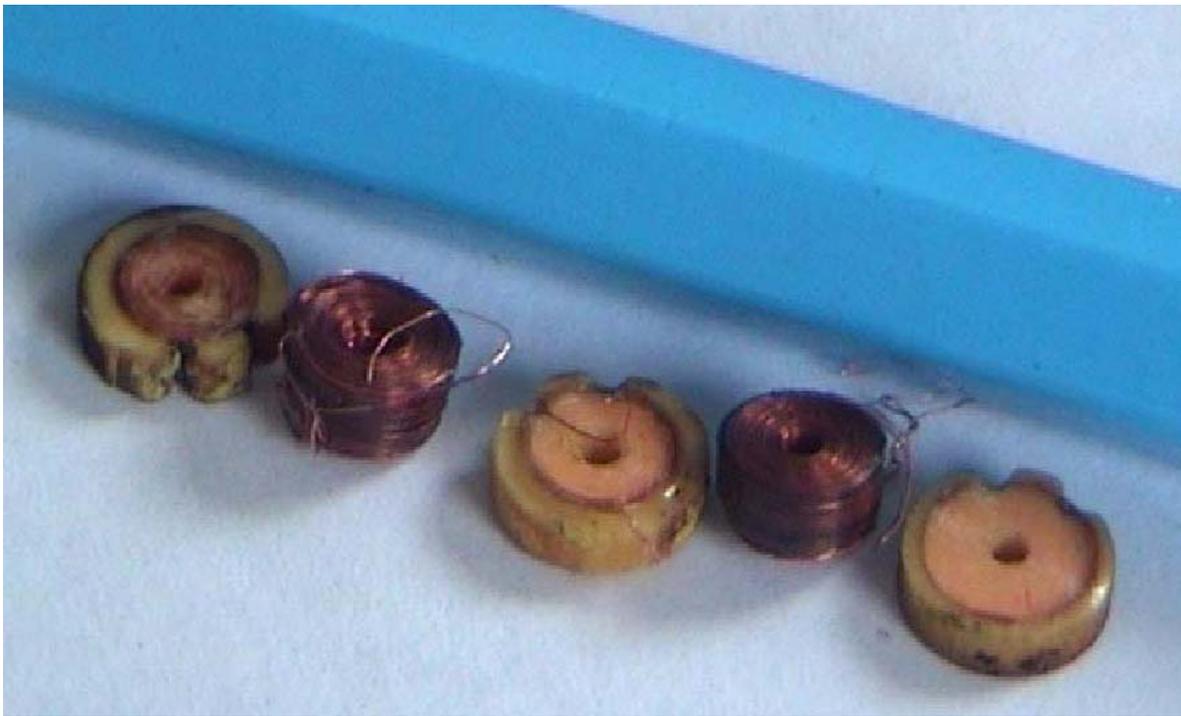
This gives an idea of the delicate nature of the wire. Note one of my dog's hairs is stuck to the tape! Once the coils were removed I felt it quite safe to ultrasonically clean the filter in isopropyl alcohol. There are two causes of leakage. I had both in the same filter. One is a build-up of conductive rubbish on the glass feedthrough insulators. Needless to say these need to be cleaned until they glisten. The other is more serious and it appears to be a conductive film between the coil winding and the copper cup. This necessitates rewinding the coil. Since one of mine was open circuit I was already resigned to that.

The coil is wound in two sections using three insulating washers, two as cheeks and one as the central partition. There is no coil former; the coil is self supporting. You may want to count the turns on your coil to see if you get the same answer as me. I think there are 610 turns of 0.071 mm (0.003") enamelled copper wire per section. The real interesting thing is that the phase of the coil reverses at the centre. So you wind 610 turns, cross the centre partition and then wind 610 in the opposite direction.

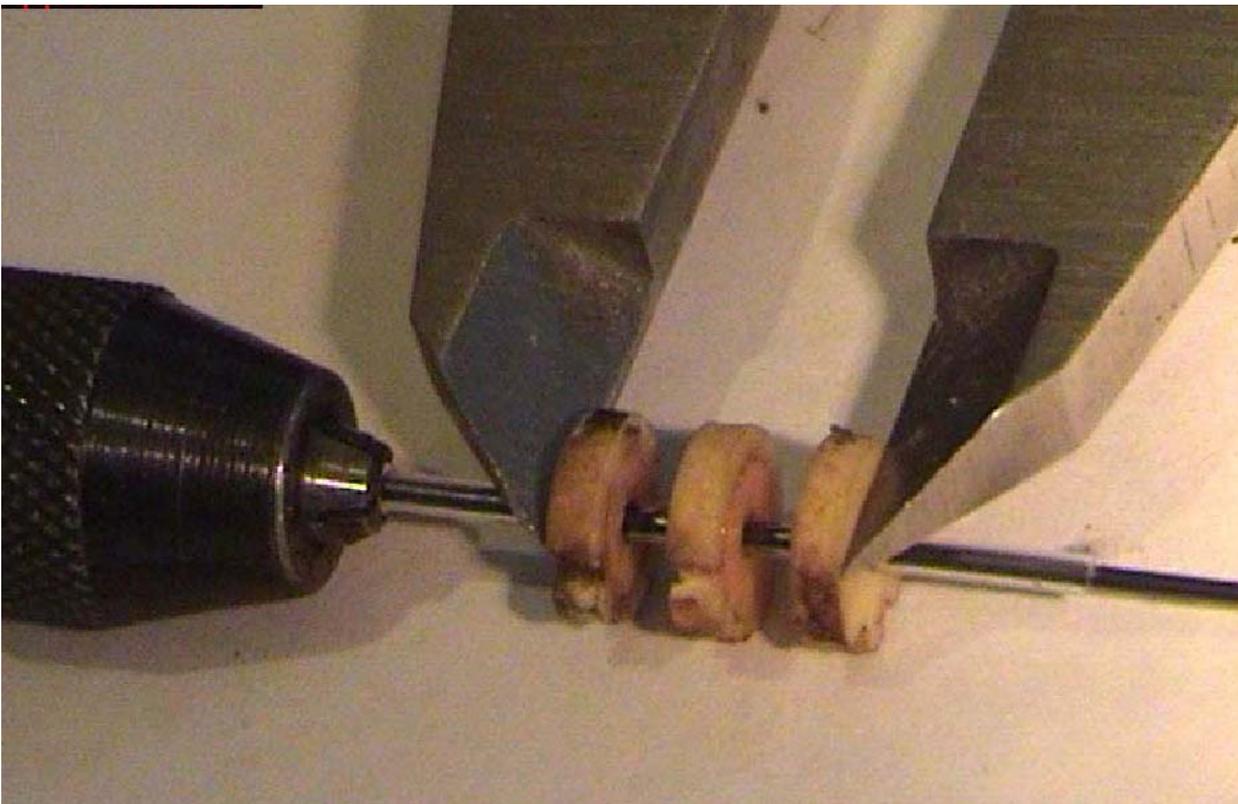
Here you see the three cheek pieces threaded onto the PTFE sleeving. There is a length of blue pivot steel inserted into the sleeving. The pin vice is gripping the sleeving in order to drive it. Note that the outside distance of the outer cheeks should be about 9.8mm. The centre cheek is centrally disposed between them.

In order to wind a formerless coil, you need to wind it on a mandrel which will be withdrawn when the coil is finished. But this is a tiny job. My first efforts failed because the mandrel damaged the wire as I withdrew it. My friend Mick Bignell, who is famous for thinking out of the box, came up with the answer. Use a piece of PTFE sleeving as the mandrel, but stiffen it with a steel rod up the centre.

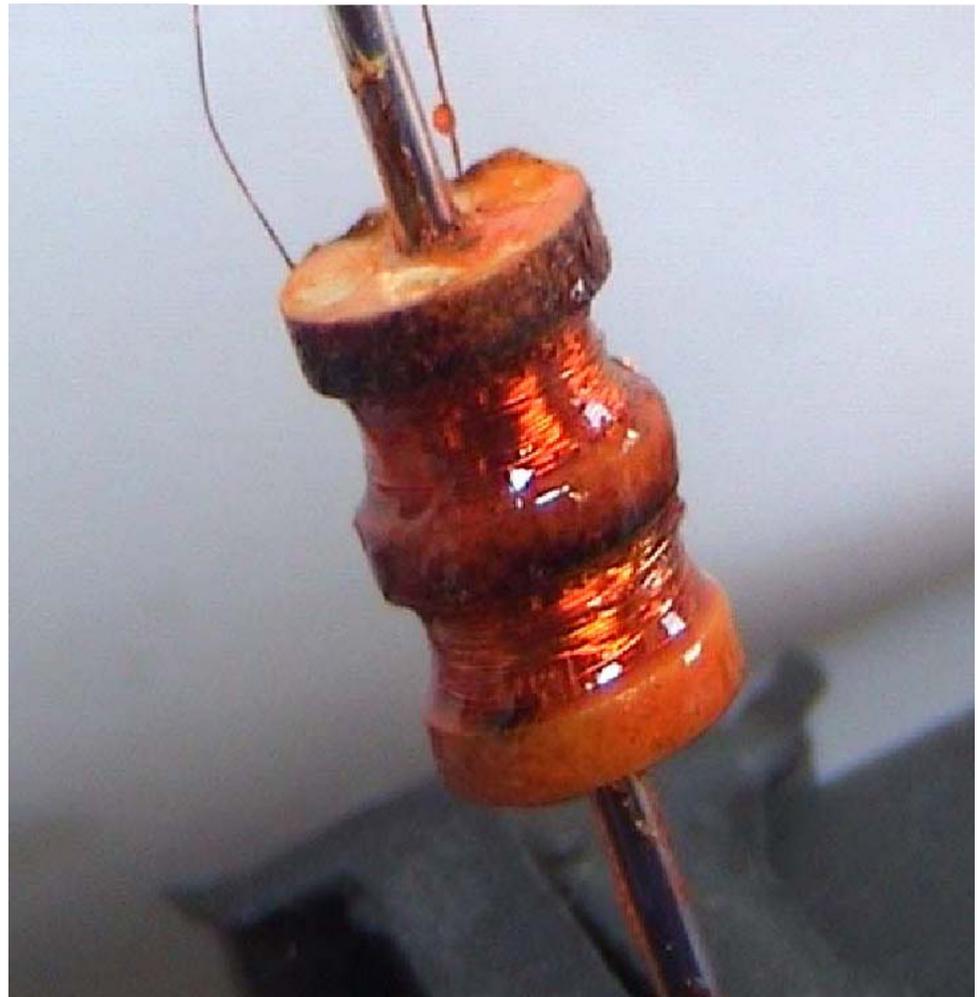
Once the coil is finished it should look like this. Give it a few hours for the varnish to get strong enough to hold it all together. Interestingly, the varnish dries in two stages. First the solvent evaporates. Then the varnish hardens using oxygen as a catalyst. Of course I was impatient!

Affix a tape extracting tag as before, and secure it with one turn of polyester tape. There is only room for one turn and it produces a nice push fit. If when you try it, it still feels loose place another extracting tag on the opposite side.

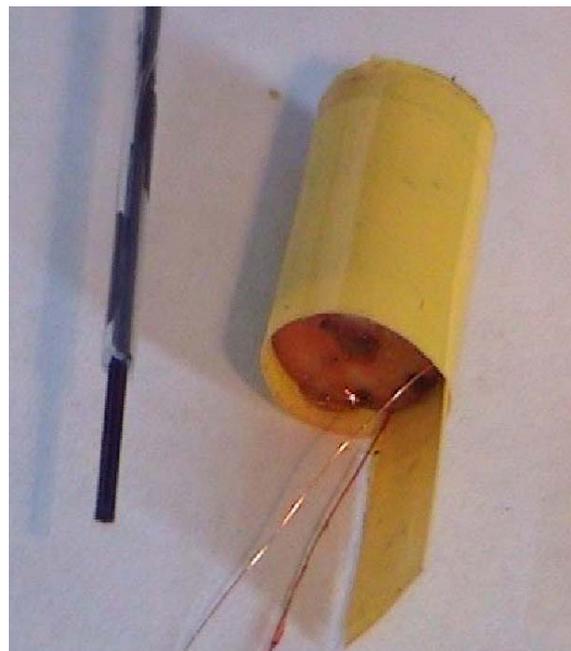
When inserting the coils avoid placing any compressive force on the filter as a whole. I found I was able to insert finger nails into the first gap between the disks so I could push against the copper cup assembly without crushing the stadia rails.

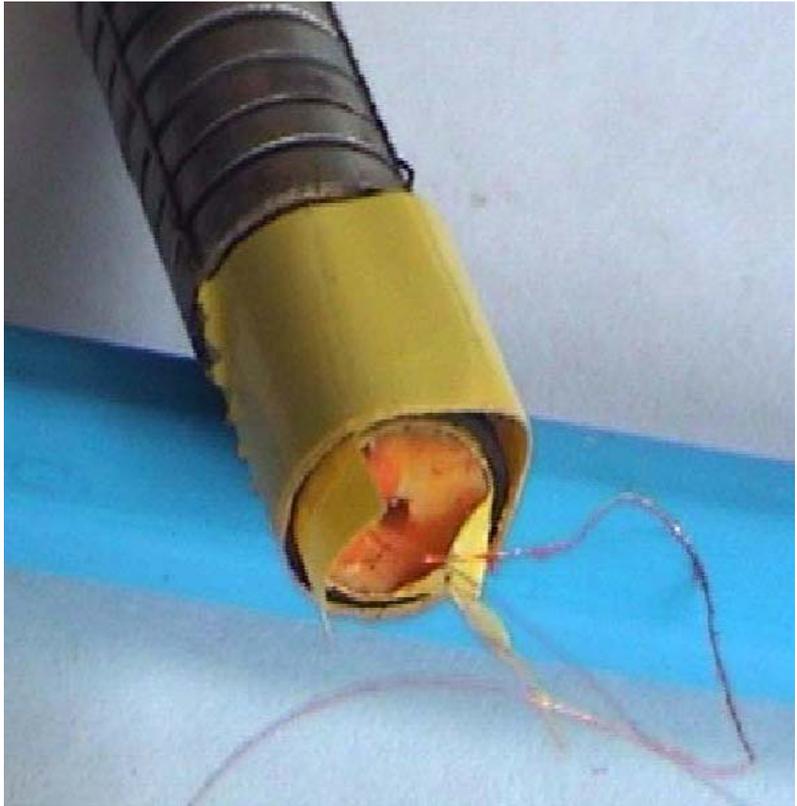
When you are happy with both coils, fifty to sixty ohms and no leakage to the metalwork, it is time to consider reassembly. You will need to replace the supporting doughnuts.

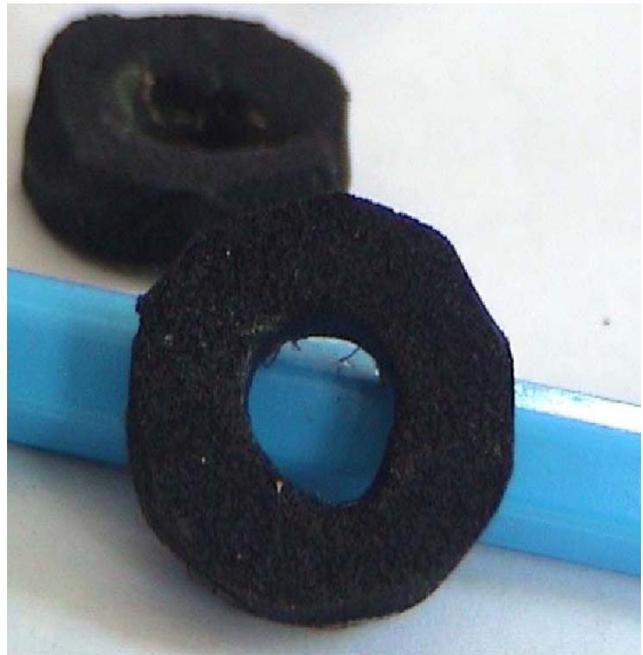
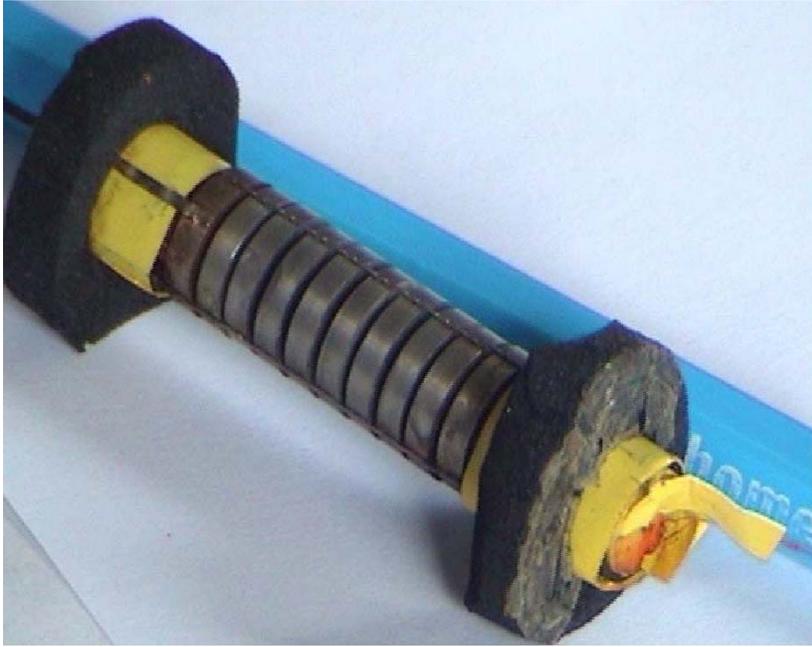
I cut a pair from some air-conditioning pipe self adhesive flat lagging which I had to hand.

A neater job would be to slice doughnuts off ready made tubular lagging. I was attracted by the air-con lagging because presumably it is good with extremes of temperature.

Place a doughnut over each copper cup, taking care not to damage the wires.

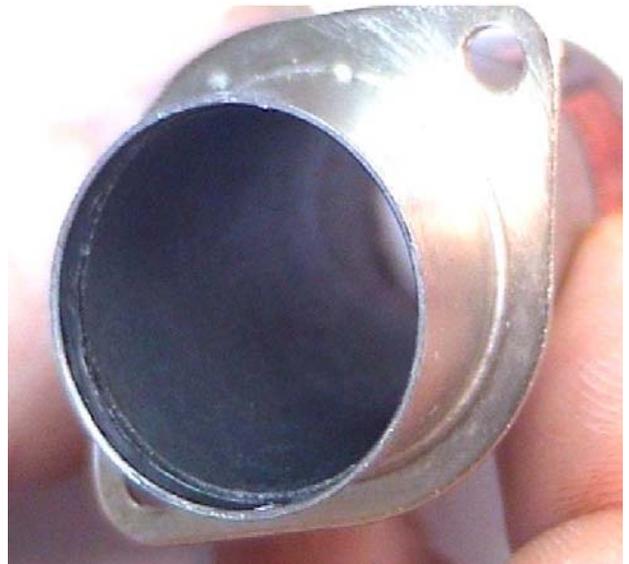
Carefully insert the filter assembly into the barrel. I used the spring hook to manipulate the foam rings as it slid down. The correct position is with the mechanical filter roughly at the longitudinal mid-point of the barrel. The foam rings were placed over the coil cups. I tried to avoid any contact between the foam and the filter disks.

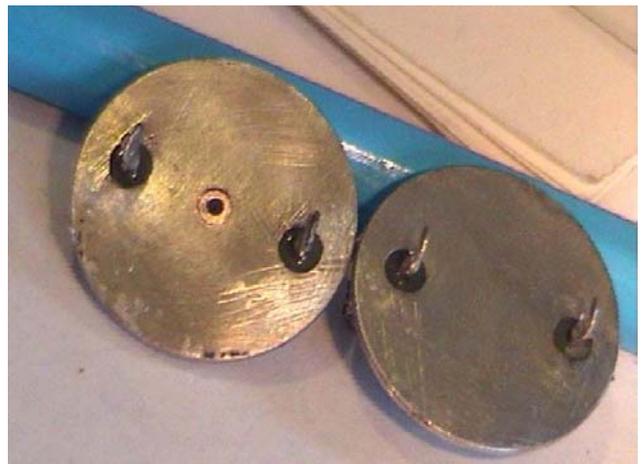
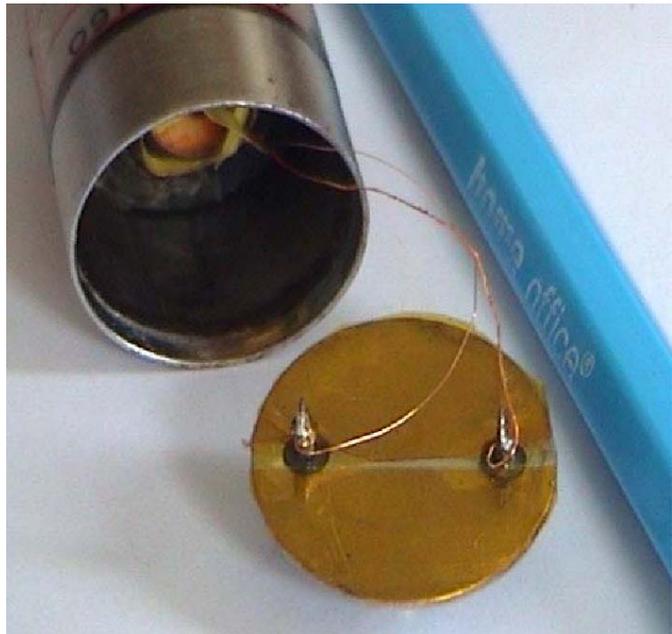
Make sure that the end caps are spotlessly clean, especially around the insulators. I placed a layer of Kapton tape over the internal surface. This was just a precaution to protect the fine wires from heat when re-soldering the case.

Then carefully connect the wires to the tags.

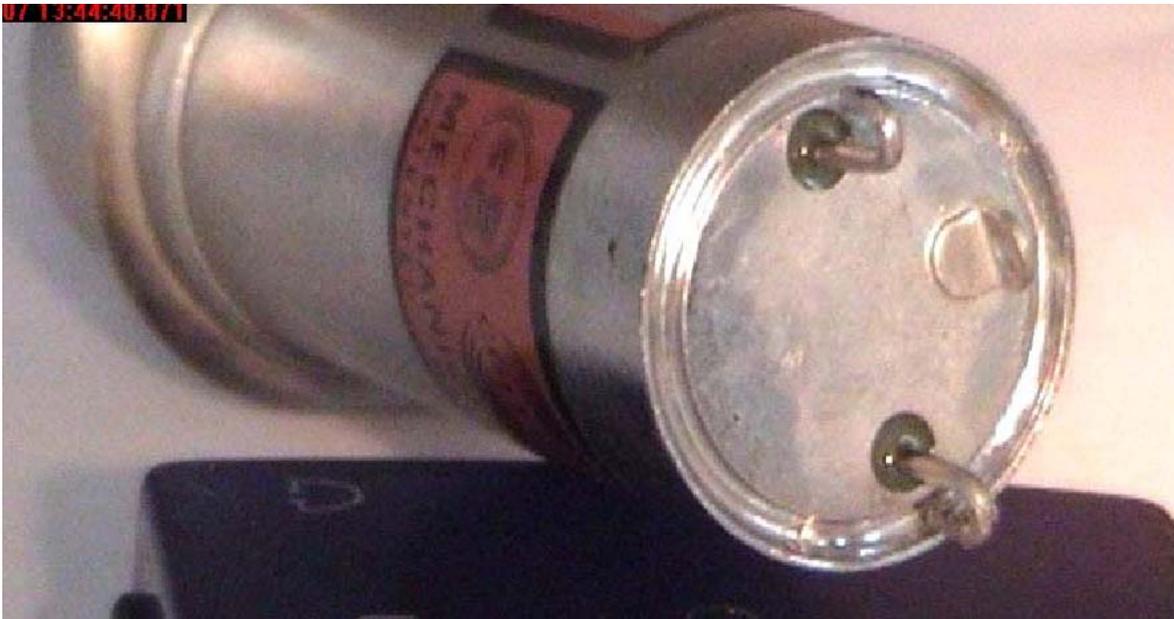
I am quite please with the appearance of the re-soldered caps. I think I got lucky!  
When I dismantled the 16 kHz filter, there was a load resistor fitted internally. It was wired in parallel with the coil at the output (top) end. The markings had all but gone but I think it was originally 56k. I elected not to refit this. This gave me the option of fitting an external resistor in order to balance my filter gains should the need arise. The 8 kHz did not have a resistor.
