## Eddystone 730 / 4 Receiver

**Philip Moss MOPBM** gets to grips with the Eddystone 730/4.

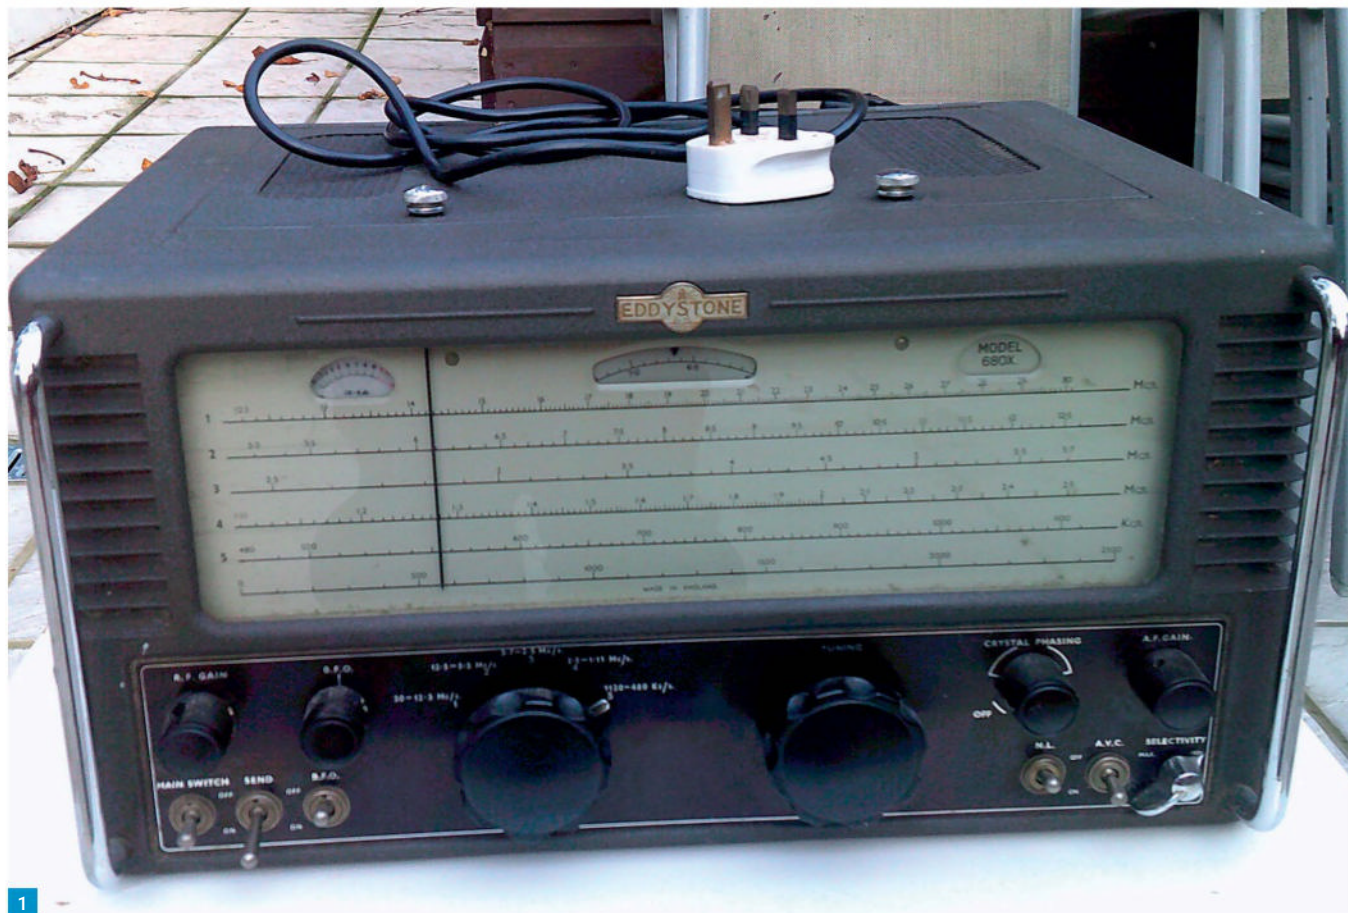
The set in the photos isn't mine partly because I sold it for use as a prop on a film set, would you believe, and partly as an unmolested set is more informative. The set photographed here, **Fig. 1**, is the one in Comms Corner at the British Vintage Wireless and Television Museum, Dulwich. This set dates to 1959.

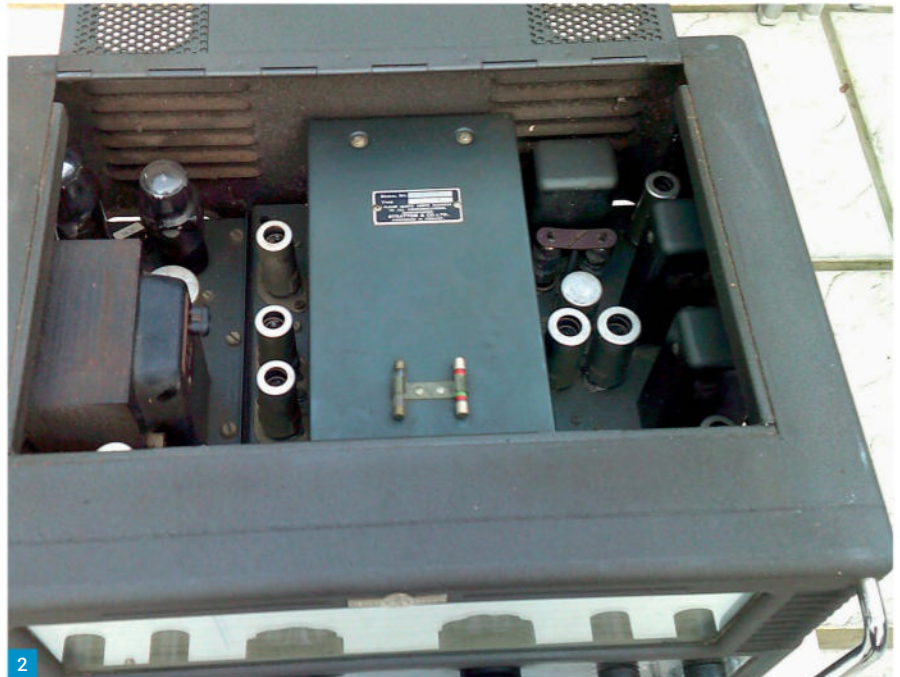
Here the set scores well, and this is true of all Eddystones I have seen. It seems very solid. The centre of the set is a diecast aluminium four-section box, each section containing one of the tuneable stages, the RFs being at the rear, the oscillator at the front, **Fig. 2**. A raised channel in the casting carries all the valves, possibly to get their heat away from the tuned circuits. This does not seem an entirely convincing reason as the rise is only a few millimetres, but I cannot think of any other. The valves are on mounting plates, suggesting that the casting was for bigger valves such as Octal, and they avoided the cost of producing a new casting for the newer valves. The tuning capacitor has three mounting screws, all of which are adjustable for height, an unusual
