# Hallicrafters FPM 300 MKII Restoration Notes

W7CPA

February 5, 2014 Update, X-LOCK Changes

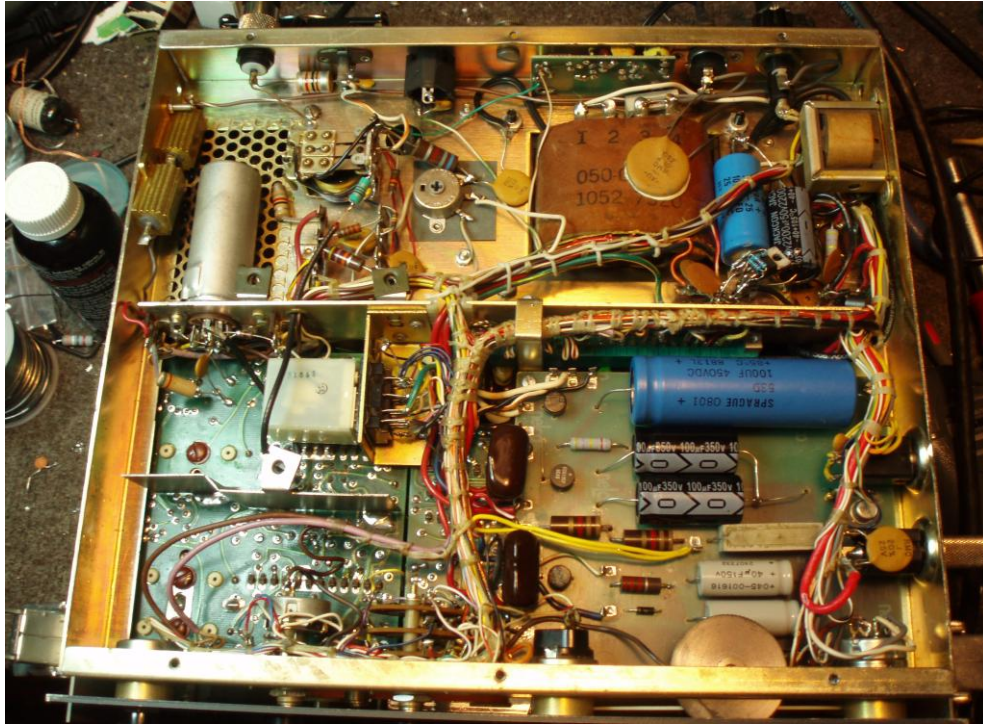
**Figure 2 - Bottom View After Changes**

One could build a tasteful little board but I just soldered the regulator to the existing terminal strip (center right area in Figure 2) and made the changes. There is plenty of room for the changes and no heat sink is required given the low current requirements of the FET circuits it's feeding. If you have a small heat sink, I would bolt it to the LM2941 lug to improve long term drift if you don't install the X-LOCK. See the data sheet for output voltage vs. temp plot – worth doing.
