The Hallicrafters S20R Sky Champion Communications Receiver

Philip Moss describes an elderly but interesting set from the USA.

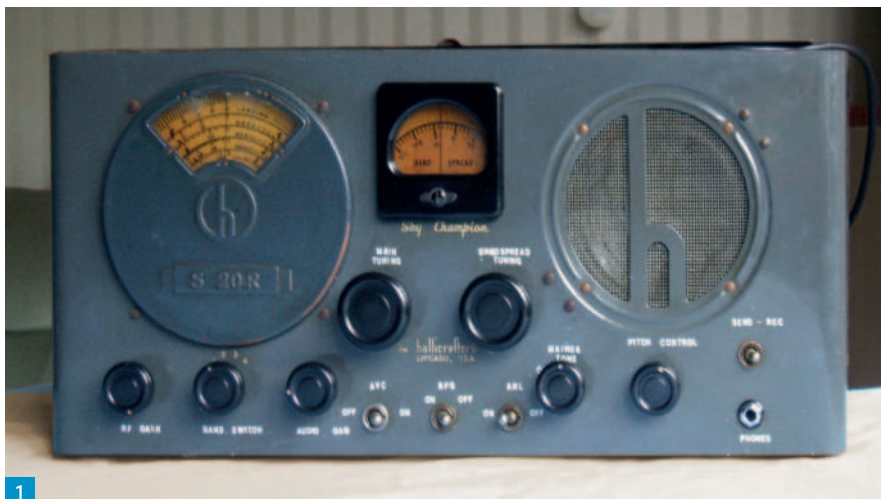
I bought this set, **Fig. 1**, from eBay, for £45 in 2012. Seeing at the time yet another ubiquitous DAC 90 was up for £51, I don't think I did too badly. The radio was in OK but not wonderful condition. Probably the many honest caveats the seller put in the description put people off, including that it was probably for 110V, which was true. Much more about the transformer later. He also said the speaker cone was jammed. The pictures, which were in-focus, showed that it was not too bad, but some corrosion was visible and it would turn out that it had probably got into the mains transformer, which he wouldn't have known. I found that out much later. It had clearly had a replacement electrolytic can, but didn't look much interfered with. Well, not quite true... I was lucky, the owner was a long way away, but his wife worked not that far from me so I was able to collect it from her and avoid a delivery charge.

Fig. 1: The S20R.
Fig. 2: Top view.
Fig. 3: Bottom view.

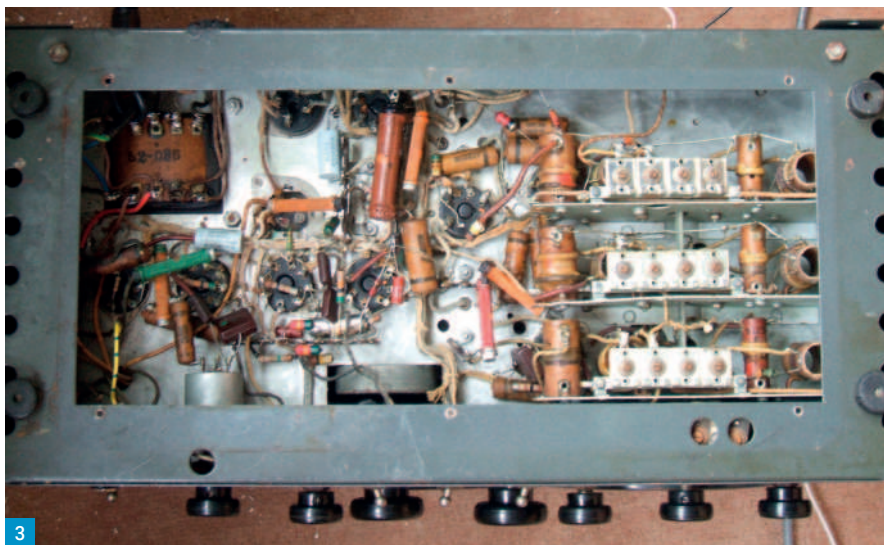
The bottom, **Fig. 3**, allows easy access, perhaps too easy, to the trimmers for the RF circuits. The coils are all air-cored and wax-impregnated, as they should be, and as the set had been damp, a very good thing too. For most purposes the top of the chassis has easy access through the lid in the top but things I did required the cabinet to be taken off. Also, the front-panel, which was a bit fiddly. I needed to repair some of the lettering. I couldn't get the correct font for the Hallicrafters name, and my work with Letraset wasn't entirely straight, but it looks fine if you don't look too closely and is much better than unreadable legends to the controls.
