Servicing and improving a KW slow motion drive

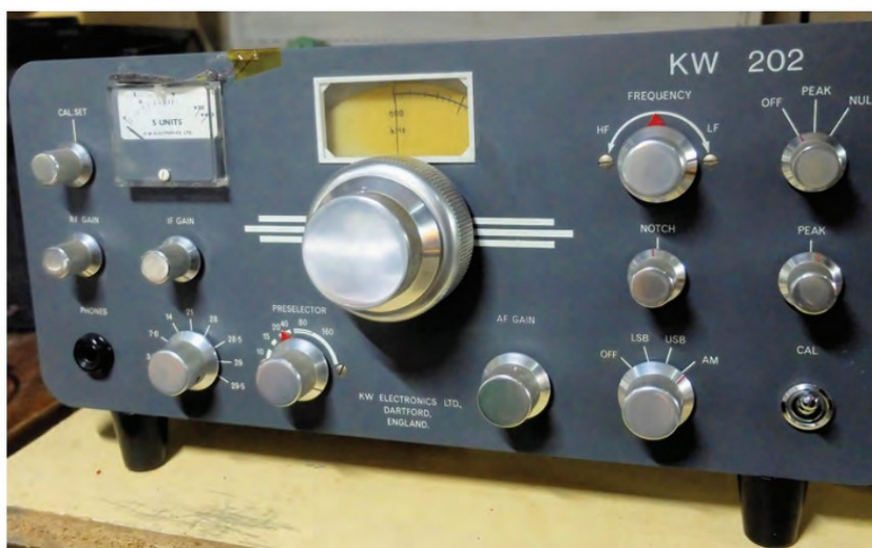
PHOTO 1: Overall view of the receiver.

1) Remove the central tuning control, using a 1/16 inch (1.55mm) Allen key (Photos 1 & 2). My example was very tight on the shaft and had to be levered off, whilst I tried not to mark the good paintwork or the polished aluminium. After removal I reamed the central hole with a 6.35mm (1/4") twist drill. This is the nominal diameter of the reduction gear shaft and it cured the problem, so perhaps something unseen was binding.

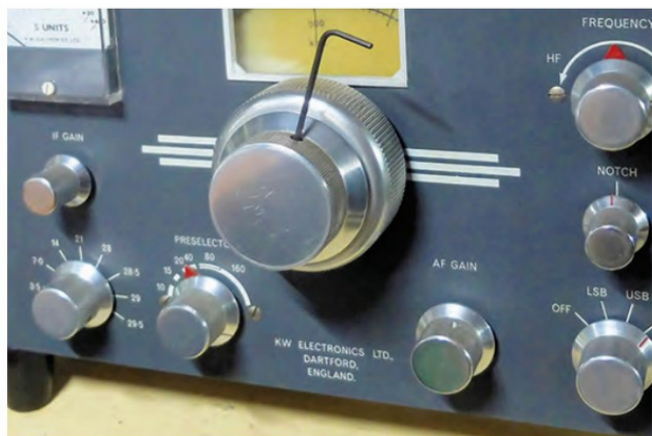
PHOTO 2: Using the Allen key to remove the inner tuning control.

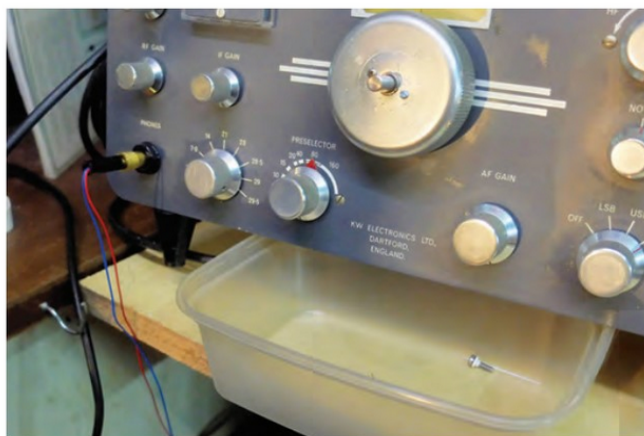
PHOTO 3: The tray to catch errant screws.

2) Unscrew the two very small (1mm-ish) screws. Use a small tray to catch them. At 5mm or so long they are easily lost in the

general debris on most workshop floors. Then remove the outer control (**Photo 3**).

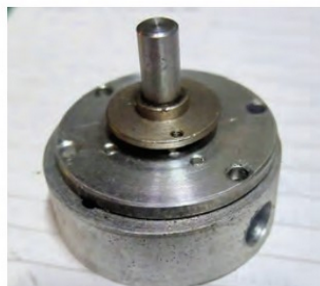
PHOTO 4: Reduction drive as removed.

3) Whilst peering down the 8mm/5-16ths hole in the spacer (while simultaneously trying to see, manipulate the screwdriver AND hold a torch), undo the two reduction drive grub screws. These are set at 90 degrees in the boss, only half a turn is required. Remove the long (4BA?) screws holding the drive and spacer to the panel. The clamp behind the panel will fall free but be retained by the VFO shaft. Withdraw the reduction drive (**Photos 4, 5, 6 & 7**).

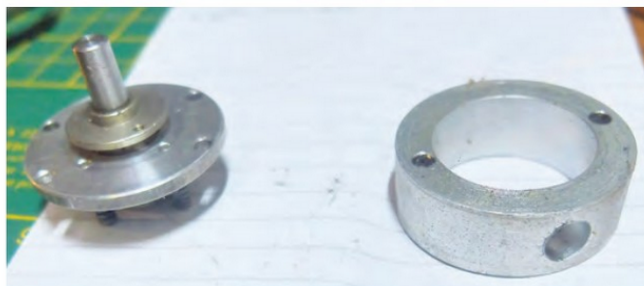
PHOTO 6: The drive and spacer separated.

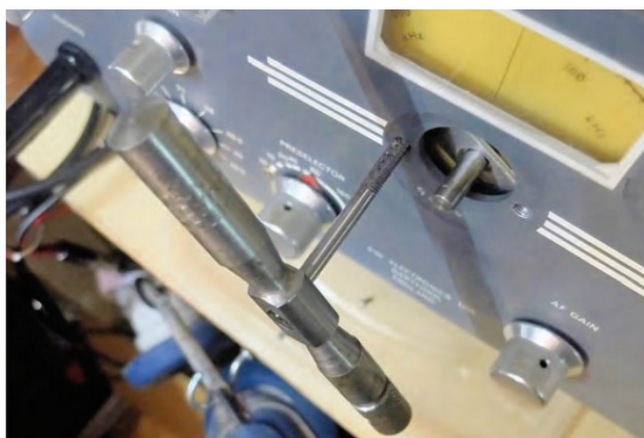
PHOTO 8: Tapping the front panel M5.

4) At this point I travelled up a blind alley, drilling out the aluminium spacer for 5mm bolts, tapping the front panel M5 accordingly (it is thick enough to be so treated) and countersinking or counterboring the spacer, in order to recess the screws. But then I realised that there was a better way (**Photo 8**). Wash the reduction drive mechanism in white spirit or other suitable solvent to remove all old grease. When

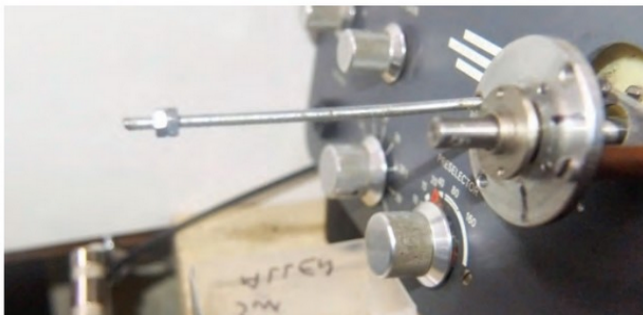
PHOTO 11: The M3 threaded rod used in reassembly.

5) Feed the M3 threaded rod through the screw holes and do it up so it is just finger tight. Its purpose is to hold the clamp bar against the rear of the panel whilst a temporary M3 x 10mm screw is inserted in the other position, briefly, to hold the clamp bar steady (**Photo 11**). Returning to the original threaded rod, this can be removed and the proper component inserted with its associated spacer. As an aside, I cannot imagine why this form of assembly was not used in the original design, in view of its advantages for access. Check that the drive operates direct though the clutch to the VFO unit and that the slow-motion mechanism operates without binding or scraping on its companions.

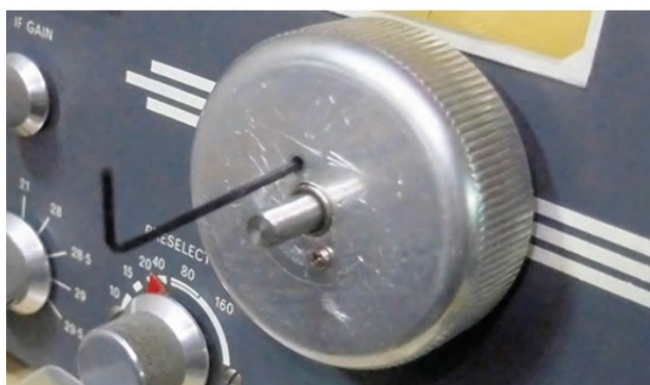
PHOTO 13: The Allen key supporting the outer control during reassembly.

7) Attach outer control knob, use the tray as in 2) and, whilst the screw is being replaced, insert the Allen key temporarily in the other screw location to hold the knob in place during this delicate operation (or use something like Blu Tack®). Check that it operates smoothly (**Photo 13**).

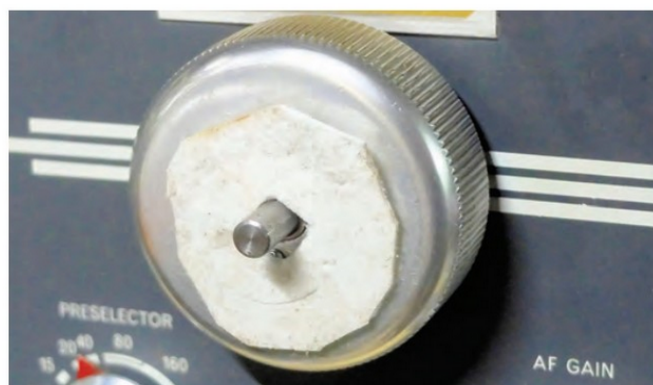
PHOTO 14: The felt disc between inner and outer controls.

8) Make a felt disc to fit over the VFO shaft to add friction and prevent any contact between inner and outer controls (**Photo 14**), then fit the inner control. Fasten the grub screw with the Allen key. Check that the controls operate smoothly. The drive should feel much silkier in operation.
