# VINTAGE RADIO

## 1940 RME model 69 communications receiver

By Fred Lever

**This communications receiver was designed in the mid-1930s. It appears to have been updated by the manufacturer to keep up with competing products. It's a hefty bit of kit, packed with parts, with many functions and some interesting quirks. One of these is a complete lack of labels for the front panel controls! A matching tuned 'pre-selector' unit was eventually acquired; it too required repair and restoration.**

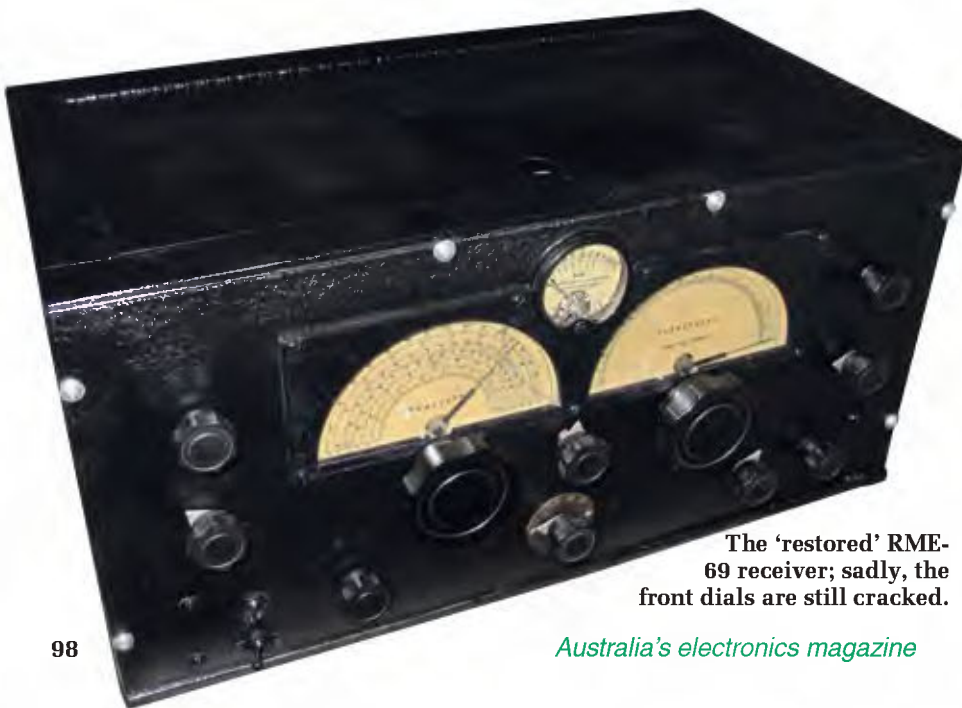
The 'restored' RME-69 receiver; sadly, the front dials are still cracked.

I achieved that by replacing obviously faulty parts and removing some strange modifications. I then carried out what I confess to being a cosmetic 'tart up' on the set and the matching pre-selector, by cleaning them and misting with a light coat of gloss black, over the faded wrinkle finish. The insides and chassis were cleaned, masked off and a light coat of silver misted over the rust and patina.

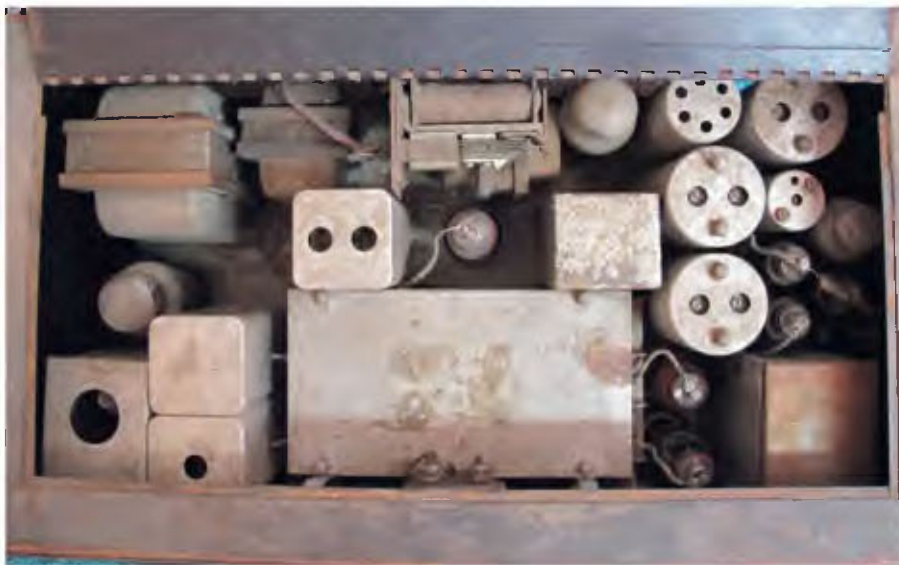
The inside of the receiver, as originally received, was full of dust and showed some surface rust.

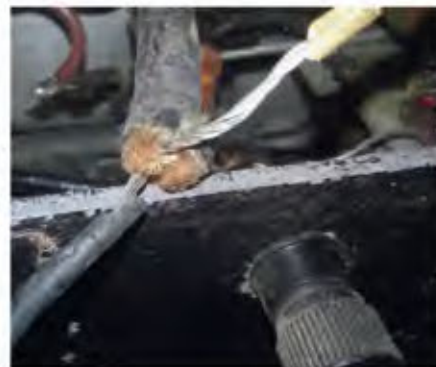
The original mains wiring in the receiver was unusable and unsafe, as shown. It was replaced with three-core cord with a chassis gland.

My first job was to remove all the existing mains wiring as it was not safe, due to rotting rubber and cracked insulation. I wired in a three-core cord with a chassis gland. After testing the insulation and Earth conductivity of the mains side of the circuit, I powered it up with low-voltage AC and

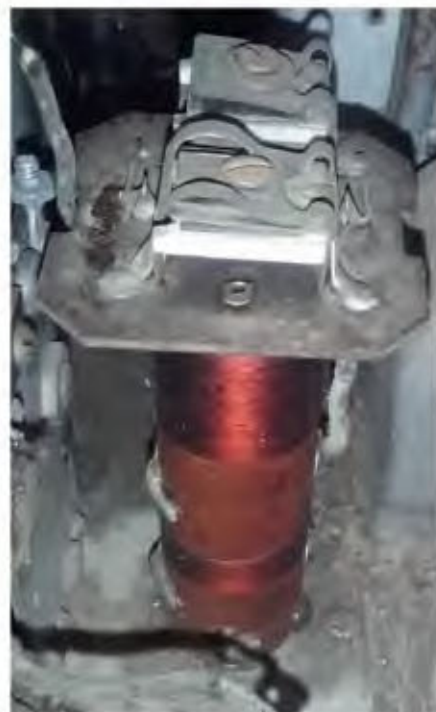
fitted inside the broadcast coil can. It was a heck of a job to get the can off, but once exposed, I found the adjusting screws on the calibration trimmers had simply unwound from vibration. You can see this clearly in the photo below.

Above: the underside of the RME chassis before any restoration work was done. Right: the calibration trimmers inside the broadcast coil had their screws unwind over time due to vibration.

Simply recalibrating the settings made the receiver work in a lively manner with gain, not loss, from the IF stages. Therefore, those two loose screws crippled the receiver on the AM band! From the corrosion on the parts, I think they had been that way for a long while. Possibly, the receiver was not used on the broadcast band in its ham duty, so this fault was never found.

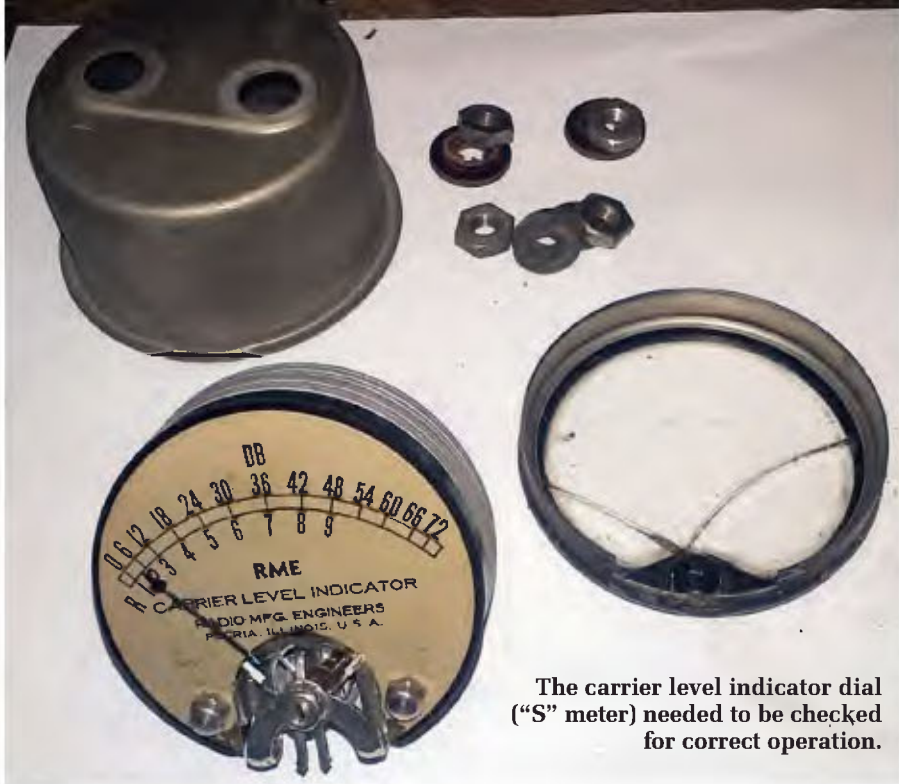
The carrier level indicator dial ("S" meter) needed to be checked for correct operation.

The meter circuit bugged me as it is not clear how it operates, and the zero adjustment (null) control did not do anything sensible. I was not sure if the meter was working, so I decided to pull it out and hook up to a bench test circuit that mimicked the set circuit. I found that the meter had an internal

The set had some prominent non-original parts fitted with strange values. I replaced them with the original values, and the S meter then worked sensibly.

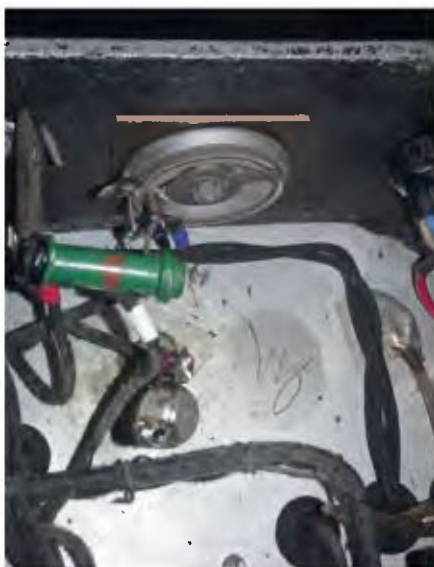
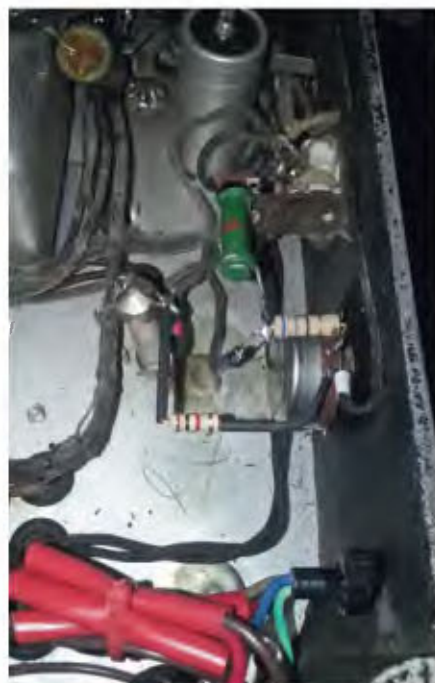
The meter is actually in a bridge circuit with  $\sim 1\text{k}\Omega$  upper arms and  $100\text{k}\Omega$  lower arms. The upper arms connect to the HT, with one of them being adjustable via the  $500\Omega$  zero-set pot. One lower arm is a fixed  $100\text{k}\Omega$  resistor passing about  $2.5\text{mA}$ , while the other is formed by the current draw of the AGC-controlled valves of about  $3\text{--}15\text{mA}$ , being equivalent to a resistor of about  $20\text{--}100\text{k}\Omega$ .

The old carrier meter zero adjustment is shown above with its replacement circuit at right ( $200\Omega$  potentiometer R10).

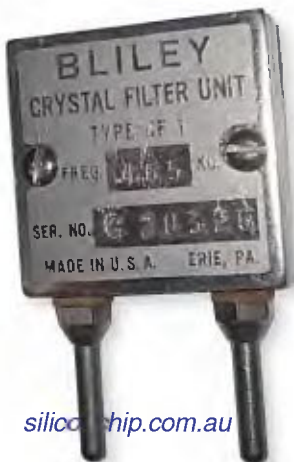
The problem was that with the crystal switched in, there was no real resonant point around the nominal frequency of  $465\text{kHz}$ , and the IF response was worsened.

The Bliley 465kHz crystal filter is shown enlarged for clarity, with an actual size of 30 x 40mm. Serial number: G20326.

cleaned and refitted it. This produced a result where the crystal does 'something' to the response of the IF strip, but I did not believe that it was working correctly. The IF pass response with filter out is about 10kHz (Fig.2) while with the filter switched in, the response is about 5kHz (Fig.3).

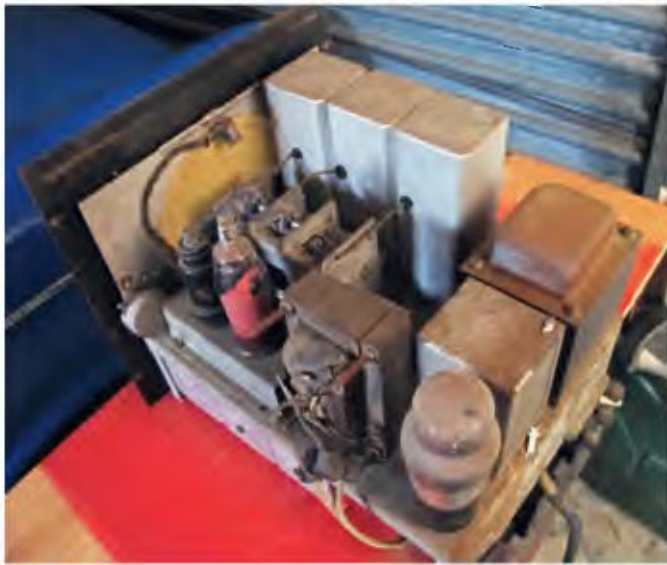
The DB-20 pre-selector had a very worn filter choke hanging off the lower left of the chassis. This choke, the power supply transformer and the type 80 rectifier valve were removed and replaced with a  $\pi$  filter.

The first thing I noted inside was a huge filter choke held down by gravity! I eased the chassis out of the case and found that the choke was connected with BB points through a bit of figure-8 wire. It seems that the original had failed, and anything handy had been pressed into service.

I decided to ditch the choke altogether, wire in some silicon diodes in place of the type 80 valve and mount some appropriate filters and dropping resistors on some tag strip. In place of the choke, I put a 3.3k $\Omega$  5W resistor and a pair of 150 $\mu$ F 400V capacitors in a  $\pi$  filter arrangement. I left a dud type 80 bottle plugged in the rectifier socket to fill the space.

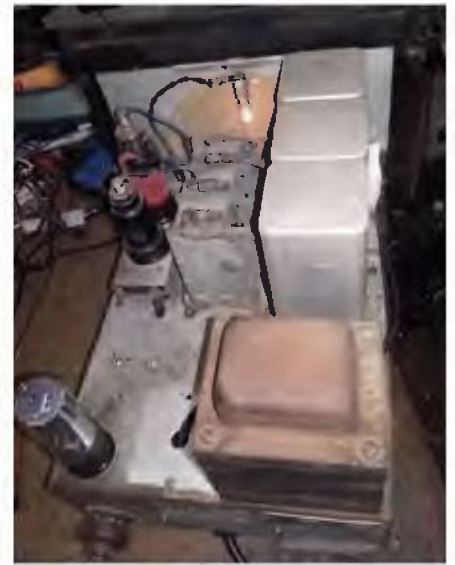
With some signal tracing and testing, I found leaky capacitors; resonant IF transformer T1 needed peaking at 465kHz; and worst of all, the 6H6 was dead.

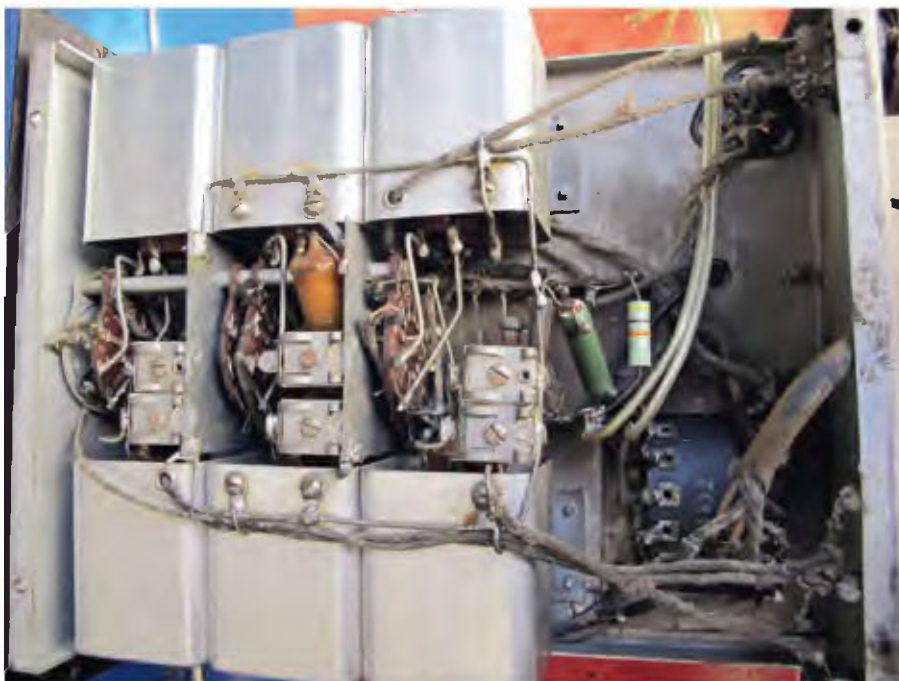
Left: the original underside of the DB-20 pre-selector. The DB-20 provides continuous coverage from 550kHz to 32MHz in six bands, and has a gain of ~20-25dB which is the basis for its name. The DB-20 was also used by the US Navy under the name CME-50063.

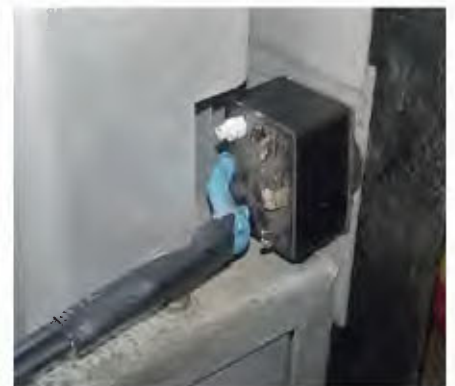
Below: a replacement switch for gain control "A" on the front panel.

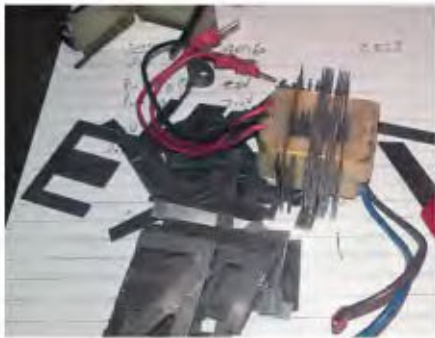
A Jaycar Cat. MM2007 transformer was rewound to act as the matching transformer for the speaker unit.

I painted a couple of layers of my favourite water-based latex over the cracked outer ring of the speaker, left that to dry and turned my attention to sourcing a matching transformer. I had an old Jaycar MM2007 240:30V AC transformer from a junked power supply. That gave me a primary winding capable of handling hundreds of volts, and a secondary that I could rewind to suit the speaker and radio.

Having rewound it, I restacked the lamination with an air gap.

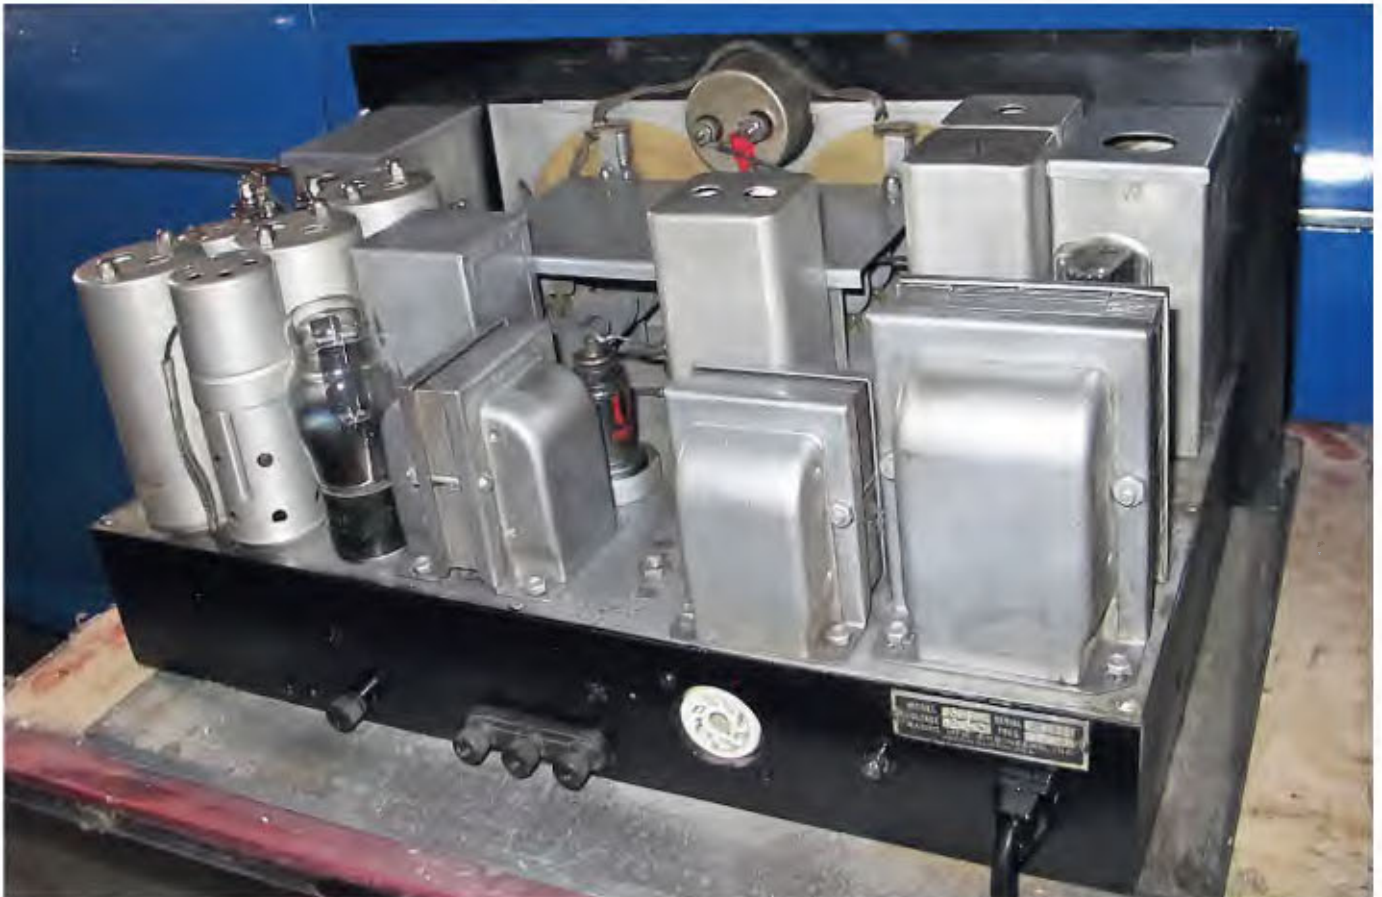
The 'restored' underside of the chassis can be seen above, with the topside shown below. This receiver was manufactured by RME at 306 First Avenue, Peoria, Illinois USA as stated on the label on the rear of the set. Around 1953, RME merged with Electro-Voice who are still around today.
