FT-1000MP Power Supply Repair

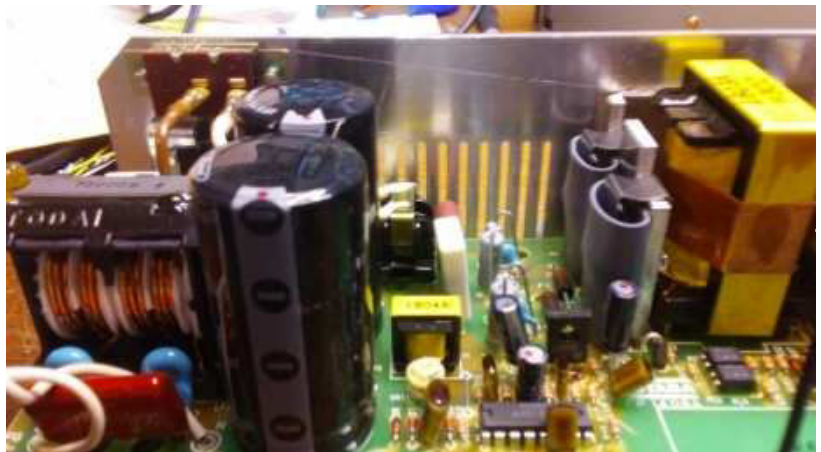
FT-1000MP switching power supply circuit board. Note slight bulges on the tops of the large capacitors.

The first thing I looked for were capacitors with bulging tops. This is an indication that they have gone bad. The two largest ones had slight bulges. They are 820uF, 200V caps. There was some silicon glue holding them together. I cut that and unsoldered them from the circuit board.

I did a search for the same capacitance and voltage, then narrowed it down to ones with the same diameter and lead spacing so it would fit on the board. Then I selected the one with the lowest ESR and highest ripple current limit. The one I selected was United Chemi-con ESMQ201VSN821MQ30S. I got a pair of them from DigiKey. They cost a little under \$4 each (July 2017)

The new caps fit perfectly on the circuit board. The new capacitors were much shorter than the original ones, so I didn't glue them together. After putting the case back together I slipped the ferrite beads over the red and black wires and secured them with a tie wrap. The supply was put back into the chassis and connected to the rest of the rig.

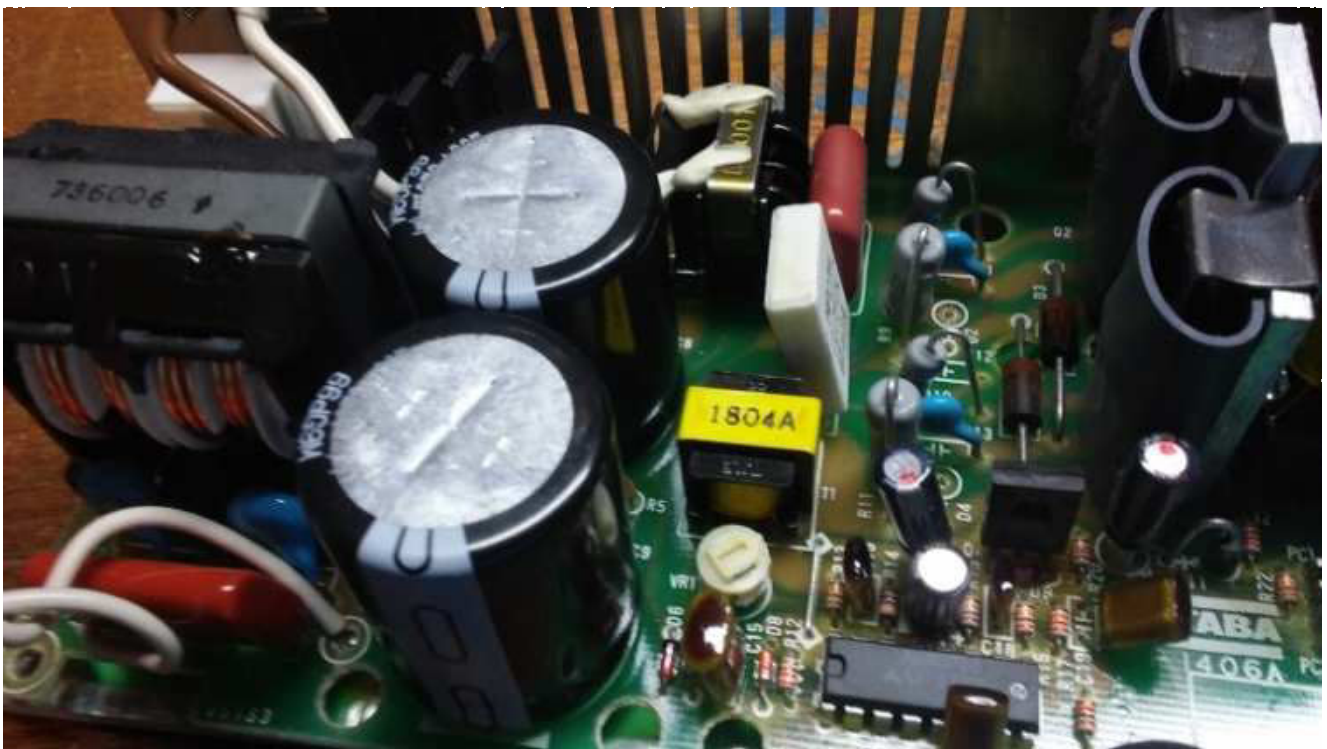
FT-1000MP switching power supply with new capacitors mounted.

My rig powered right up after replacing the capacitors. I was fortunate that no other components had failed. I was fairly confident there were no other failed parts because the rig died slowly. If you turned yours on and heard a bang when it died, it is more likely that you blew a FET and/or control chip. Repairing that type of failure would be much more difficult.
