Yaesu FT-736R PSU repair

Updated for DigiKey (North American) sources & data
*I gratefully acknowledge OZ1DB and his original repair documentation
and DL7VHF for his schematic diagrams*

The built in AC/DC power supply on the FT-736R commonly fails after about 10 years of normal use. The reason is usually faulty electrolytic capacitors (dried out) or bad solder joints on the switch mode power supply board FP-1274A.

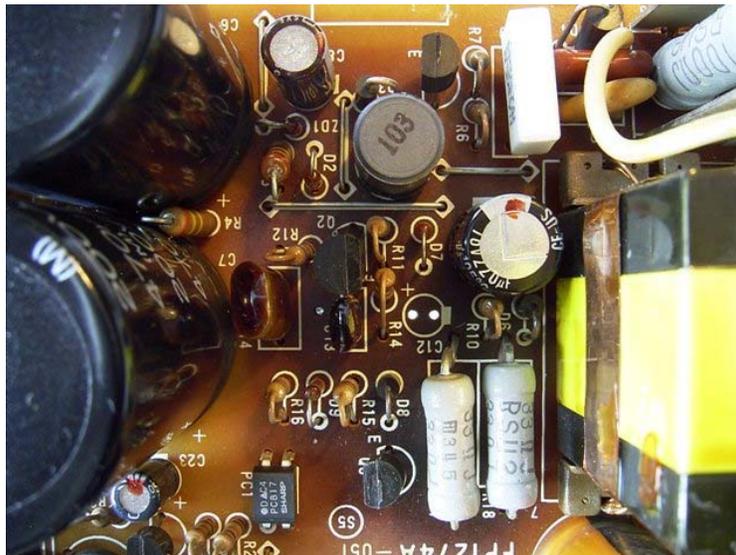
The board is usually discolored between the two 470uF/200V electrolytic capacitors and the transformer. The reason for this (and the short life of the capacitors) is two very hot 33ohm, 2W resistors (R17 and R18). See figure 1.

Fig 1. - Check C8, C9, C12 (C12 is removed here) and C22. They are likely out of spec.

- a. I suggest you replace at least C8, C9, C12 or preferably all electrolytic capacitors on the PSU PCB with +105 C versions, but not necessarily the rectifier filter's 470 uF/200 V big caps, if they seem OK and you can measure their value or even better, the ESR too.

- b. Replace R17 and R18 (optional) with a pair of 5W, 33ohm resistors (DigiKey p/n 45F33RE-ND). Install the new resistors on end, and do not trim the long lead...instead coil it so that it can dissipate some of the heat from the resistor (wrap it around a drill bit to coil it).

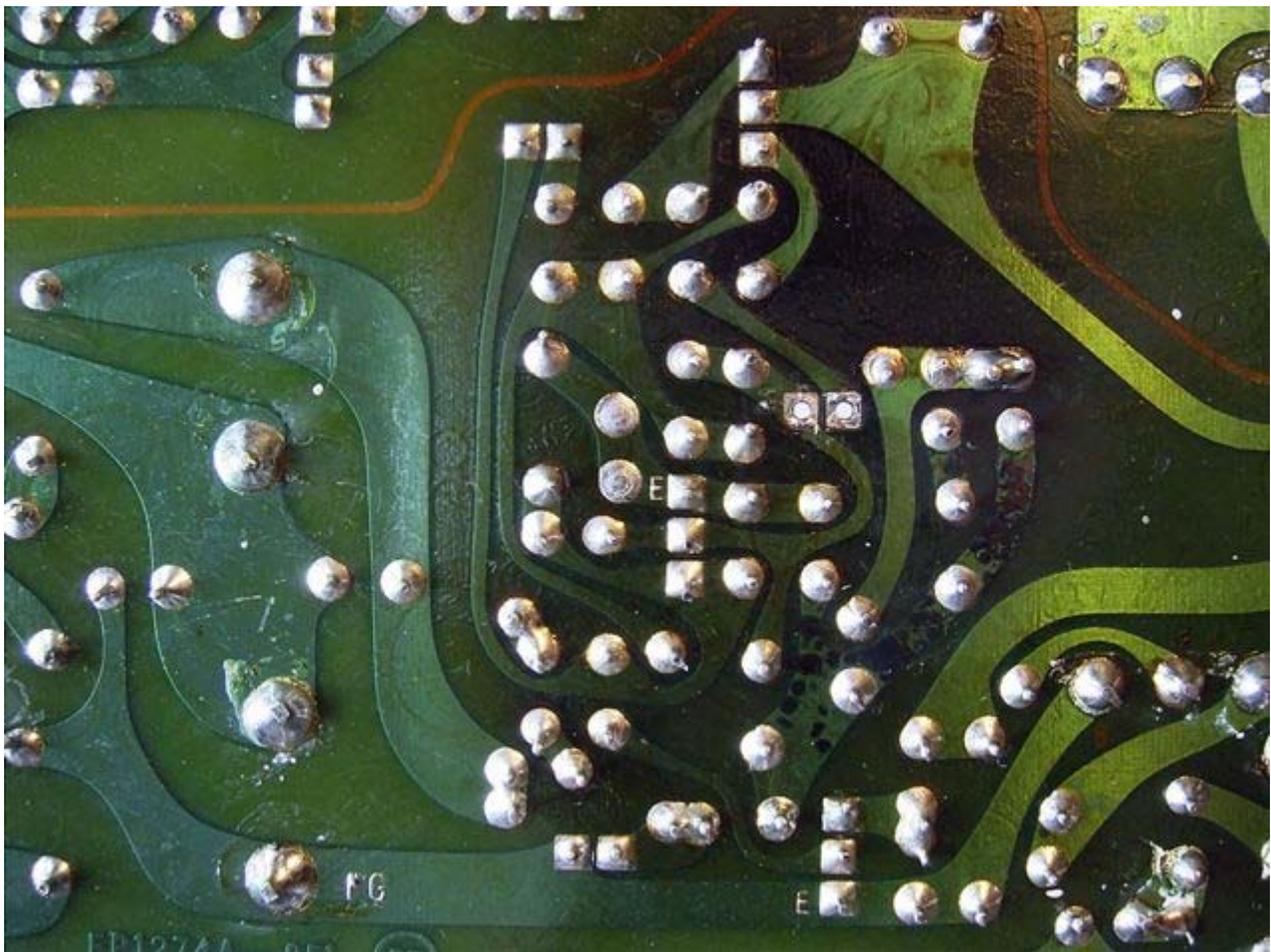
Fig 2. Thoroughly inspect the solder side of the board for cracked solder joints - the next picture shows several bad joints.

- c. Re-solder (with fresh solder and flux) all the cracked or “cold” solder connections on the PCB (especially around the transformer).
- d. Remove solder splashes (and possible solder bridges) with brush carefully.

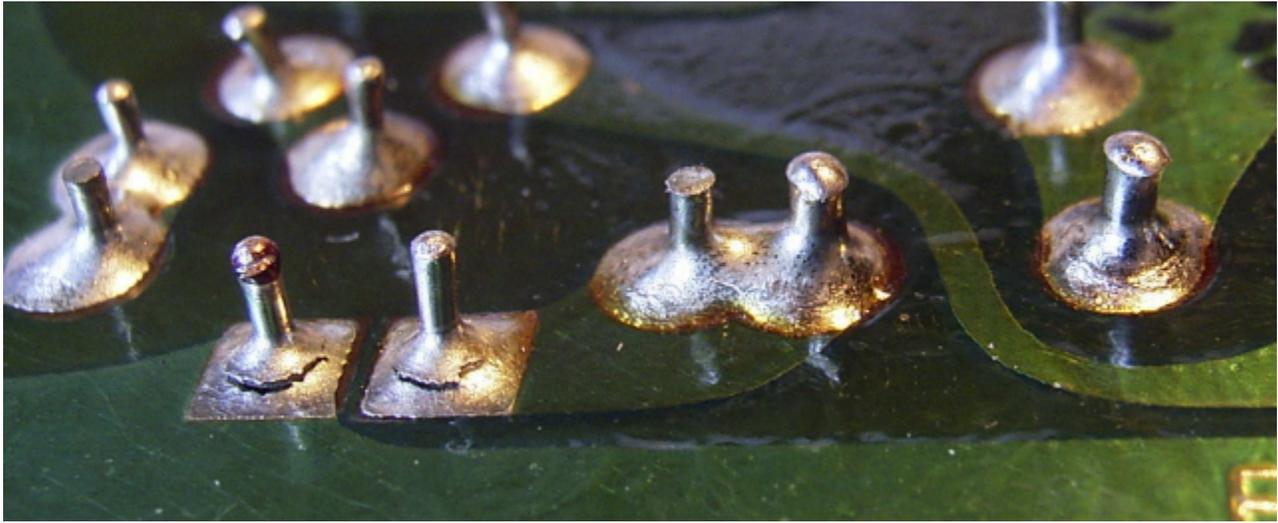
Fig 3. Close up photo showing cracked solder connections

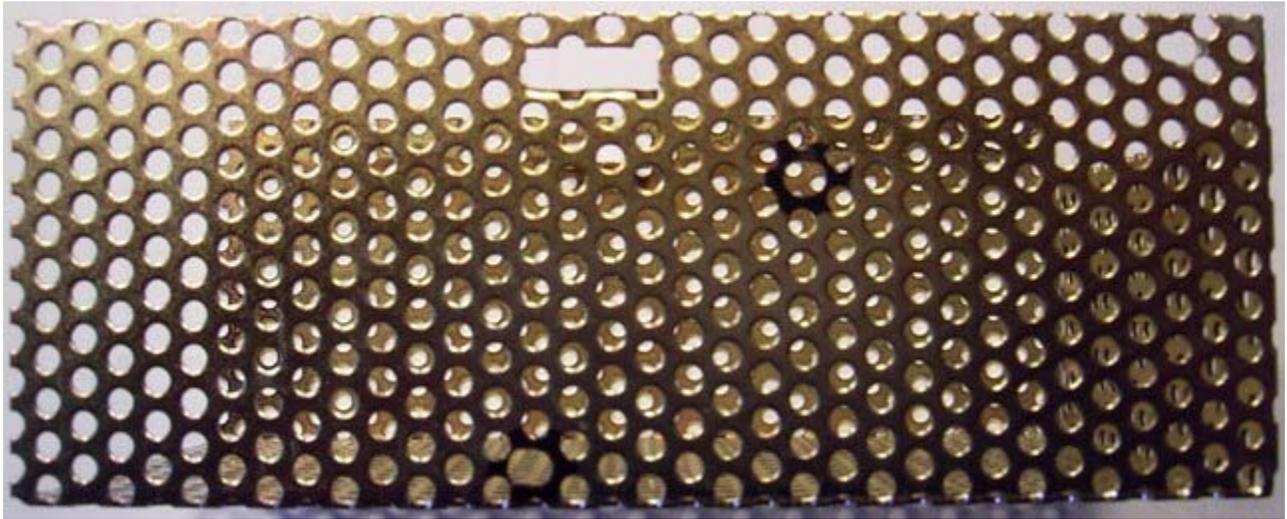
Fig 4. Modified cover with two oval shaped holes for the fan. These holes were enlarged up to 3.8 mm before filing them into an oval shape.

You may install the fan in the middle of the PCB long side on the perforated cover - see pics. Test for sufficient room between the fan and inside PCB components.

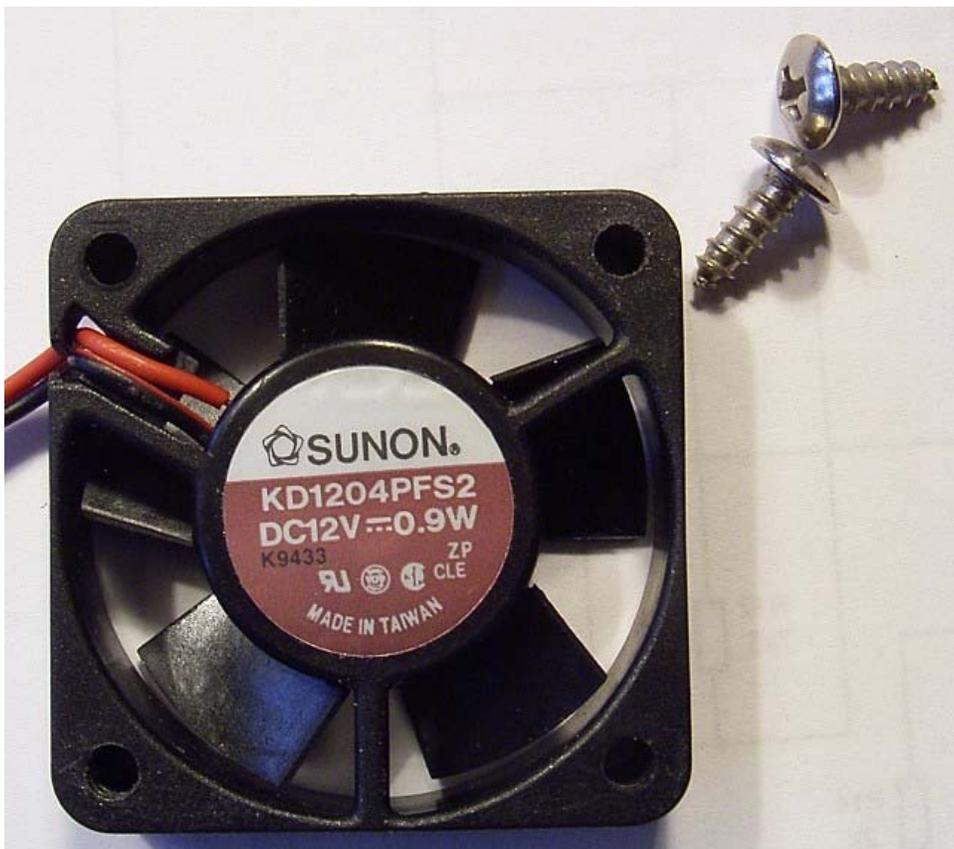
Fig 5. Fan with 2 x 3.5 mm screws

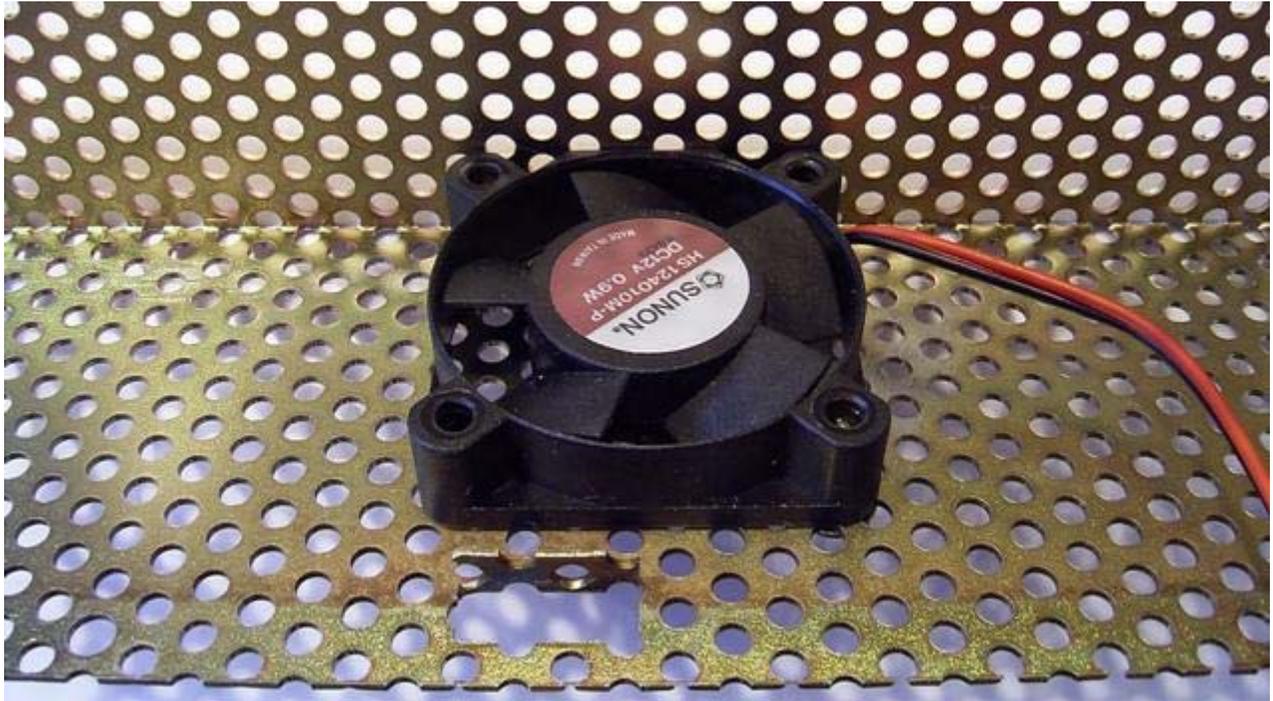
Fig 6. Fan at site, wires are cut 12 cm from fan

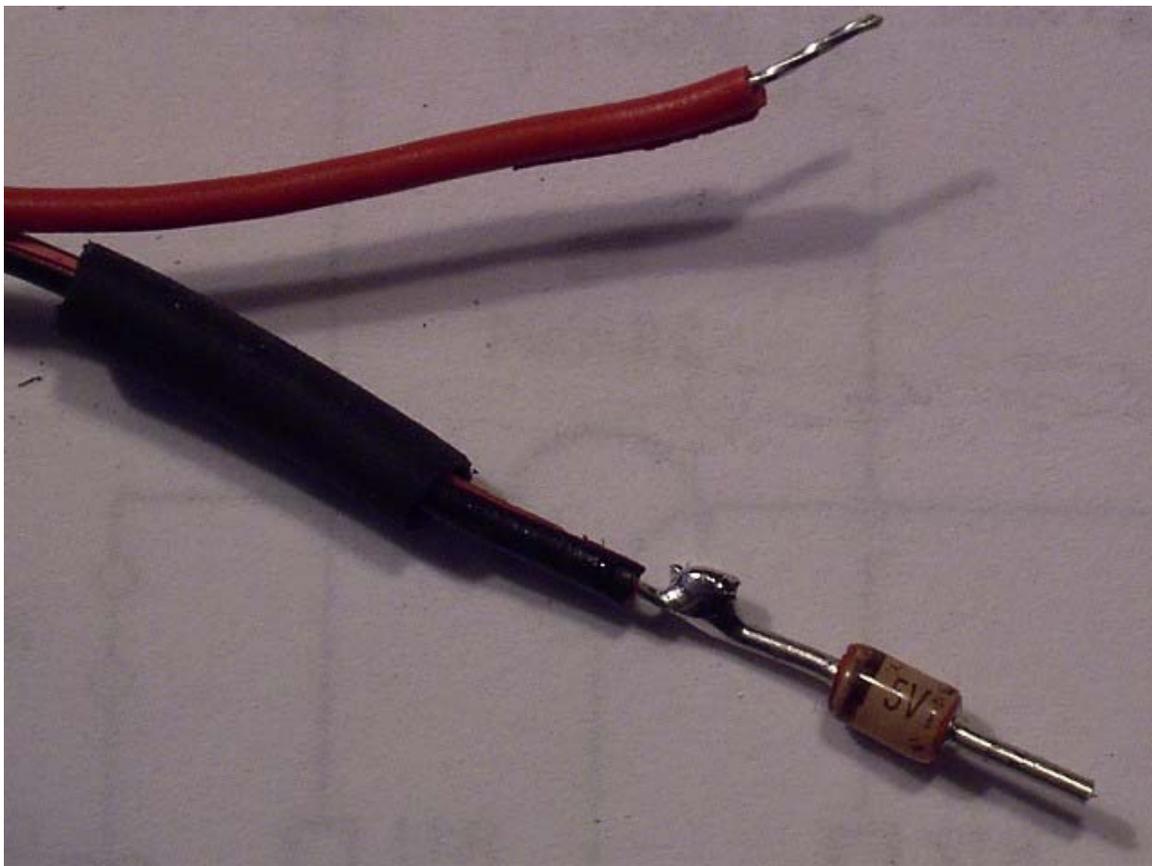
Fig 7. A 5V/1W zener diode plus a piece of shrink tube are added to the minus wire (the fan speed is reduced to improve lifetime and reduce noise)

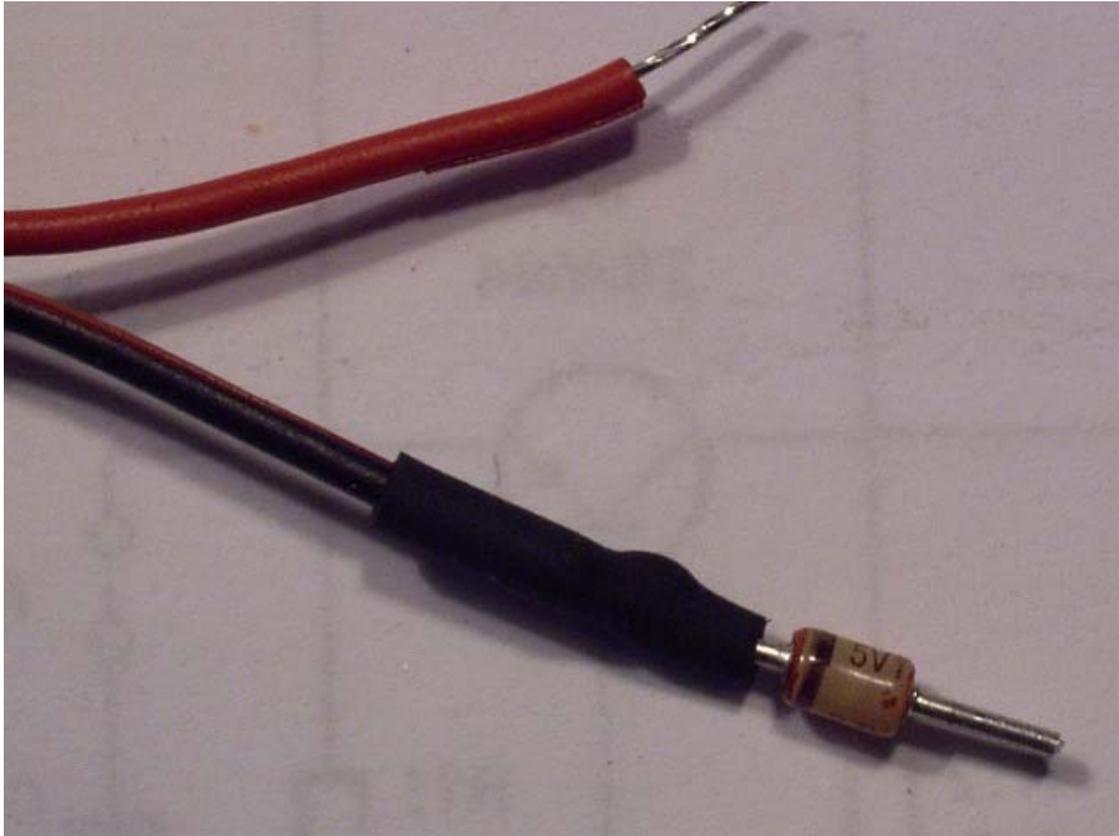
Fig 8. The wire and diode is ready to insert the PCB-holes and solder

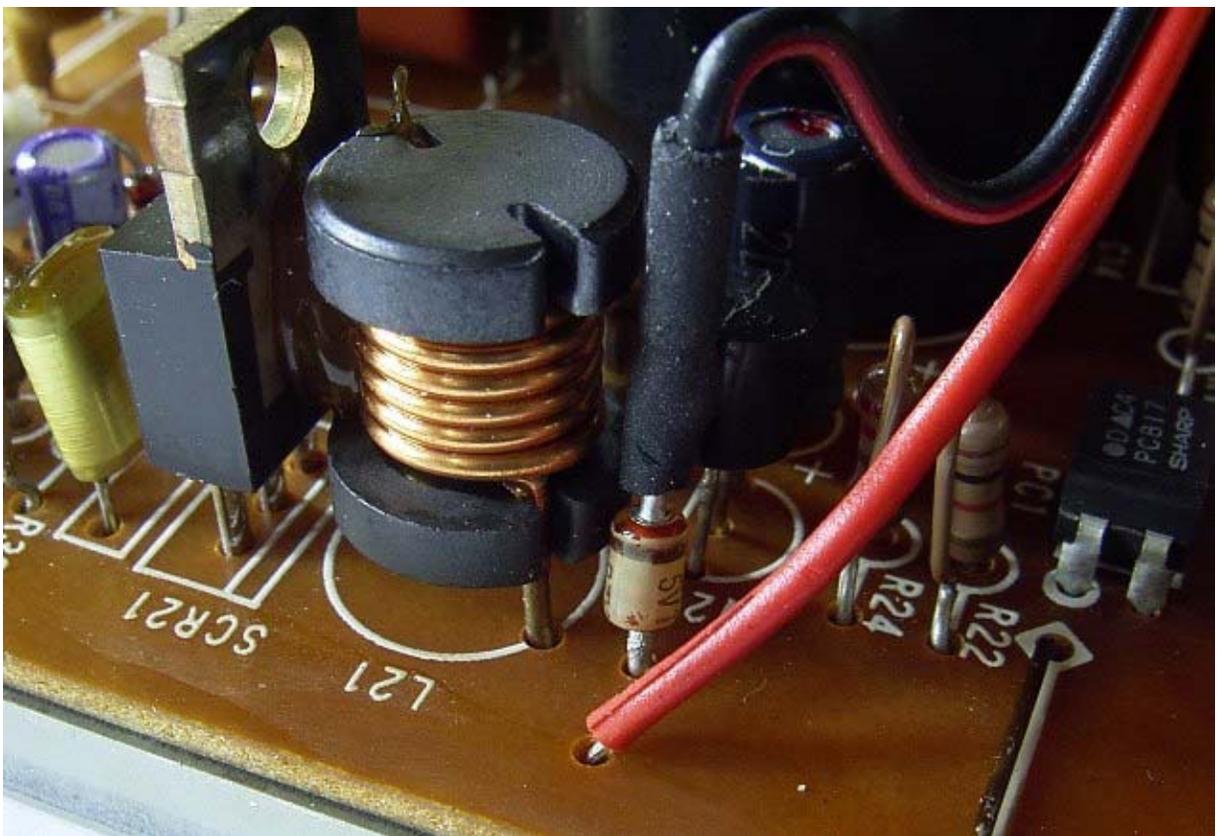
Fig 9. Notice where and how the wire and diode are inserted into the PCB

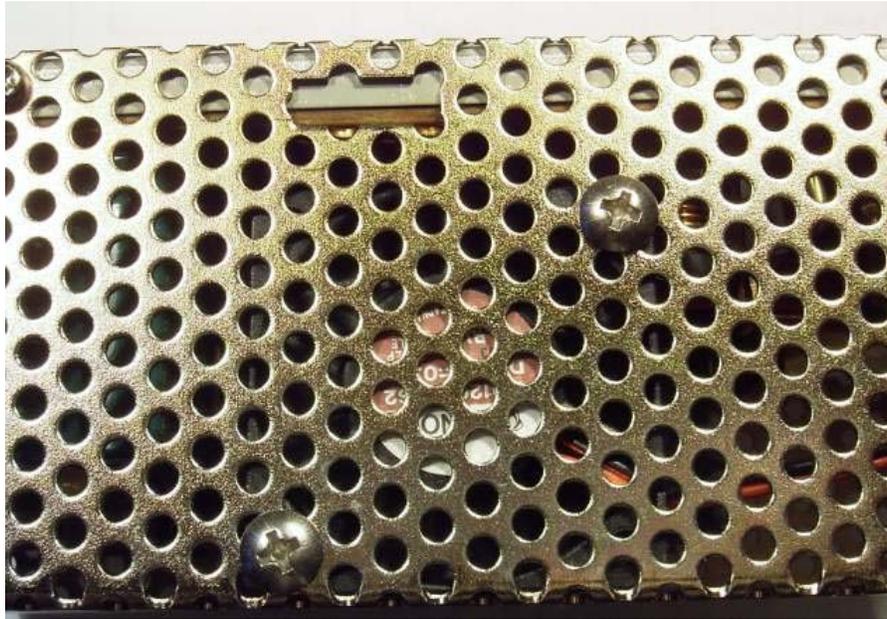
Fig 10. Showing the fan through the perforation

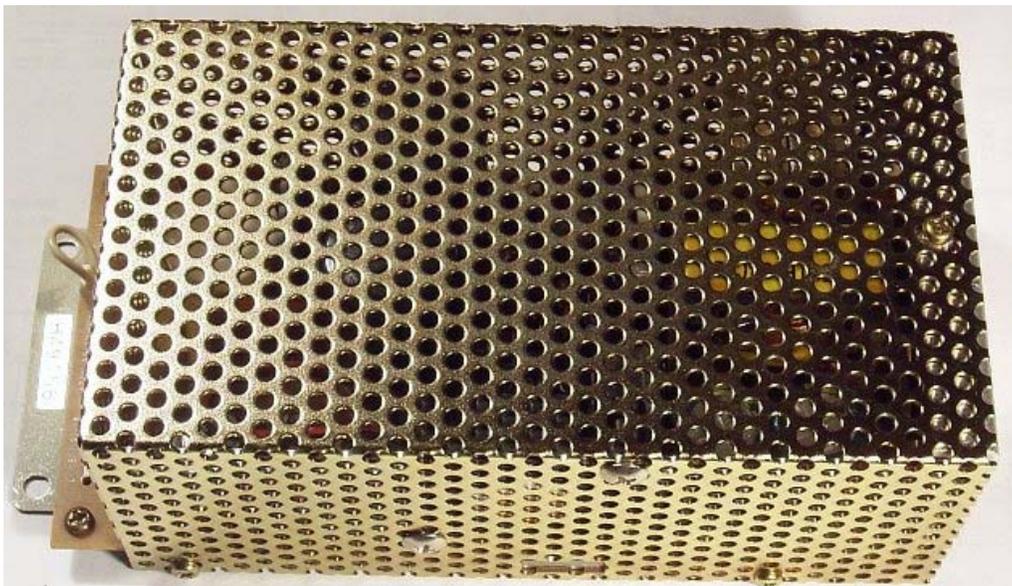
Fig 11. Completed power supply ready to install into FT-736R.

Be sure to roll and shake the unit to check for any loose parts inside. Remove any objects that do not belong there.

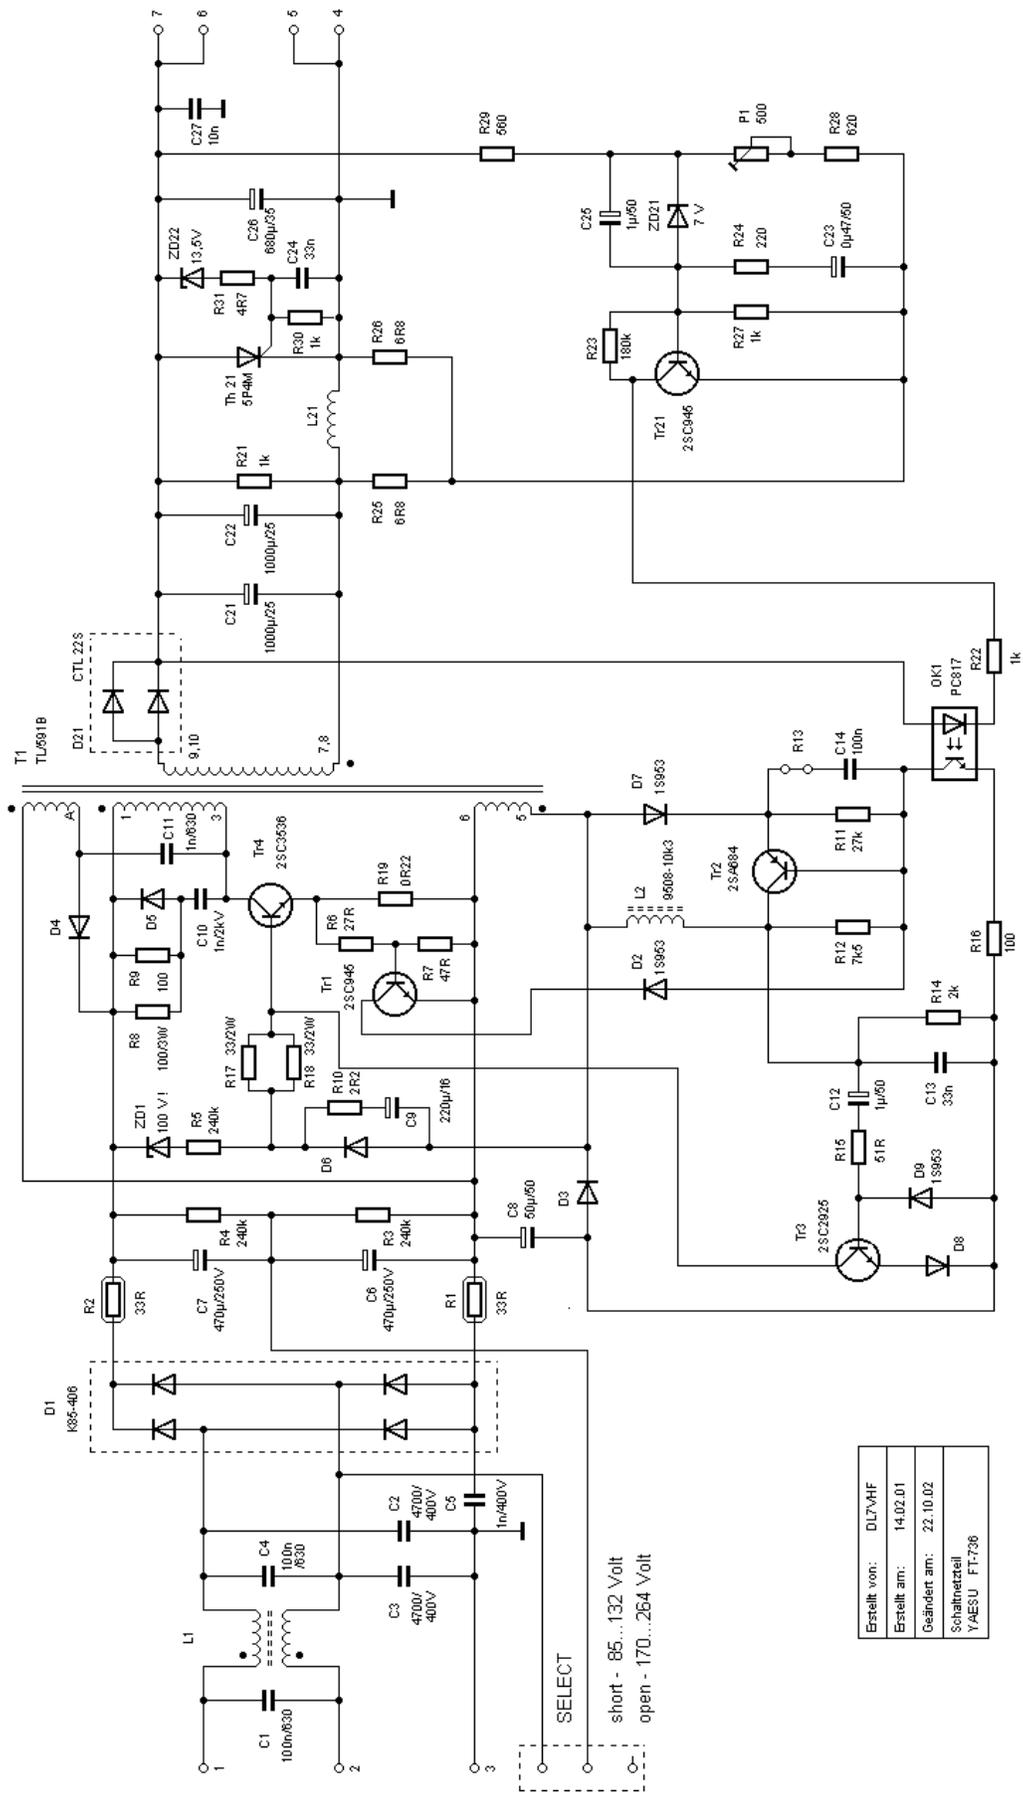
DL7VHF's FT-736R Power Supply Schematic

Erstellt von:	DL7VHF
Erstellt am:	14.02.01
Geändert am:	22.10.02
Schaltzeichen:	YAESU FT-736
