MODEL 962

Model 962 test report

24 Sept 98

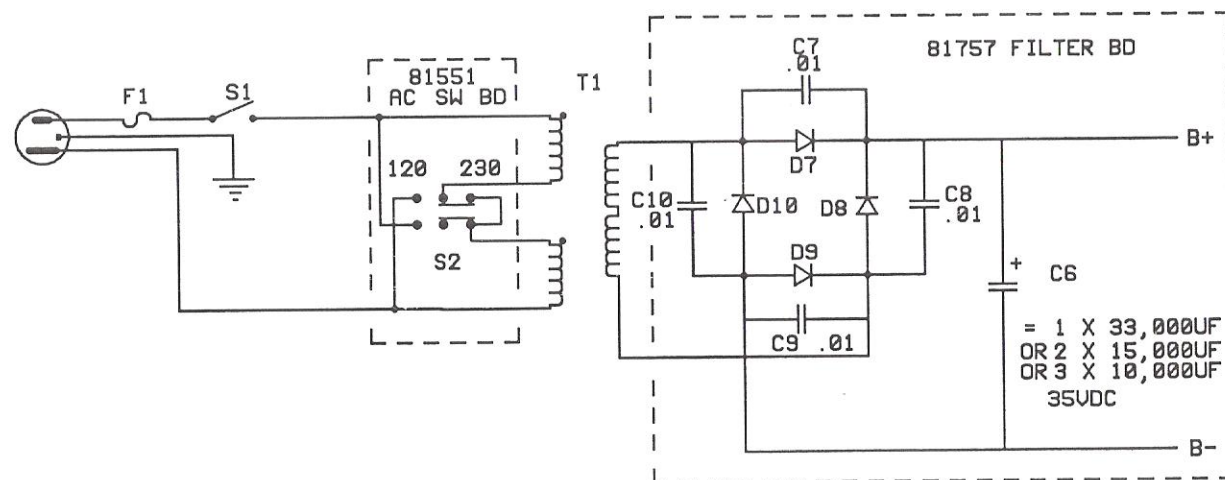
Voltage overshoot on turn-on causes 564 over voltage protection to "buzz"

Caused by c12 - r560 charge timepulls gnd and base of Q5 to B- till charged

Add 1000 uF to AUX 12 Vdc jacks on rear chassisThis caused over current trip on some units....

Change C12 from 33uF to 10 uF.....(R21-31 and C12 feedback gnd ripple to Q5 to reduce ripple on output).....this ripple was found on first run only with red zeners (change zeners also reduced ripple).

Change R10 from 1K to 4.7K To delay trip

MOVE C2 to IC #4+5
added GK resistor 1KΩ
