Technical Bulletin

ICOM

IC-735

HF ALL BAND TRANSCEIVER
GJ36783

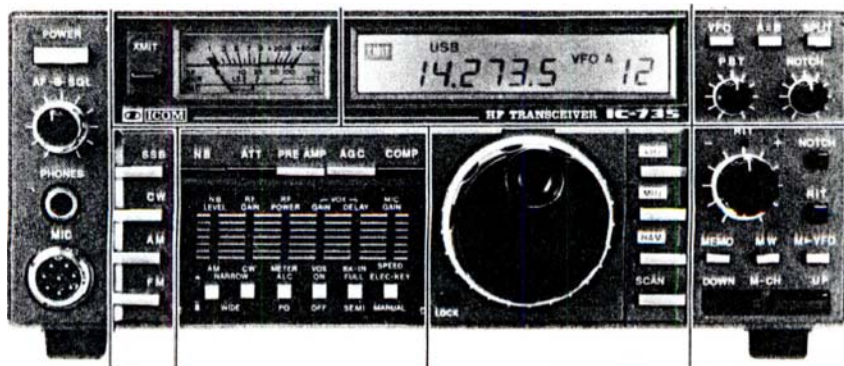
Replace the following trimmer caps:

C37	10pf	with an Icom # 4610000110 12pf unit vco cap (white)
C45	10pf	with an Icom # 4610000110 12pf unit vco cap (white)
C52	6pf	with an Icom # 4610000100 6pf unit vco cap (red)
C59	6pf	with an Icom # 4610000100 6pf unit vco cap (red)
C138	6pf	with an Icom # 4610000100 6pf unit REF osc (red)

The replacement trimmer caps are long-life ceramics. A partial realignment will be required after these trimmers are replaced. See Service Manual for procedure.
