TS440S Repair FAQ

10-29-02 by Mike Freeman KC8QNO

I recently ran into some problems with my Kenwood TS-440S. Here is a list of my problems.

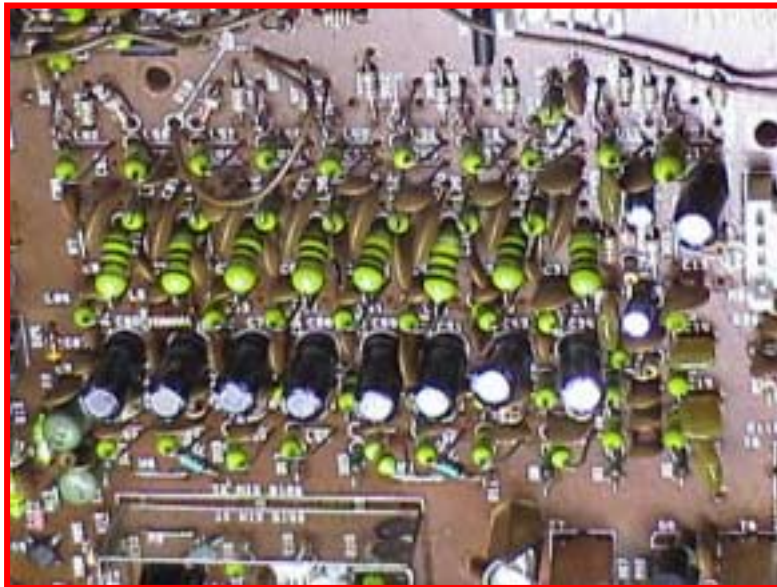
RF Board - Close up of band select filters (metal shield removed).

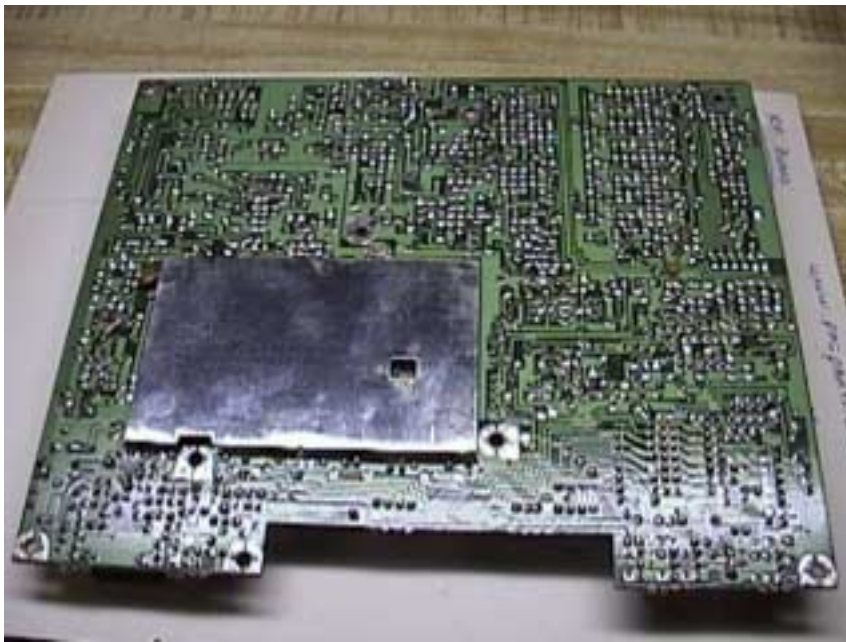
RF board removed (solder side) with shield.

If you find a bad diode remove the RF board carefully (like you did with the PLL board). Notice the metal shield? Well you guessed it, you must carefully remove it by unsoldering it from the RF board.
