# SERVICE BULLETIN

from: TRIO-KENWOOD COMMUNICATIONS, INC.

SUBJECT: TS-520/520S: BS-5 SWEEP INTERFERENCE

DATE 8/10/79

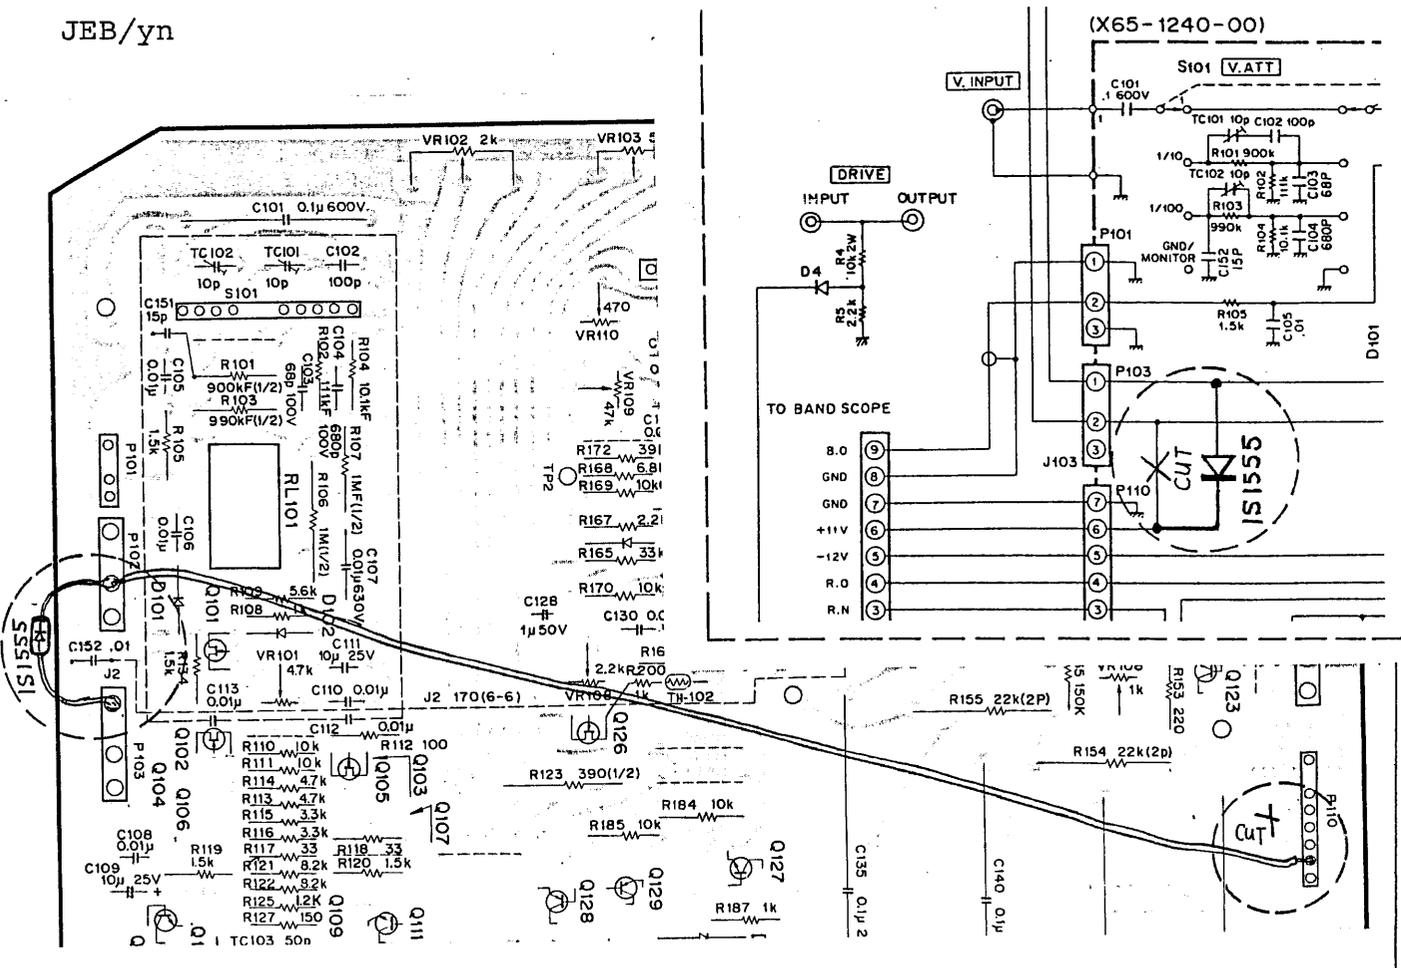
BS-5 users may report ignition-like interference on 80 & 40M from their SM-220 with BS-5. Noise will be heard between 3850-3870 Khz, and 7245- 7260Khz any time the scope is on.

The sweep signal mixes with the IF (carrier) frequency. This derived signal, or its second harmonic will usually be less than an S1 signal, unless the coax ground to the scope is opened, in which case S9 may be indicated.

On the SM-220 PCB X65-1240-00, change the BS-5 +11V DC supply point:

1. Cut the foil path between connector P110 pin 6 & Connector P103 pin 2.
2. Install a 1S1555 diode between Connector P110 pin 6 and Connector P103 pin 1.

New Part: 1S1555 V11-0076-05
