SSCA Discussion on the Icom M-802 Clipping Issue

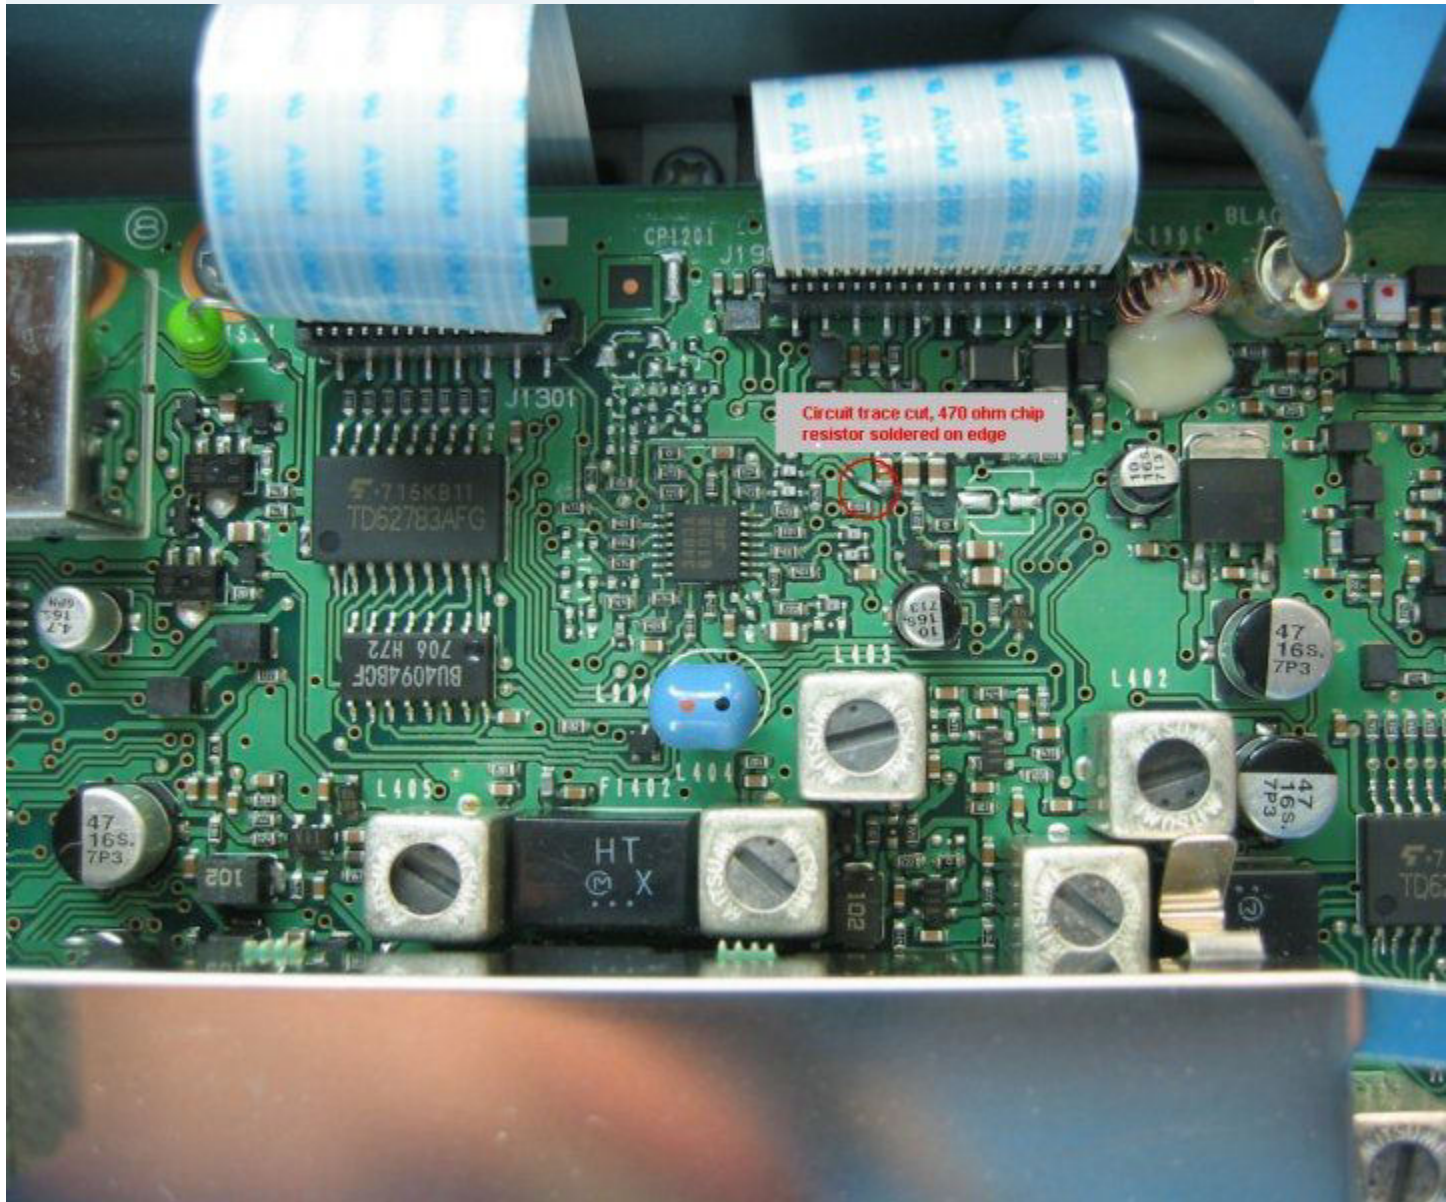
If you have a transceiver with serial number before 0108261, you can visually check for the mod by removing the cover of the transceiver and look for the added resistor near the center back edge of the main board which is the large board you see after removing the top cover. To add the resistor, a circuit trace is cut and the chip resistor is soldered on edge bridging the cut. Icom has now come out with a new board version that accommodates the resistor placement. See photo's. If you're a good techie with magnifiers, the right soldering tools and steady hands, you can easily do it yourself. I've done a few.
