## Drake R4B First Mixer V2 6HS6 Alternative

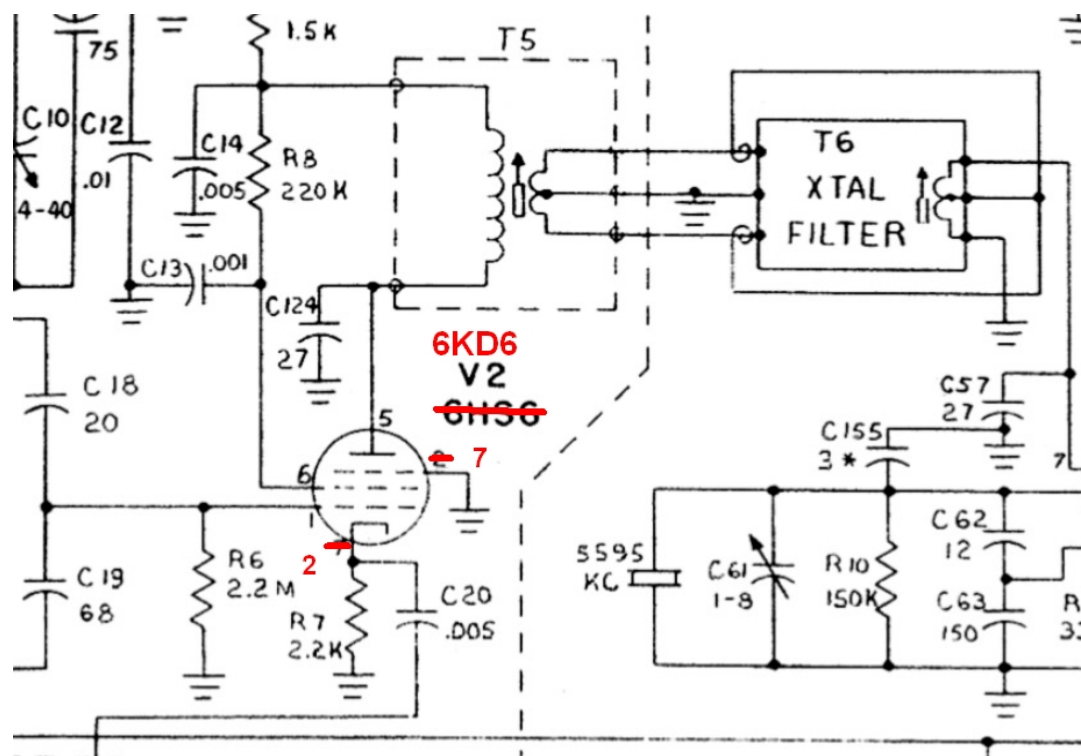
1. Remove the wire to ground on pin 2.
2. Remove R7 2.2 K from pin 7 to ground.
3. Reinstall R7 2.2 K between pin 2 and ground.
4. Disconnect C20 .005 uf from pin 7 and reconnect to pin 2. You will need to lengthen the lead and use some sleeving to prevent any short to other pins.
5. Ground pin 7.
